Abstract

The objective of this research is to develop a comprehensive classification and documentation of the failures in buildings that occurred in Puerto Rico in January 2020 as a result of the southern earthquakes, determine the causes of those failures, and develop general recommendations that decrease the propensity of these failures to occur.

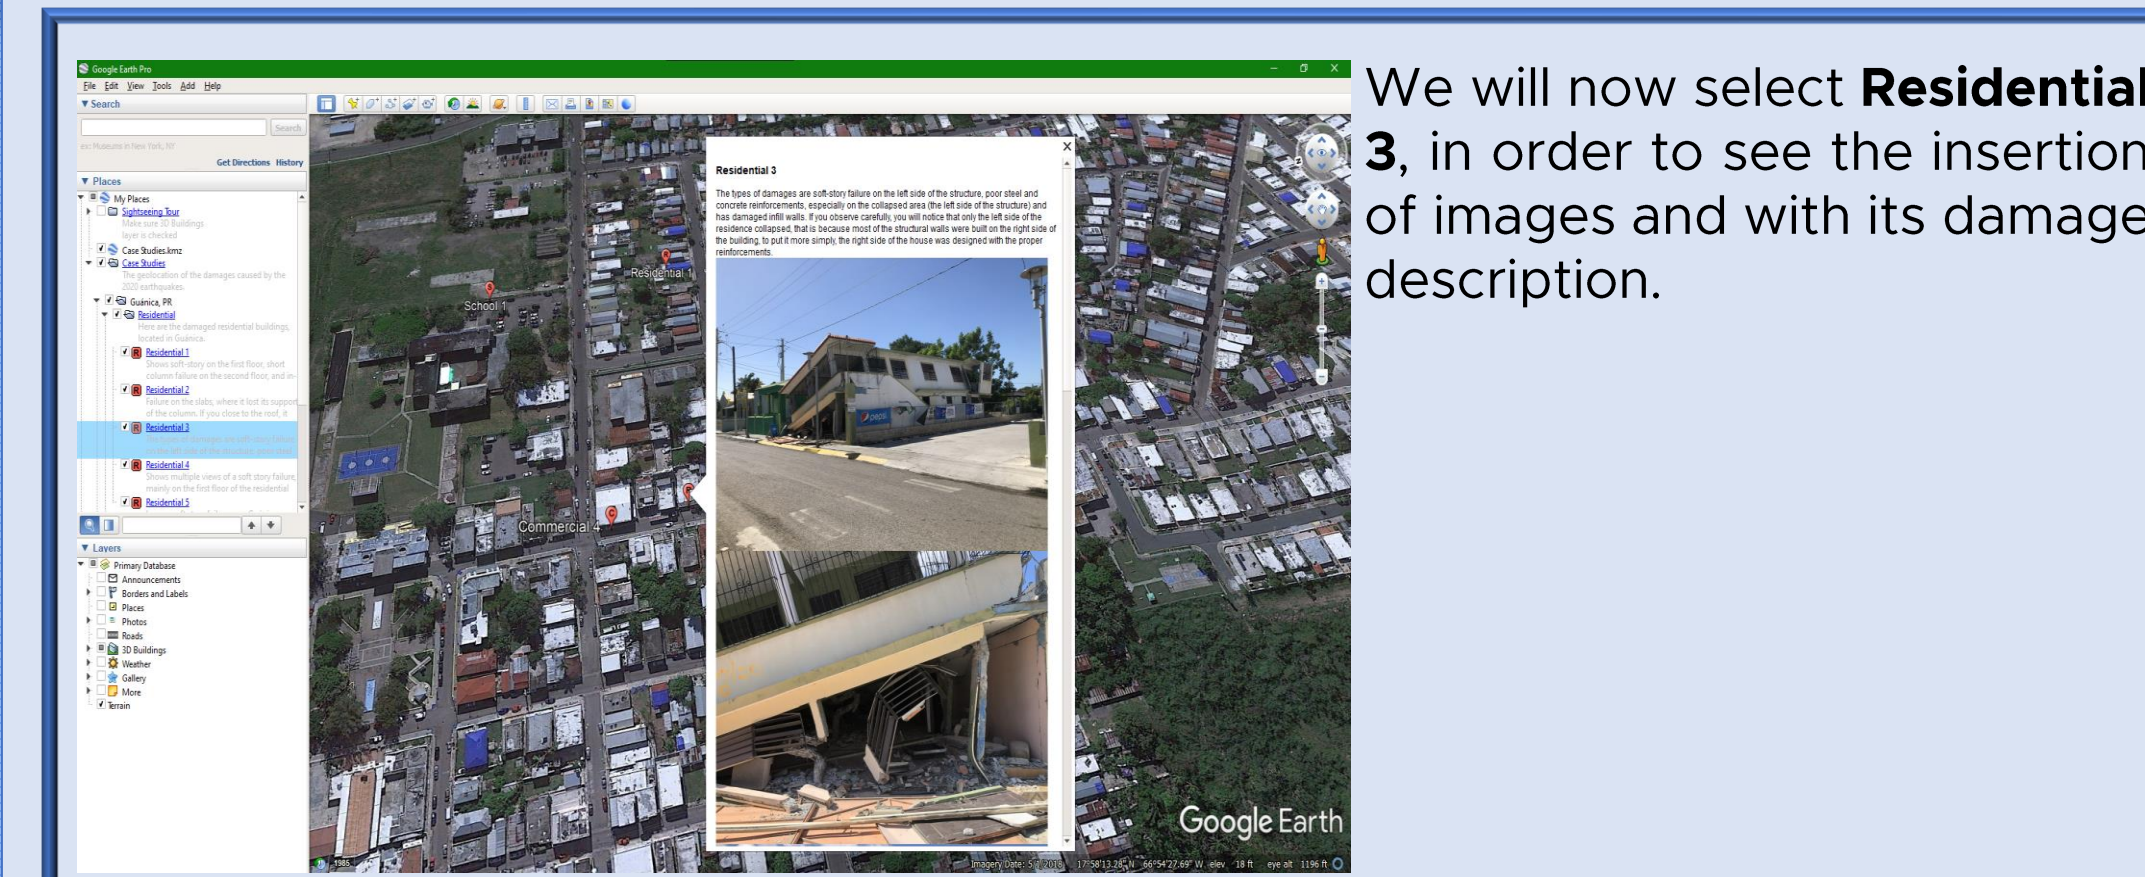
For this case, the damage description says the following:

"The types of damages are soft-story failure on the left side of the structure, poor concrete quality and steel reinforcement details, especially on the collapsed area (the left side of the structure) and has damaged infill walls. If you observe carefully, you will notice that only the left side of the residence collapsed, that is because most of the structural walls were built on the right side of the building. Although the presence of walls only on one side triggered undesired torsional effects, this is one of many cases observed where the presence of walls played a significant role in avoiding collapse."
