INTRODUCTION

SCOPE

The project consists of the detailed visual and structural evaluation of each member of bridge #1103 located in Juncos, Puerto Rico by using the current design codes and manuals to find its condition and propose an appropriate retrofit solutions along with a new permanent detour which will serve for traffic control during the repairs to the bridge. Also an alternative road and a rest area building was proposed for drivers to stop during their trip.

The bridge #1103 and project # AC-003008 is in the state road PR-30 located in Juncos Puerto Rico. The bypass contains two identical bridges with a median that separates them. The one chosen was the right bridge, the Gurabo to Juncos direction. The bridge is 173 feet long and 40 feet wide. It contains 2 lanes of 12 feet each and an exclusive lane for emergencies of 12 feet wide and lesser left side small 4 feet margin which includes concrete barriers. The bridge has a vertical clearance of 14 feet and 6 inches and its superstructure contains the following components: a concrete slab 6 inches thick, 5 T-Girders beams of variable section, 10 steel bearings that support the girders and bent beams, 20 diaphragms and 2 b

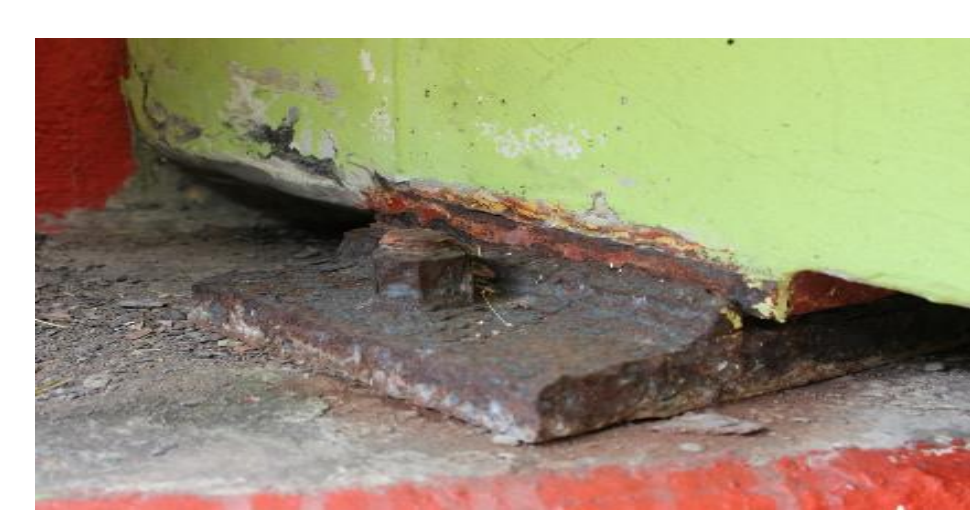
Detailed Element inspection

Bearing plate rating 4
