Analysis of a Slope Failure in Los Canales Road in Carolina Puerto Rico after the Tropical Storm Irene

Melissa Castro Del Valle
Civil Engineering
Omaira Collazos, Ph.D.
Civil and Environmental Engineering Department
Polytechnic University of Puerto Rico

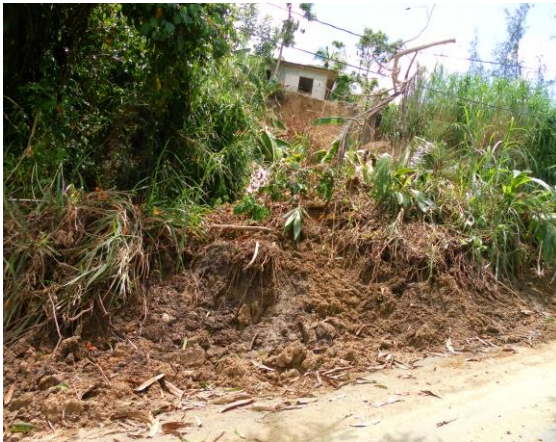
Figure 3
Landslide Movement (Front View)

After a visual inspection of the failure, a rotational soil movement type was assumed creating a circular failure surface. Figure 3 shows the landslide movement over the road. In Figure 4 the slip surface is shown through a portion of the slope's crest side-view.

As conclusion for this study, the main factor contributing or causing the failure of Los Canales slope was the saturation of the soil due to the heavy rainfalls.

Based on the analysis results, the soil properties and slope geometry, soil nailing is highly recommended for the slope restoration. This in-situ reinforcement is appropriate since the space at the toe is limited. Figure 12 shows a cross-section of a typical soil nailing design to improve slope stability due to a road widening. This technique is also suitable for sites with difficult access like the site being addressed in this study.

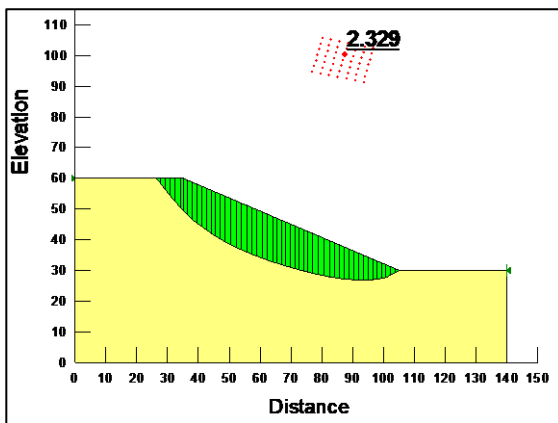
Figure 8
Model 1 Analysis Results

The first model represents the original dry conditions of the slope before the storm and toe removal. For this model the peak value of the angle of friction was used since the model intended to represent the stable condition of the slope before failure. After performing the analysis a factor of safety (FS) of 2.33 was obtained. For slope stability analyses a factor of safety greater than 1.5 is considered stable. Figure 8 shows the slip failure surface and the origin of the radius.

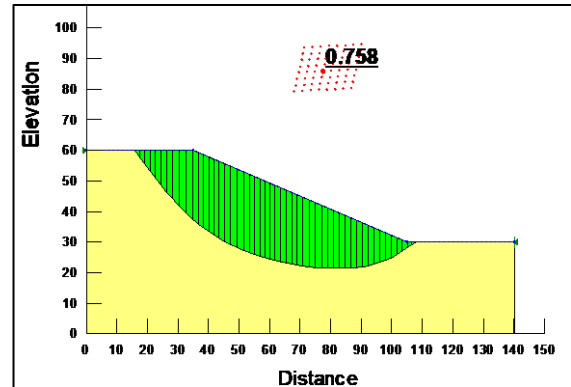
Figure 9
Model 2 Analysis Results

Figure 9 shows the failure surface, the factor of safety and the origin of the radius for model 2. A factor of safety of 0.76 was obtained, which was less than 1.5, indicating slope failure.

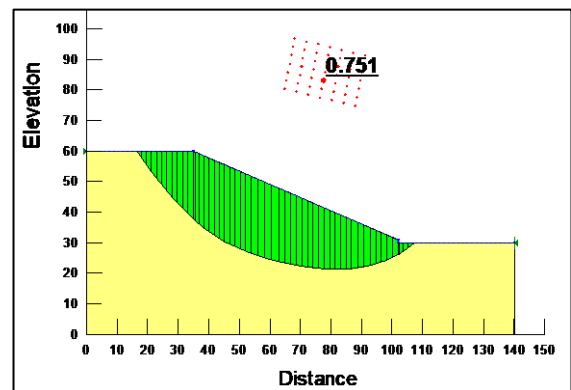
Figure 10
Model 3 Analysis Results

The third model considers a piezometric line representing the soil saturation as well as the 24 inches removed from the slope's toe. Figure 10 shows the critical center and the failure surface. A factor of safety of 0.75 was obtained. This value is less than the minimum factor of safety therefore the slope is at failure.

explained before, represents the original dry conditions of the slope and the factor of safety was 2.33 approximately. Model 2 analyzes the effect of the rainfall through saturation of the soil and the factor of safety obtained was 0.76, this value indicates instability or failure of the slope. Comparing Model 1 with Model 2 there is a decrease in the shear resistance and a notable increase in the mobilized stress. This change in stress is a triggering factor to landslide development. Is due to heavy rainfalls that pore water pressures within the slope increase and therefore the shear strength of soils decreases compromising the stability of the slope. Model 3 considers the soil saturation and the portion of the toe removed. The factor of safety obtained for this model is 0.75, which indicates slope failure. However this value it's not too different from the value obtained in the analysis performed in Model 2. Therefore it can be concluded that the removal of the toe did not cause the slope failure.

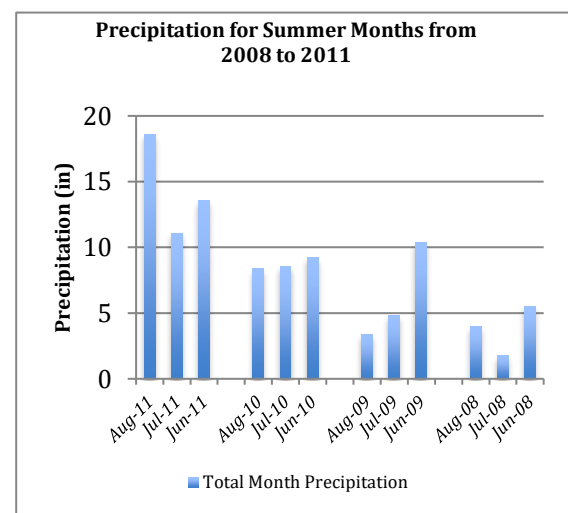
Figure 11

The total precipitation during the month of August for the slope location was 18.56 inches and the greatest precipitation in a 24-hour rain was 5.91 inches during the days 21 and 22 (storm strike) [10]. The total precipitation for the summer months is presented in Figure 11. This data shows that the rainfalls during the 2011 summer were exceedingly great compared to the previous years. This figure also shows heavy rainfalls during the months of June and July in 2011 prior to the storm.

This contributed to the process of saturation of the slope and a gradual decrease of the soil shear resistance. Finally in August 2011 the storm rainfall ultimately drove the slope to failure.
