Piedras Blancas Landslide: Mitigation Works

*Janet Rendón Ferrer
Civil Engineering
Omaira Collazos, Ph. D.
Civil Engineering Department
Polytechnic University of Puerto Rico*

Key Terms — *back analysis, colluvium, gabions, landslide.*

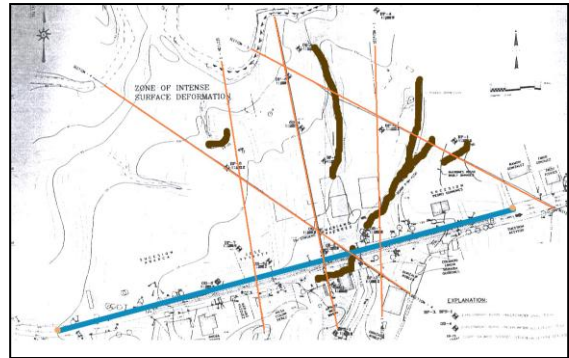
Figure 1
Piedras Blancas Landslide: Survey Map

Evaluation of the land survey map prepared by previous investigators (Figure 1), together with the data on Figure 7 of this project, and visits to the site has permitted the following observations:

- Higher groundwater level occurred near the creek or the highway proximity.
- Irregularities of the surface are seen clearly because fill, cut and re-grading works.

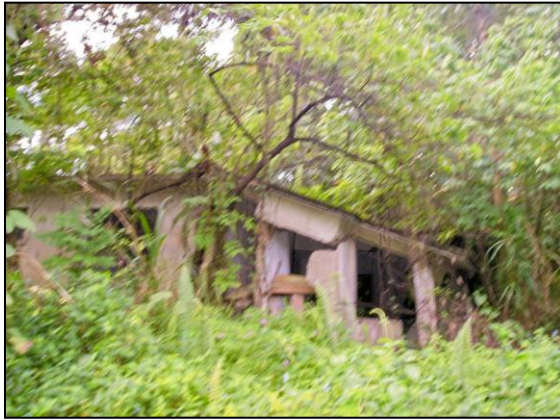
Figure 2
Piedras Blancas Landslide: Abandon residence

Fill and cuts, necessary for residence and road construction diminish slope stabilization [2]. Previous studies on Piedras Blancas failure present information about cuts on the south side of the highway PR-111 and fill works in the north side of

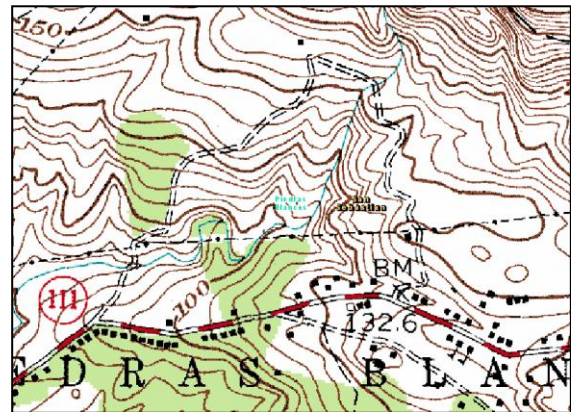
Figure 3

Topographic Map of San Sebastian

Water converges to Piedras Bancas failure zone. This zone is near a hollow area (Figures 3). This type of topography is susceptible to the initiation of landslide, [10]. They act not only as sources of landslides but also as conduits for debris flow of previous events. This must be an alert to project planners and designers. He suggests hollow mapping and identification in landslide hazard map [13].

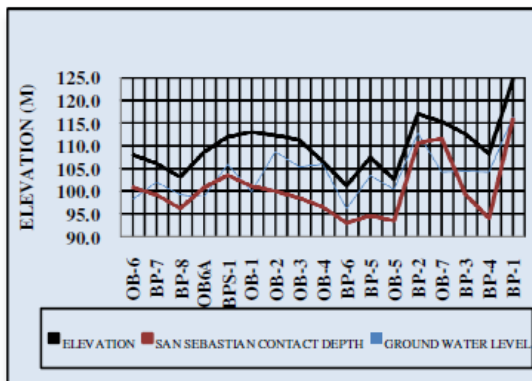
Figure 7
Elevations vs. Borings Layout at San Sebastian Formation

Figure 7 presents groundwater leveling, surface leveling, and San Sebastian Formation leveling vs. borings' layout. Chart intends to show the influence of these levels with the deformed areas. Figure 1 corresponds to Piedras Blancas failure's survey map prepared by Geocim and PRHTA [12].

Figure 7 and survey map data present similarities in borings OB-7, OB-1, OB-6 and OB6-A. These borings are located near the highway PR-111 and have their groundwater levels below the San Sebastian Formation contact zone. On the other hand, the survey map shows borings OB-7 and OB-1 near large scarps and fissures but borings OB-6 and OB6-A without any noticeable deformation. It was observed that there no construction of residences at OB-6 and OB6-A zones.

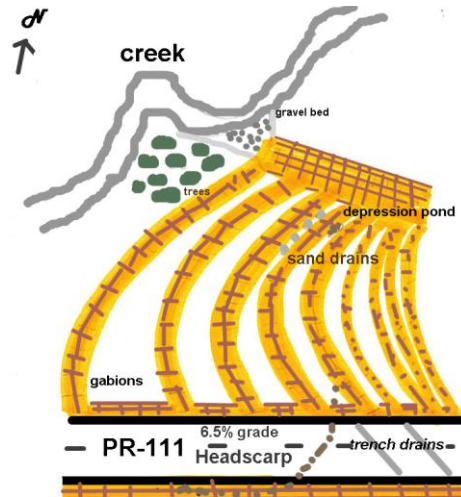
Figure 8
Piedras Blancas Terraces Alignment

The design proposes nine terraces reinforced by gabion walls (Figure 8). The gabion walls have three different heights of 6, 9 and 10 feet (Figures 9 to 11). Stability calculations were done with a friction angle of 15 degrees. It is a conservative value chosen considering that cross sections # 4 and #5 had values of 7 and 33 degrees, respectively. (Table 1). These sections are aligned toward northwest more similar to terraces that are directed toward the west. Terraces elevations are close to the natural contours elevations presented in the topographic map (Figure 3). It is a way to return balance to the site. Terrace number six has the San Sebastian Formation soil. It needs special consideration for drainage (Tables 6 & 7). It could affect terraces five and seven.

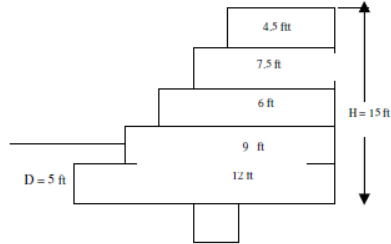
Figure 11
Gabion Wall

Type 2, $q_{toe} = 1231.45 \text{ lbs/ft}^2$, $q_{heel} = 737.3 \text{ lbs/ft}^2$ (Figure 11)
