Structural Evaluation and Rehabilitation Design of Puente Blanco in Quebradillas

Lismarie Vargas Andino

Master in Civil Engineering

Polytechnic University of Puerto Rico

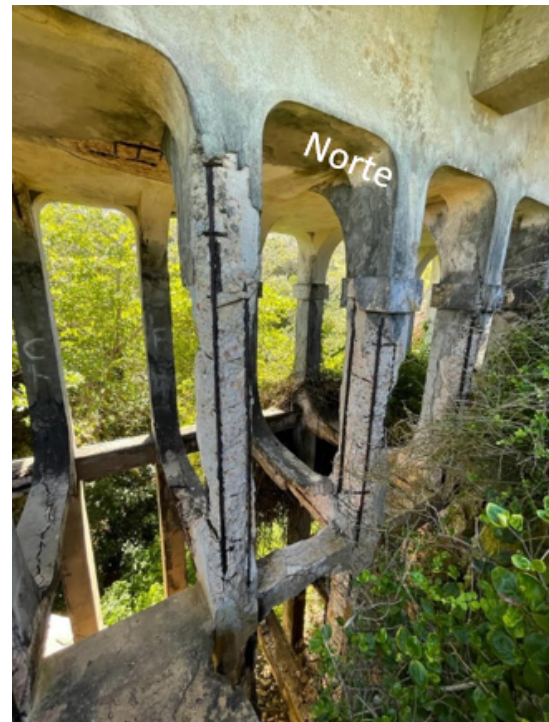
Figure 6
View of north side of the bridge

It was noticed that the north side of the bridge, which is closest to the coast, is more deteriorated than the south side. The north side of the bridge has advanced stages of rebar corrosion, concrete cracking, and concrete spalling (figure 6). Meanwhile, the elements on the south side are not as deteriorated (figure 7).

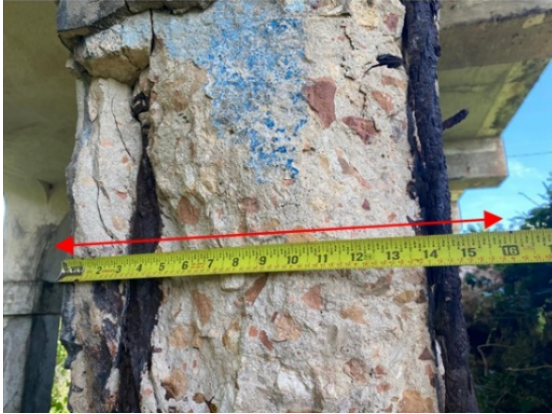
Figure 8
Example of north side column

As an example of the conditions found in the north side of the bridge, figure 8 shows contrast of the current condition of one of the columns with a red line indicating its original 16-in depth. It is estimated that this column has lost approximately 20 percent of its gross sectional area.

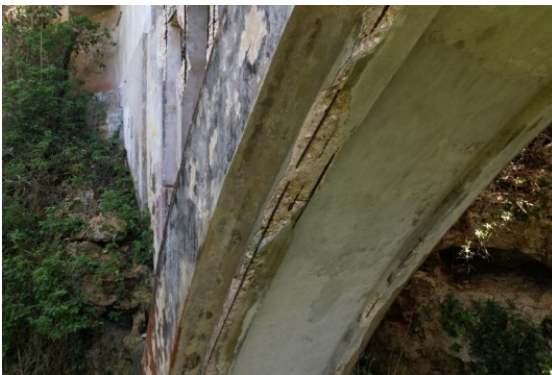
Figure 9
The inferior side of the arch

Figure 9 shows the present condition underneath the bridge. It can be seen that some of the rebar of the arch has been exposed due to corrosion on the north side of the bridge.

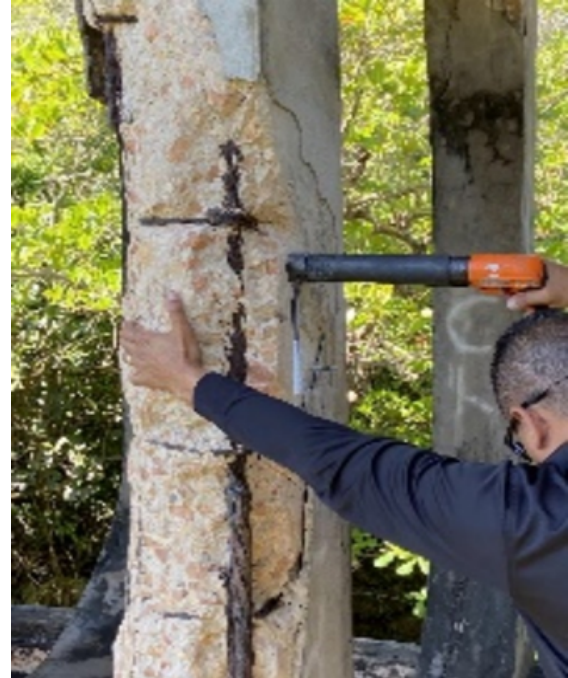
Figure 10
Windsor probe test

In accordance with the Handbook of Nondestructive Testing of Concrete, the bridge was subjected to nondestructive testing for compressive strength [5]. A Windsor probe test was conducted on the bridge in accordance with ASTM C803 [6]. This is a special gun that inserts the probe into the concrete and the depth of penetration can be approximately related to the strength of the actual concrete. Three nondestructive tests were taken on a column on the north side (figure 10). This test required that the concrete not be plastered to obtain accurate results. The tests suggest that the concrete has a compressive strength of 5,500 psi.

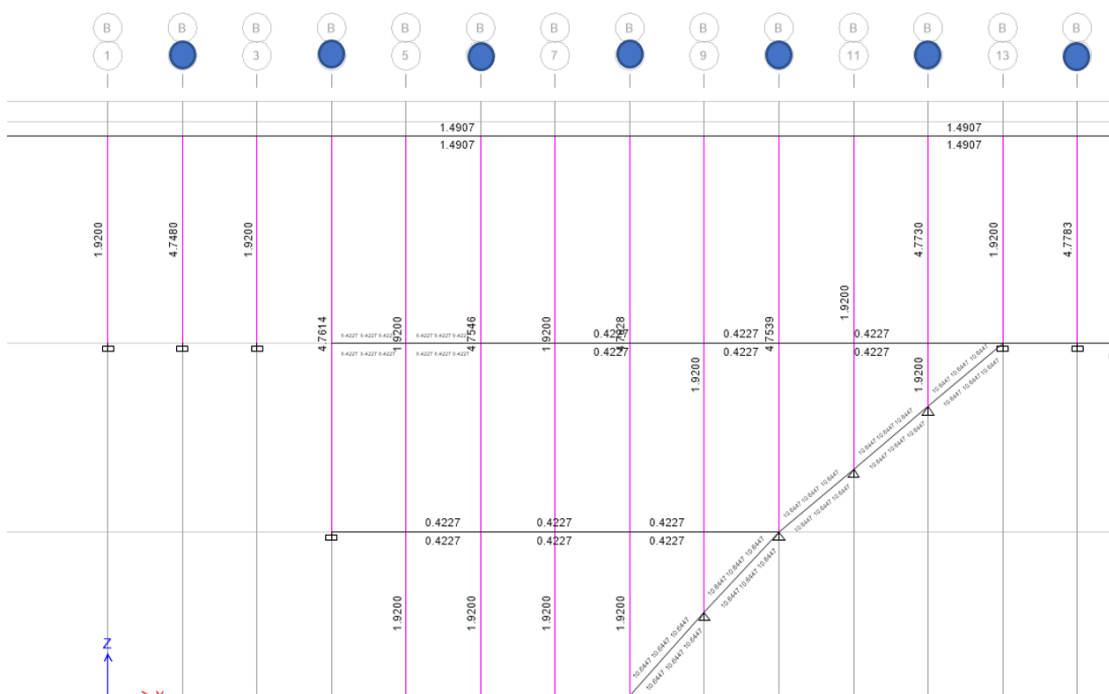
Figure 12
Structural model results with pedestrian and cyclist loads

Figure 12 shows that, as a result of the analysis, it was identified that the columns on the axes marked with a blue circle, require 4.75 in^2 of additional reinforcement. Similarly, columns on axes not marked with blue circle, require 1.92 in^2 of additional reinforcement.

The results of the structural analysis require increasing the ductility in the columns. To solve this, the installation of six No. 8 bars on the columns, as shown in figures 13 and 14.
