Reduction in Dye Test Failures Incidence for Cartridges Manufacturing Process in the Medical Device Industry

Perla M. López Morales

Master of Engineering in Manufacturing Engineering

Polytechnic University of Puerto Rico

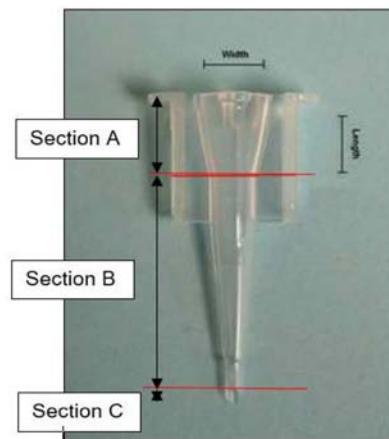
Figure 1
Cartridge Sections

The Dye Test is declared fail if one of the following conditions is identified:

- Cartridges contain voids in Section A that do exceed a minimum of 0.100" wide and 0.250" length.
- There are gaps or missing purple dye in section B and C.
- Cartridges that do not show presence of basecoat and/or topcoat.

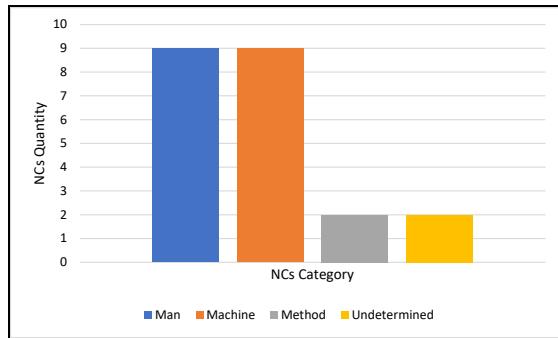
Figure 2
Dye Test Failure Assignable Causes of NC's

The 22 Non-conformances covered on Effective Monitoring failed, were analyzed, and shown that the assignable causes were distributed between man omission error, machine malfunction and method as shown on Figure 2.

A total of 9 Non-conformances revealed that most of these dye test failures were attributed to operator omission errors. The investigations show that operators skipped or did not follow the instructions established on the coating manufacturing procedure. The second incidence demonstrates that 9 failures were attributed to coater machine malfunction when processing the production orders on coater machines. The coater machine is an equipment used to dispense the basecoat and topcoat solutions to coated cartridges. The third incidence corresponds to method with 2 Non-conformances. In both Non-conformances investigations was demonstrated that manufacturing procedures instructions were not clear and caused confusion to operator during coating process execution. In addition, 2 Non-conformances were evaluated, however, a root cause was not possible to determine due to the unique failure detected.

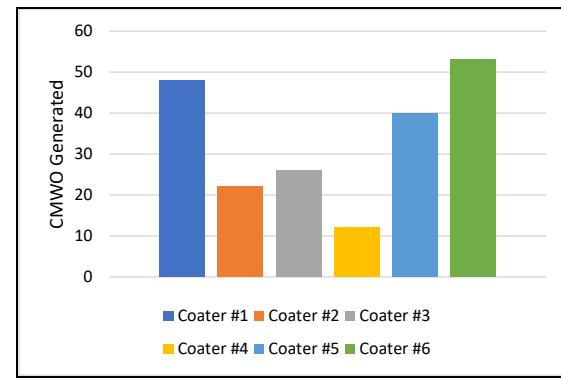
Figure 3
Dye Test Failure Assignable Causes of NC's

- The coater #1 has a total of 48 CMWO generated, where the major incidence corresponds to axis error with 20 CMWO events. The axis errors are distributed in X, Y and Z axis. Due to the complexity of the equipment, it only has the capacity to reflect an axis error, however, the root cause is different in each CMWO. The second incidence is the cosmetic defects with a total of this 13 CMWO that are detected by coater operator. When operator identifies a significant trend of "overflow" "tip" or "plugged" condition on cartridges, equipment is verified by technician and cartridges with cosmetic defects are discarded as part of normal manufacturing process. The third incidence corresponds to needle washer problems with a total of 6 CMWO. These events are related to misalignment of needle washer on equipment

- during the changeover or any other incidence during execution.
 - The coater machine #2 has a total of 22 CMWO, where the major incidence corresponds to axis error with 10 CMWO events. The axis errors are distributed in X, Y and Z axis. The second incidence is cosmetic defects with a total of 6 CMWO that are detected by coater operator. The third incidence corresponds to atypical events with a total of 3 CWMO. These events are different in each case and cannot be related.

- The coater machine #3 has a total of 26 CMWO, where the major incidence corresponds to axis error with 13 CMWO events. The axis errors are distributed in X, Y and Z axis. The second incidence is cosmetic defects with a total of 6 CMWO that are detected by coater operator. The third incidence corresponds to atypical events with a total of 5 CWMO. These events are different in each case and cannot be related.

- The coater machine #4 has a total of 12 CMWO, where the major incidence corresponds to cosmetic defects with a total of 6 CMWO that are detected by the coater operator. The second incidence is related to atypical events with a total of two 2 CWMO. These events are different in each case and cannot be related. The third incidence corresponds to axis errors with a total of 2 related to Y axis. Due to the complexity of the equipment, it only has the capacity to reflect an axis error, however, the root cause is different in each CMWO.

- The coater machine #5 has a total of 40 CMWO, where the major incidence corresponds to cosmetic defects with a total of 13 CMWO that are detected by coater operator. The second incidence is related to Vacuum System events with a total of 9 CWMO where chiller of the vacuum system was replaced and required re-validation activities. The third incidence corresponds to atypical events with a total of 8 CWMO which includes problems with manifold misalignment and pumps failures.

- The coater machine #6 has a total of 53 CMWO, where the major incidence corresponds to axis error with 39 CMWO events. The axis errors are distributed in X, Y and Z axis. In this equipment, most of these events were associated to X axis error where slider and motor of this axis were replaced as part of the troubleshooting and required re-validation activities execution. The second incidence is cosmetic defects with a total of 5 CMWO. The third incidence corresponds to needle washer problems with a total of 4 CWMO. These events are related to misalignment of needle washer on equipment during the changeover or any other incidence during execution.

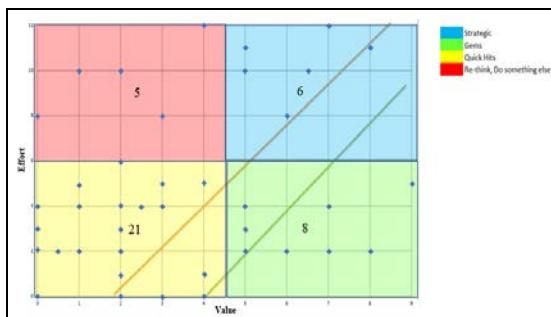
Figure 4
“Effort versus Value” Matrix

As shown in Figure 4, only 8 actions fall between the desire zone identified are those described with the most positive impact added with a lower cost of investment. Of those 8 actions, only 6 actions were considered because were directly related to Dye Test failures and implementation will not require much effort or support from different functional groups. These 6 actions are described below.

1. Add inspection step after a changeover to assure that cartridge clamp is aligned with the nesting tray.
2. Update manufacturing procedures to include tray flatness verification and ensure all screws are in place. (3 manufacturing procedures)
3. Install vacuum lines with negative slope posture to avoid manifold misalignment.
4. New tool design to avoid tilt of basecoat solution jar and avoid air bubbles on lines. Also include a poka-yoke identification of solution limit.
5. Implement the use of dummy cartridges when cartridge is dropped or discarded.
6. Implementation of analytic balance for dye test solution preparation.
