Dominguito Transformer Overload

Eliam J. Silva Matos

Polytechnic University of Puerto Rico

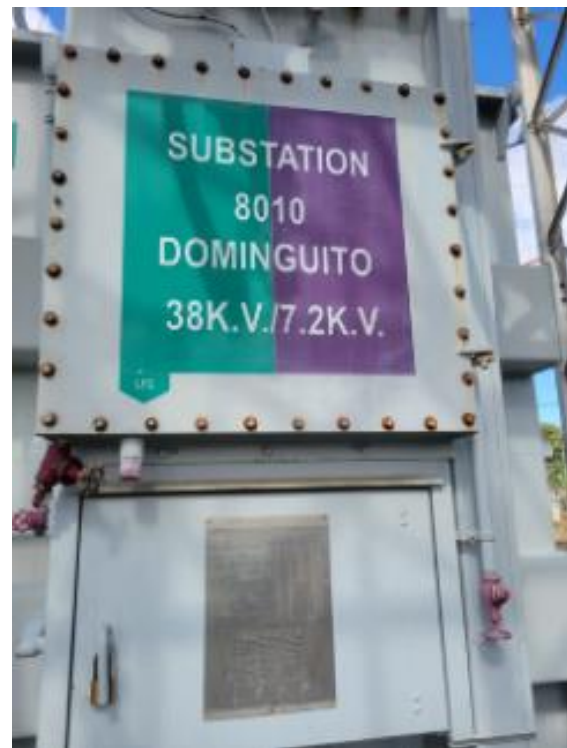
Figure 1
Dominguito Transformer

Assessments were made in Arecibo, Puerto Rico, between 2021 and 2023 to determine the root cause for loading issues that were occurring in this area. From this investigation, it was found that Dominguito substation has an overload on the 8010-distribution transformer. This type of transformer is no longer produced on the market.

Figure 1 shows the Dominguito 8010 transformer. Three alternatives were established to eliminate the Dominguito overload. The first alternative was to replace three transmission poles and enable the Arecibo Rural substation 8003. The estimated cost is \$21,000. The second alternative was to make an underground repair between the feeders 8007-1 (Mirador Azul) and 8010-3 (Dominguito) to transfer the load from 8010-03 to 8007-3. The estimated cost is \$59,000. The third option was to make a transformer convention on 8015-09 (Arecibo SECT). Instead of installing a step-down transformer, the best option is to change the lateral loads to a direct conversion of 13.2 kV. Feeder 8015-09 (Arecibo SECT) passing across the majority of Sub 8010 feeders. It can cost \$100,000 or more.

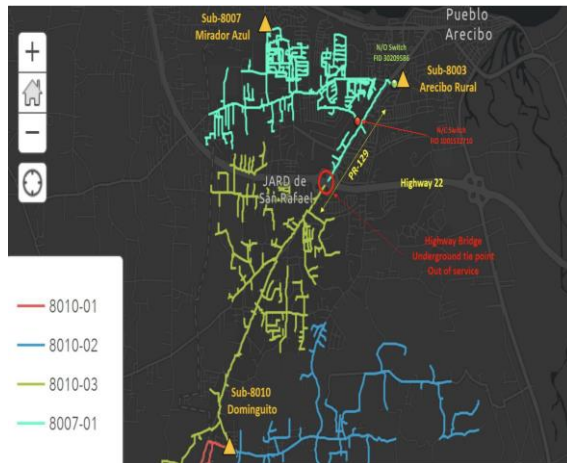
Figure 2
Arecibo Distribution Diagram

Figure 2 shows the Arecibo Distribution Diagram. The feeders are marked with yellow triangles. The plan was to use the backbone (336 SPACER, 556 ACSR) of the feeder 8007-01 through the PR 129 to transfer the loads from feeder 8010-03 to the Arecibo Rural 8003 substation. In parallel, the underground section under the Highway PR-22 Bridge was going to be completed. The availability of the materials for this job needs to be verified in the warehouse. Finally, circuit 8007-01 will be sectionalize such that the load can be transferred from the Dominguito 8010 substation.
