# *Automobile Cabin Water Leak Resolution*

*Jean Ortiz Sánchez  
Engineering Management Graduate Program  
Dr. Héctor J. Cruzado  
Graduate School  
Polytechnic University of Puerto Rico*

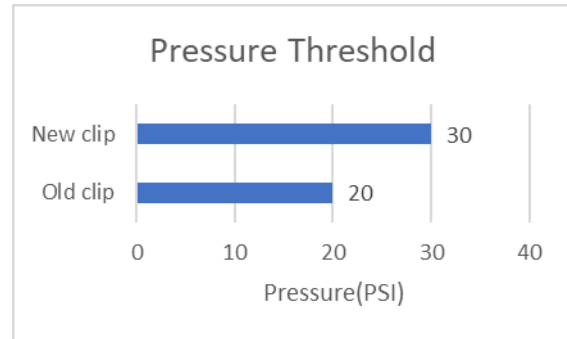
Figure 1  
Pressure comparison

The last solution tested was the replacement of the holding that creates pressure between the roof of the vehicle and the gasket. After changing the clip and creating a tighter seal, the seal was tested by using a pressure washer with a pressure of 30 psi. The cost for the new clip is \$4.32. Figure 1, shows that the new seal can handle 50% more pressure than the one using the old clip, increasing from 20 psi to 30 psi. In Figure 2, a side by side comparison

The most cost-effective solution is the clip replacement. It is the least costly and it does not require taking the entire antenna assembly apart.

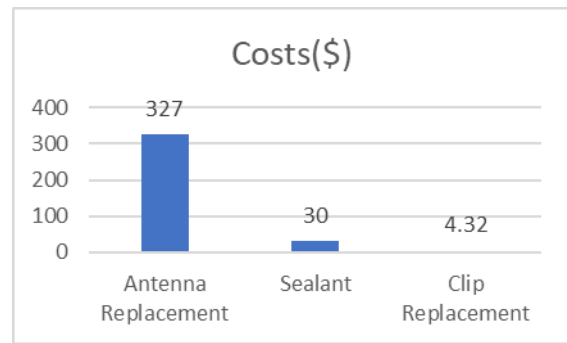
Figure 2  
Cost comparison

for the cost can be seen. Showing that the solution with the lowest cost is the clip replacement.
