Effects of In-stream Sand and Gravel Mining in Scour at Bridges in Puerto Rico

Ana L. Torres Santana

Master of Engineering in Civil Engineering

Polytechnic University of Puerto Rico

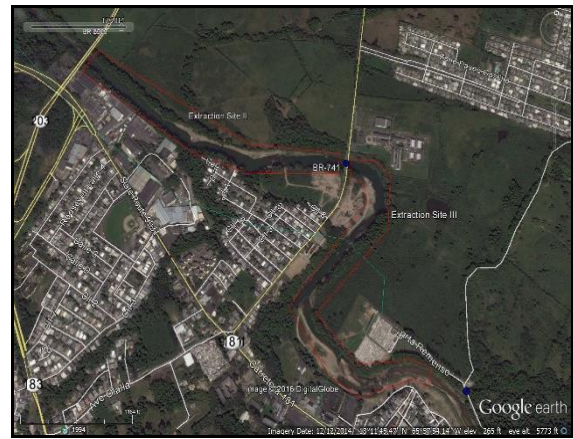
Figure 1
BR-741 PR-181, San Lorenzo

Bridge BR-741, located at Road PR-181 over the Río Grande de Loíza in the Municipality of San Lorenzo, is a three span bridge constructed in 1975. During years there has been a sand and gravel extraction activity from two different operators. As shown in Figure 1 in an aerial photo of 2014 [1], an operator is located upstream and another operator

downstream the BR-741. Permits were granted independently by the DRNA for both operators after fulfilling DRNA requirements under Regulation Number 6916 of December 2004 for Extraction, Excavation, Removal and Dredging of Soil [2].

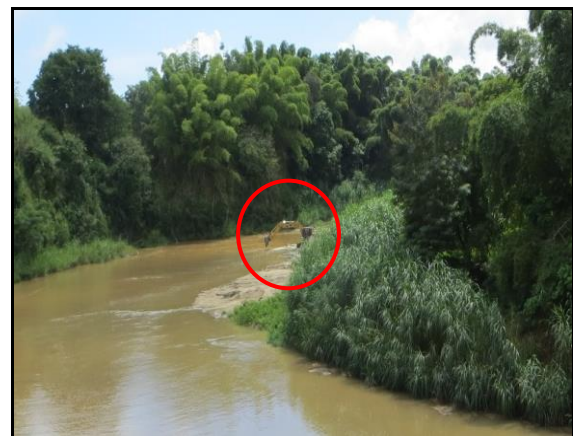
Figure 2
Sand Extraction at Río Grande de Loíza, San Lorenzo

Figure 2 shows sand removal activities being held by operator upstream the BR-741 on the Río Grande de Loíza.

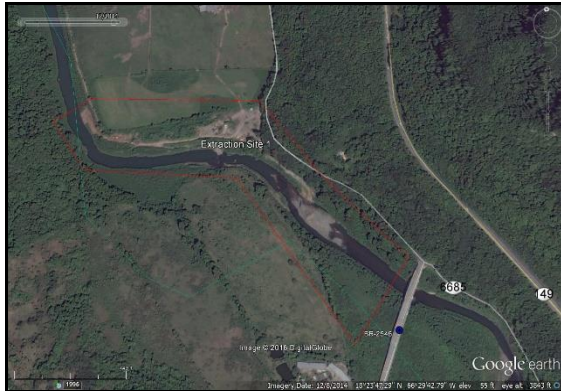
Figure 3
BR-2456 PR-642, Manatí

Bridge BR-2456 is located at Road PR-642, over the Río Grande de Manatí in the Municipality

of Manatí as shown in Figure 3 [3]. A sand extraction operation has been held for years upstream the bridge. The river has signs of lateral migration.

Both bridges are been classified as scour critical after Scour Critical Evaluation was performed by PRHTA as defined by HEC-18 [4] and following guidelines for the bridge evaluation.

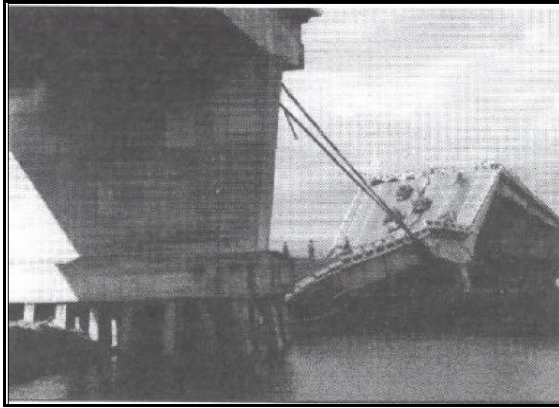
Figure 10
Failure of the Kaoping Bridge

On 1995, the Kaoping Bridge over the Kaoping River in Taiwan, was suffering the undermining of its piers due to the effect of headcutting of over 7 m from in-stream gravel mine located downstream the bridge. As a countermeasure, the downstream margin was protected with gabions and concrete jacks to control the incision as shown on Figure 9 and the gravel mining was prohibited 1 mile from the bridge [6].

But on August 2000, after a typhoon, the bridge had a sudden settlement at one of the piers that caused the bridge to collapse as shown on Figure 10. An investigation headed to erosion of the river bed due to extensive gravel quarrying as the cause for the pier failure [8].

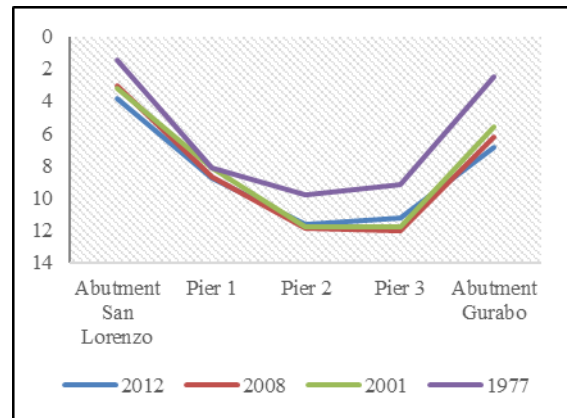
Figure 12
Bed Elevation Plot for BR-741

By comparison of field inspection reports, since 1977, it is noticeable a bed degradation on BR-741 in the Río Grande de Loíza. Figure 12 shows a plot of the measurements taken at the field during the last 37 years. The bed elevation on Pier 3 has dropped approximately 3 meters.

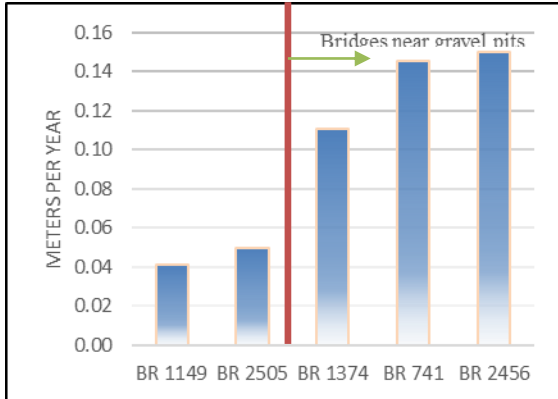
Figure 13
Bed Elevation Change per Year

Figure 13 summarizes the change in bed elevation along a period of time recorded by field inspections from PRHTA for five different bridges. Bridge BR 2505 is located downstream BR 741 in the Río Grande de Loíza while BR 1149 is

downstream the BR 2456 and BR 1374. It is noticeable that higher long term degradation had occurred in bridges that are in a reach with in-stream mining near them.

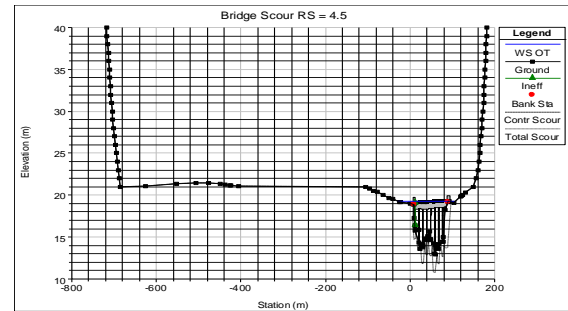
Figure 14
Bridge Scour Results Plot using Steady Flow

Figure 14 is a Plot of the results obtained for the Bridge showing the elevation and the depth of scour for each abutment and pier.

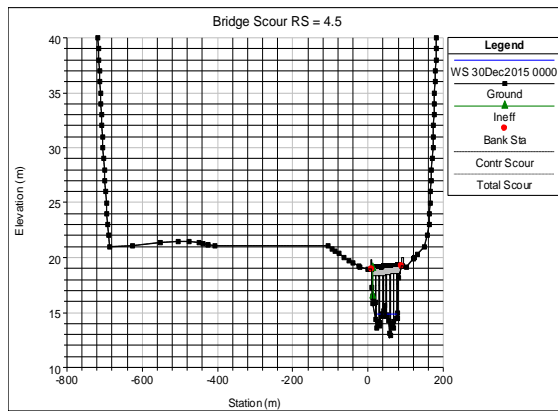
Figure 16
Scour Results Plot with Quasi- Unsteady Flow (Day 1)

After performing a Sediment Transport Analysis, a computation of the bridge scour was made with HEC-RAS Bridge Scour application using the new hydraulic parameters. Figure 16 and Figure 17 shows the Bridge scour plot for the day 1 and 41 respectively.

The difference in scour depth for the worst pier when using this approach is 1.1 m larger when comparing with results of the steady flow analysis. Nevertheless, the right abutment will suffer an increase of 2.01 meters of its scour depth.

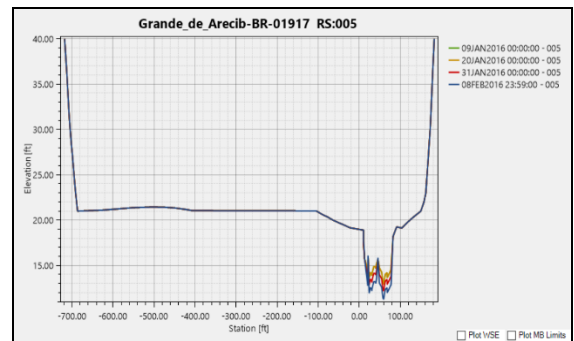
Figure 18
Channel Bed Change in Elevation at Station 4

Figure 18 shows the difference in bed elevation at Station 4 where the bridge is located. The plot illustrates the change in elevation in a time period before and after the dredging event.
