Assembly Fit-up Issue Investigation of a First Stage High Pressure Gas Turbine Rotor

Antonio Miranda Rivera

Advisor: Dr. Rafael Nieves Castro Graduate School, Polytechnic University of Puerto Rico

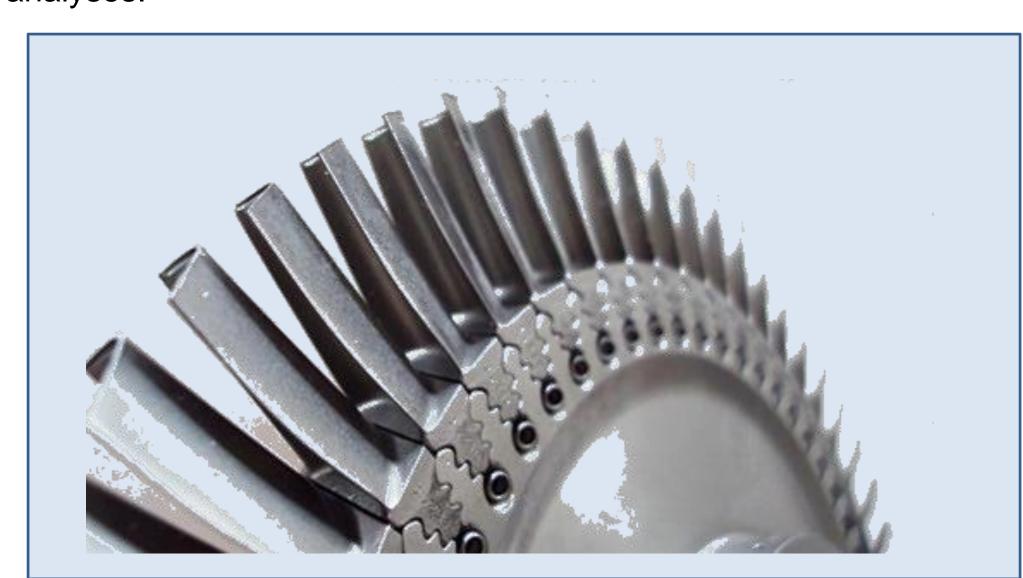
Figure 1. Turbofan HPT Rotor Sub-Assembly

This article will summarize the investigation of fit-up issues encountered during the sub-assembly of high pressure turbine blades and disk. The dovetail design of the blades incorporates 4 total pressure faces. These blades will slide in into the disk which will incorporate a similar dovetail design. This is shown on figure 1. The fitup issues occur during the installation process of blades and disk.

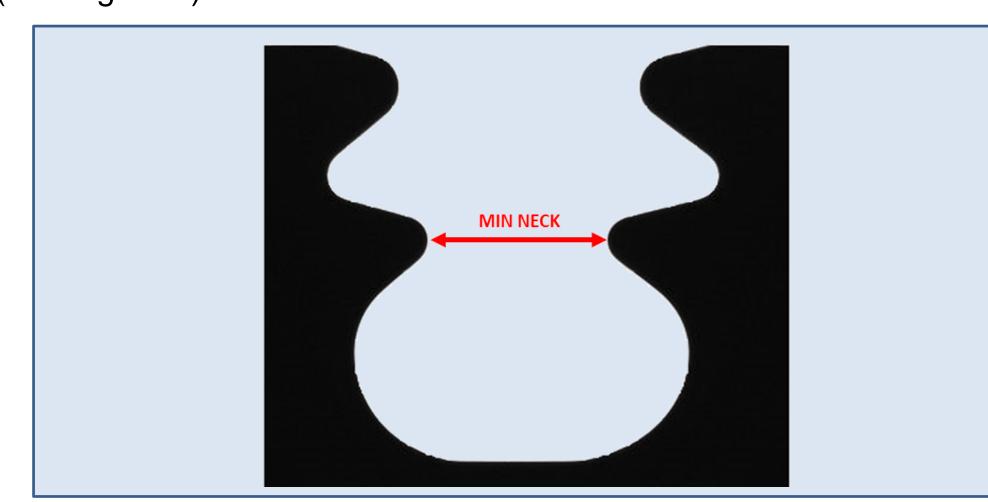
Figure 2. Disk Dovetail Sketch – MIN Neck

Preliminary engineering visual review of parts performed at the customer assembly facility indicated high risk of interference fit between blades and disk located along the MIN Neck region interface (see Figure 2).

DRAWING TOLERANCE STACKUP: The final fix to eliminate any future fitup events is to reduce the MIN neck thickness of the blades by 0.002in. This change will increase the current worst-case minimum clearance from line on line (0.000 clearance) to 0.002in. This minimum limit will provide adequate clearance to prevent future fitup events.

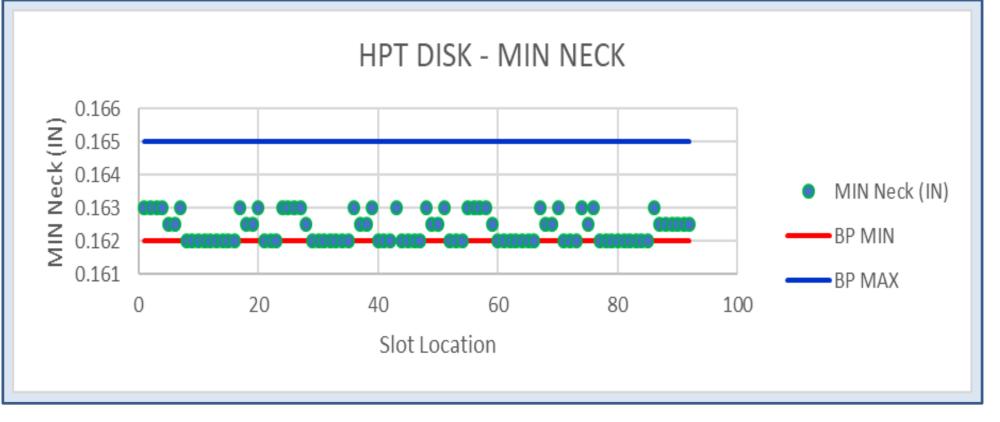
Chart 1. Disk Dovetail Sketch – MIN Neck

Inspection results for the high-pressure turbine disk are summarized on Chart 1. These shows that the MIN neck met the drawing requirements but process was targeted towards the lower end of the drawing tolerance band. However, measurements run consistently on the lower side which closes to a minimum the amount of room to install blades.

<u>CLEANING</u>: Short-term solution for potential future fitup events will be to incorporate a detailed cleaning of the MIN neck area of the disk. However, performing this detailed cleaning process require additional time that will translate into cost-in for the customer. This was determined to be acceptable on the short term until the long term fix was implemented.

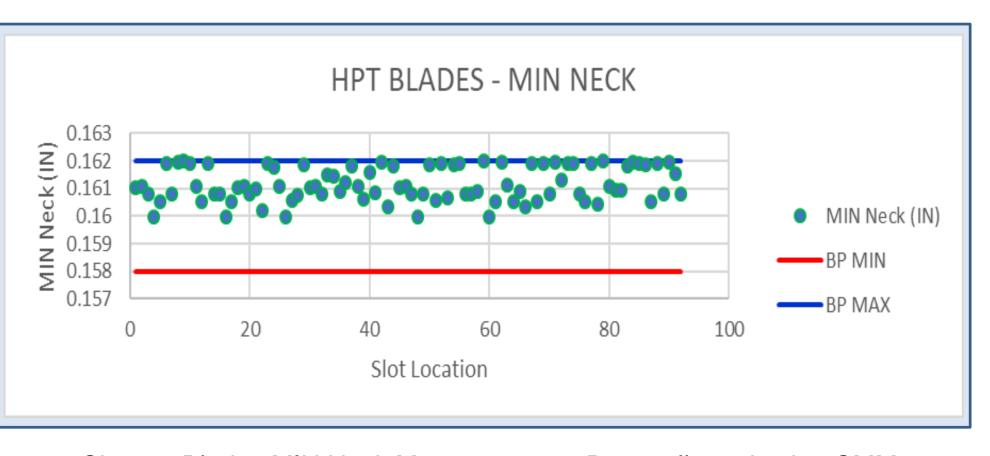
Chart 2. Blades MIN Neck Measurements. Data collected using CMM

For the blades, results summarized on Chart 2 shows that MIN neck is conforming but running on the higher end of the drawing tolerance band. However, measurements run consistently on the higher side which closes to a minimum the amount of room for installation. Opposite to the disk, the blades were new make, meaning that they came right from the manufacturing source.

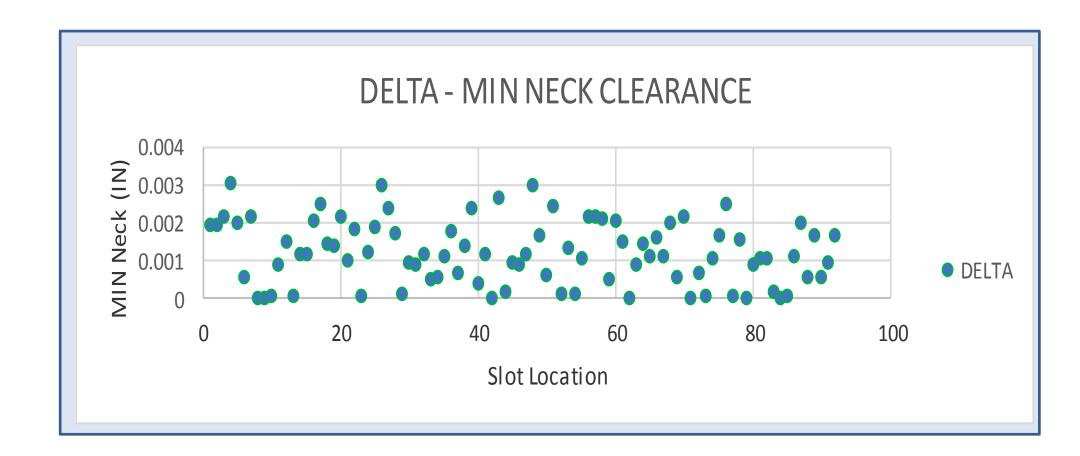
Chart 3. MIN Neck Resultant Clearance

Chart 3 shows the resultant circumferential clearance at the MIN neck region between the disk and blades (92pcs) based on the individual data collected for each component. It is evident that on many slot locations the clearance is almost zero or close to.

Inspection results indicated that both components met the drawing requirements and should assembled together. Looking back at the inspection results it can be seen that the fielded disk and new make blades ran at the low and high side of the tolerance band respectively. As a result, some of the disk/blade slot combinations would provide a line on line fit during the disk/blades sub - assembly and any other factors that may occur during the assembly process might contribute to the fit-up issues that were localized on this MIN Neck interface.
