Existing Structures Evaluation According to Previous and Present Building Codes

Wigberto Pontón Álvarez
Master of Engineering
in Civil Engineering
Dr. Bernardo Deschappelles
Civil and Environmental
Engineering & Land Surveying
Department Polytechnic
University of Puerto Rico

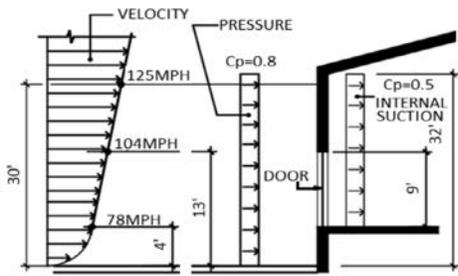
Figure 7 - Wind Velocity and Pressure

Metal doors and louver windows of different brands, manufacturers, factory year, installation and construction details were damaged. All these doors and louvers were specified to stand a wind pressure of at least 125mph and failed; the wind imparted pressure was above their code design limitations. For example of the above, the main entrance rolling doors of Building #7 were blown out and these doors are certified by the manufacturer for 135mph. For the code required 125mph velocity (wind at 30'-0" above ground level) the wind velocity at 13'-0 (on top of the door) and 4'-0' (at bottom of the door) are,

Which are less than the certified 135mph wind resistance of the doors. See Figure 7 and 8. Also by the Bernoulli equation the pressure at the stagnation point is given by,

The mean pressure will be 21.11psf and taking an external typical pressure coefficient of 0.8 and an internal of -0.5 the net pressure on the door will be $1.3 \times 21.11 = 27.43\text{psf}$. According to the ASCE for an Exposure C with a wind speed of 125mph the pressure is 24.63psf up to an elevation of 15'-0" for MWRS or 34.39psf for cladding. The mean pressure will be 21.11psf and taking an external typical pressure coefficient of 0.8 and an internal of -0.5 the net pressure on the door will be $1.3 \times 21.11 = 27.43\text{psf}$. According to the ASCE for an Exposure C with a wind speed of 125mph the pressure is 24.63psf up to an elevation of 15'-0" for MWRS or 34.39psf for cladding. Taking an external pressure with ASCE coefficient of 0.7 and an internal of 0.18, the net pressure on the door will be $0.88 \times 34.39 = 30.13\text{psf}$. The door pressure resistance rating, without considering a bluff body coefficient of 1.2 is,

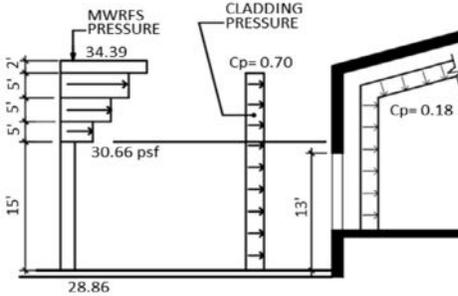
Figure 8 - Pressure Profile as ASCE

Which is above the building construction code requirements. Be advised that 135mph rating is when the door extremely deforms or water infiltration is too high. Structural collapse of the door will be at a higher wind velocity than 135mph.

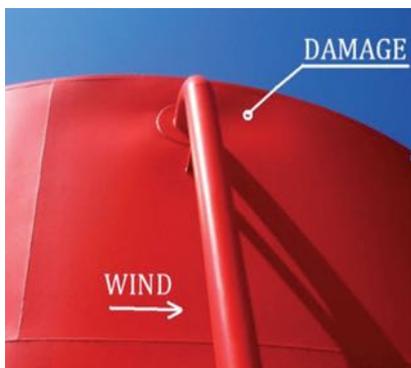
Figure 9 - Damaged Water Tank Riser

A water tank constructed near Building #6 was impacted by the shock wave. The overflow pipe, with a very small area to stand wind pressure, was noticed to have a bent at the attachment area to the tank. To cause such a damage to the mentioned connection, an extraordinary event force of very high proportions and way above the design criteria was re-

quired. The tank was inspected and no abnormalities or dents at the downspout were detected right after the final paint was applied, months before the refinery accident. See Figure 9.

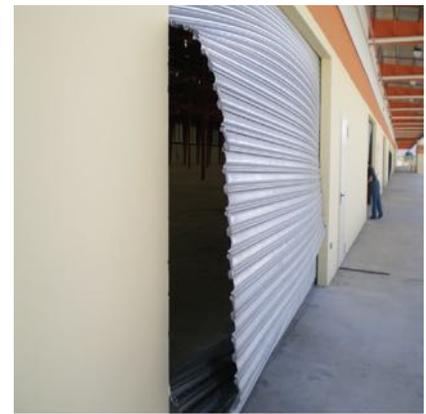
Figure 10 - Windward Doors Blown-Out

Building #7 is a pre-engineered metal structure with a footprint of 150'- 0" x 576'- 0", close to 96,000sf with support facilities, gabled roof with eave and ridge height of 32'-0" and 37'-0" respectively. It was designed with the UBC Code for a 125mph design wind and experienced all the front rolling doors, on the windward wall, blown away. See Figure 10. Loose screws and siding were observed on some areas on the rear leeward wall and left side wall of the building. At the corner intersection of the leeward and left walls, the corner trim was observed to be out of alignment and loose. All the cross bracing on the leeward or back wall with big louvers and small siding sections was noticed to be sagging in the same direction. On the windward or front wall with small louvers and large siding sections, the cross bracing was in perfect condition. See Figure 11 for leeward bracing elevation and condition; also see Figure 12 for leeward louvers blown-out.

funneling a higher velocity wind along the front wall causing suction. See Figure 10 for door damage. The wind pressure against the front and right side wall and the skin drag on the building envelope created a differential displacement at roof level. The displacement along the front wall with small windows and a higher stiffness was less than the back wall displacement with big windows and a low stiffness. The leeward wall deflected more, forcing the leeward cross bracing to sag. The windward cross bracing was able to stand the wind load without sagging with a minimum displacement. The difference in displacement at the leeward and windward cross bracing created a torsion effect on the whole structure. All of the above situation was caused by a wind load beyond the structure capacity and specifications.

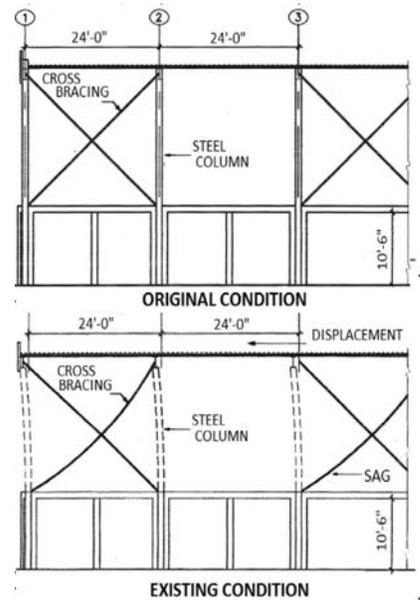
Figure 11 - Leeward Elevation

The metal structure is a very elastic and flexible structure with very slender columns. The structure drift tolerance is in the order of H/90 which allows elastic displacements under the design criteria of a 125mph wind. During the wind impact, the structure deflected above the expected, creating relative displacement with regard to the rigid masonry walls and causing the plaster in a limited area in the interface of the metal structure with the masonry wall to crack or fall, causing a cosmetic damage. The metal envelope of the building, without considering the canopy, is close to 116,900sf and the masonry envelope is close to 16,700sf. The metal structure contributes to 87% of the area exposed to the wind, at a

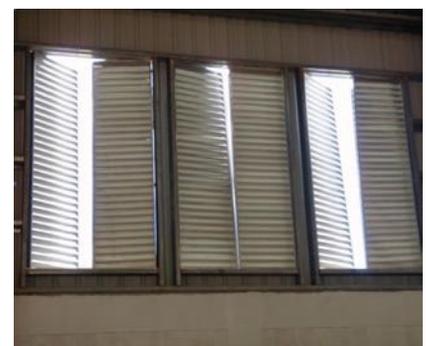
Figure 12 - Leeward Louvers

Another possibility for the doors on the windward wall, blown out as the louvers windows on the leeward wall, is that as the doors collapsed, a breach was created on the building envelope

and the pressure inside the building became the same as the exterior pressure at the openings. After the doors were blown out, the building became a partially enclosed building and the internal pressure coefficients shifted to +/- 0.55, yielding a maximum suction of 32.65psf on the leeward side and a pressure of 40.89 on the windward wall. Obviously, the windows capacity was overstressed. Also, the phenomenon of Blast Effect [5] was probably present. When a breach is created, wind rushes in causing an abrupt increase in internal pressure and overshooting the external pressure for a short time. A breach at or close to the stagnation point can increase the internal pressure by a factor of 1.50. This means that the internal pressure can reach $0.00256 (125)^2 (1.50) = 60.00$ psf, more than twice the design load. As an example on figure 14, the difference between an enclosed and a partially enclosed building is shown.

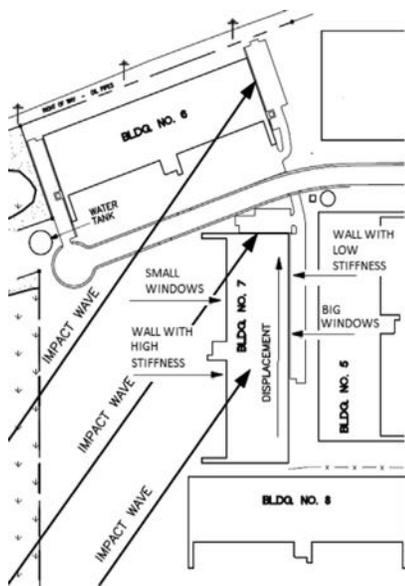
Figure 12 - Wind Approach to Building #7

The wind approach to the structure was most probable close to 45° or less with the building front wall. See Figure 13. There is a possibility that other buildings and the service core of Building #7 diverted the wind,

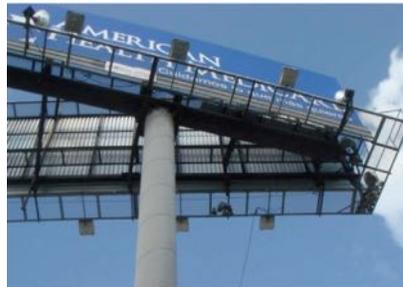
Figure 15 - Billboard Impacted by Minimal Wind Load

Nearby the International Trade Center a billboard without construction drawings or erection date was investigated. See Figure 15. Besides some gap between plates; maybe caused by wind rattling; no damage could be related to the wind force due

that the billboard screens were literally aligned with the wind direction and were exposed to a minimal load.

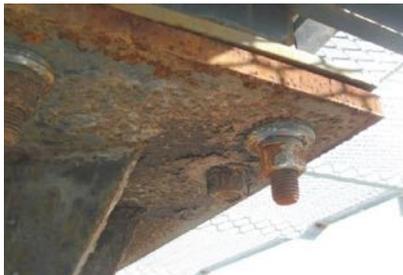
Figure 16 - Structural Condition of Billboard Connections

The maintenance had been very negligent and the structure is with rusted plates and bolts. See Figure 16.

In order to get the billboard in compliance, an as-built was done and a structural evaluation performed to upgrade the billboard structural capacity. See Figure 17 for the billboard wind loading

Afterward it was confirmed that the structure could be upgraded with \$35,000.00 and a new structure will cost \$55,000.00 plus

installation. It is cost wise to upgrade the existing structure. The rehabilitation of the footing will be evaluated once the geotechnical report is ordered.
