Analysis of Billboards Signs Collapse Due to Intensive Wind of Hurricane Maria

CE- 6905 Master of Engineering in Civil Engineering
 Ernesto J. Santiago Caraballo, B.S.C.E., P.E.
 Gustavo E. Pacheco-Crosetti, Ph.D., P.E.
 Polytechnic University of Puerto Rico

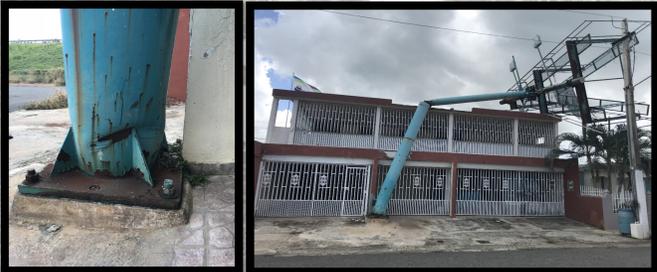
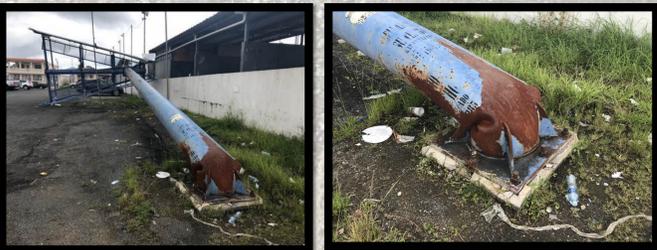
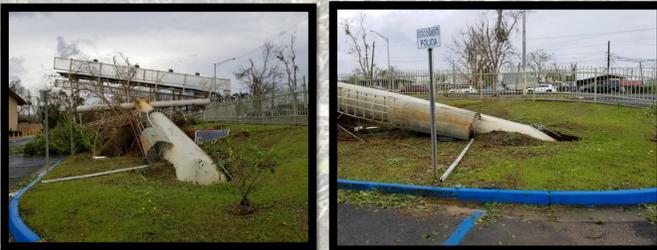
- The high winds produced by hurricanes, tornadoes and other severe storms can cause widespread destruction.
- On September 20, 2017, the island was hit by strong Category IV hurricane called "Maria" [1].
- Wind speeds of 155 mph were recorded by weather agencies in different places of Puerto Rico.
- As shown in the next figures wind force acting on existing signs face was excessive enough to produce local buckling and plastic yielding failures at the base of the free standing structure.

Different Types of Billboard Collapse in San Juan Metropolitan Area

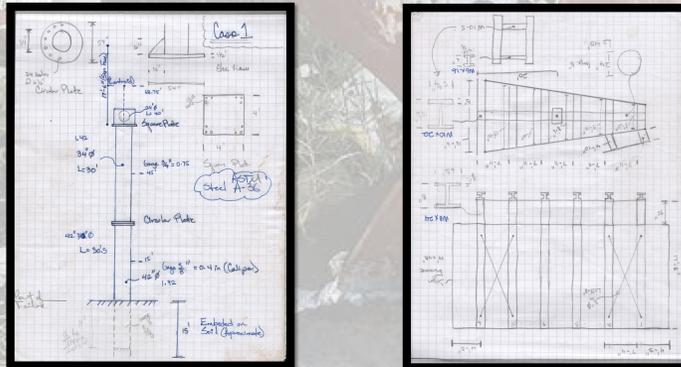
Field Data Sketch Up

- Different cases of billboard failures were identified.
- Field visits were developed to perform a visual inspection, take measurements, and perform a general assessment of the failure, and identified main damages as caused by local buckling and yielding of the post.
- 14' x 48' Billboard Sign located at Christian Church parking at the Municipality of Bayamon was selected.
- Dimensions of the structure were obtained from the site visit.
- Linear Elastic Buckling Analysis was performed to find the critical load factor and the buckling modal shape, and determine which velocity of wind produced the critical condition that may produce caused the buckling failure.
- Full Static Nonlinear Analysis (Pushover Analysis) considering material nonlinearity and geometric P-Delta effects was performed with the same purpose.

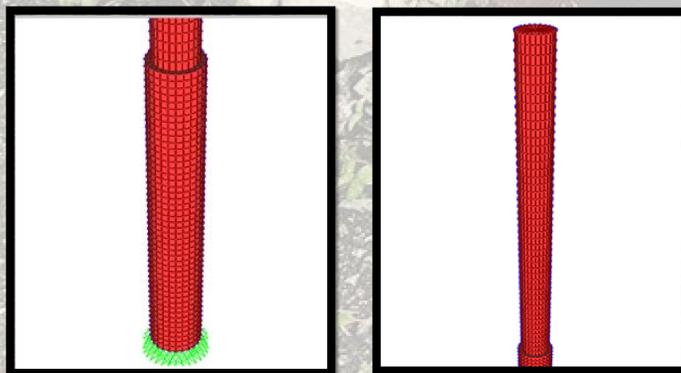
FEA software Analytical Model

- A discretization of shell element pin connected at the base with 48 division on Z direction and 24 on the angular direction.
- A rigid diaphragm plate was inserted between both poles to connect one each other.
- Additional diaphragm plate was located on top of the upper pole.

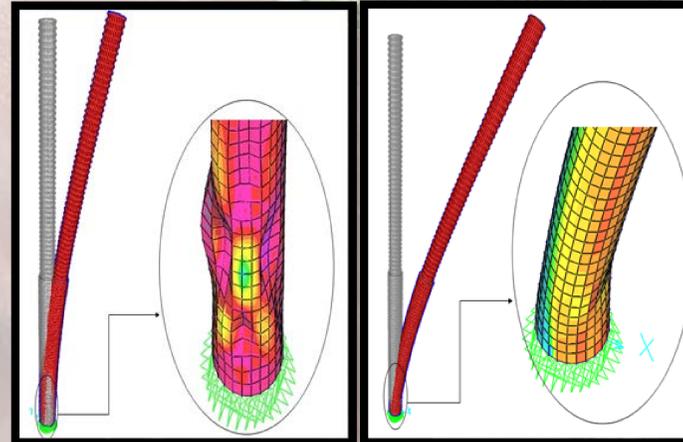
Deformed Shapes:

Trials	Analysis Type	Critical Load Factor	Wind Speed (MPH)
1	Linear	31.15	310
2	Linear	14.24	209

Trials	Fy (Ksi)	Wind Speed (MPH)
1	36,000	111
2	46,000	136

- After linear buckling analysis modeling was performed, the most reasonable model was the linear buckling analysis in Trial 2. That trial resulted in the lower critical load factor, meaning that this condition was the governing one. And the buckling mode showed a strong resemblance to the field observation.

- From this results lower loads were obtained, it clearly shows that the failure condition was not initiated by elastic buckling and that perhaps it was due to plasticization accompanied subsequently of local buckling or yielding accompanied by an inelastic local buckling.

- It is recommended to obtain more information about the properties of the material, the original design specifications and perform laboratory tests, in order to be able to do additional analysis of "pushover" and determine the wind speed more assertively.
