# CASE STUDY: EVALUATION OF A TWO-LEVEL RESIDENCE STRUCTURAL PLAN (STILT HOUSE WITH OPEN SPACE ON THE FIRST FLOOR) AND COMPLIANCE RECOMMENDATIONS FOR EARTHQUAKE RESISTANCE IN PUERTO RICO USING ACI318-14 CODE

Author: Moisés Torres Méndez, P.E.  
 Advisor: Manuel Coll Borgo, Ph.D., P.E.  
 Civil and Environmental Engineering and Land Surveying Department  
 Polytechnic University of Puerto Rico

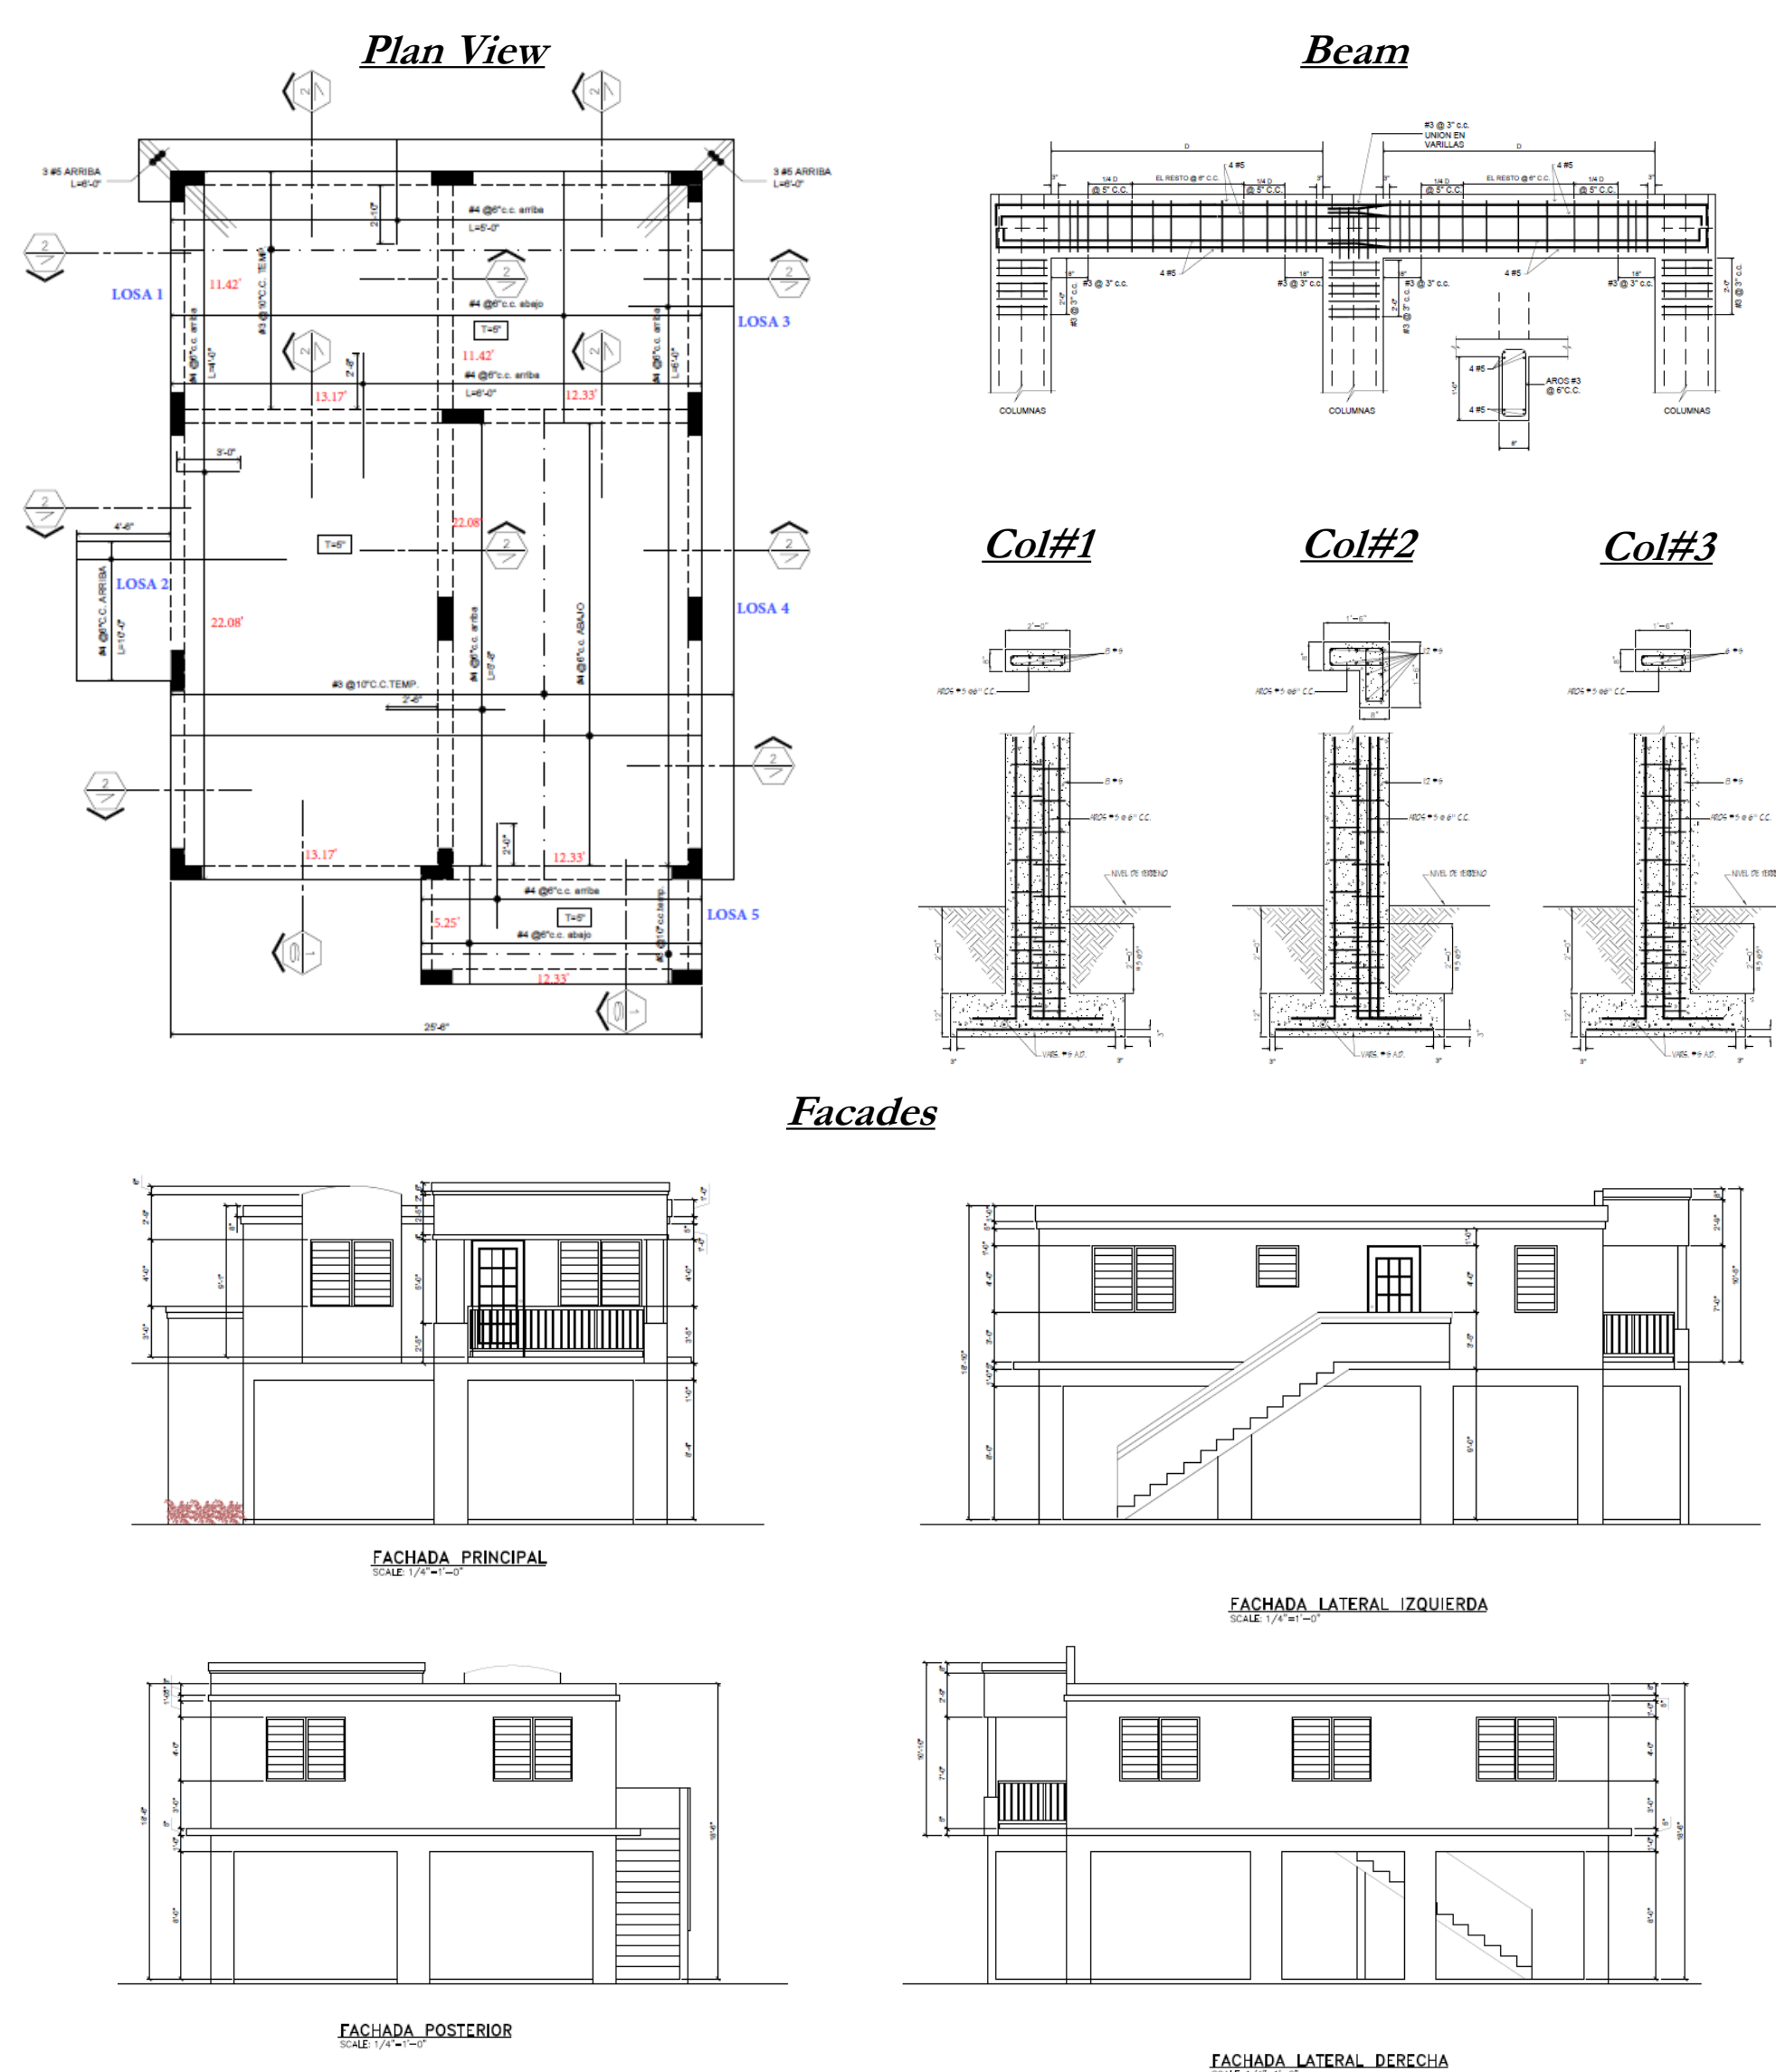
## Original Construction Plan

1. This case study's redesign satisfies ACI318-14, 18.2.3 through 18.2.8 and 18.6 through 18.8
2. The original beam (8"x12") was increased to meet the minimum dimensions required in ACI318-14, 18.6.2.1. The final suggested dimension (10"x14") allows a greater effective depth. It is important to ensure from the beginning, that the effective depth,  $d > 14"$ . For a lower height it is necessary to consider the design as a T-beam.
