Abstract

Damaged Magnet Wire Solution for Boeing 787-10 Electric Motor Pump

Frank R. Montes Díaz. Advisor: Héctor J. Cruzado, PhD, PE Polytechnic University of Puerto Rico

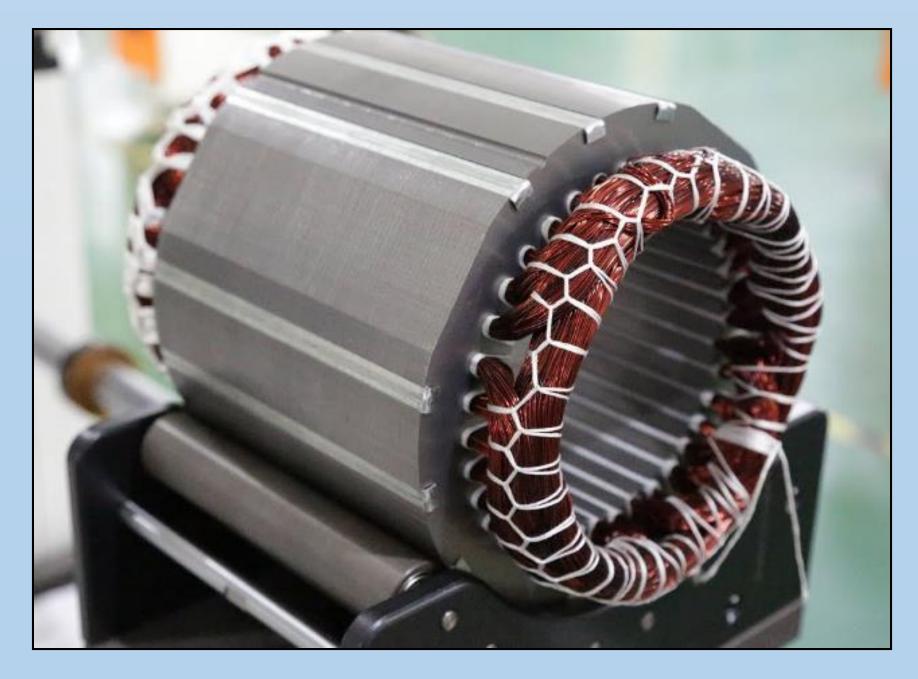
Figure 1 **Finished Stator Example**

Before the implementation of the plastic shim in the manufacturing process of electric motor stators demonstrated in figure 1, the company faced significant challenges. Rejections due to nicked magnet wires during the removal process resulted in a notable financial and customer impact. To address concerns, a project was initiated to find a viable solution. After evaluation and testing, it was determined that the implementation of a plastic shim in the manufacturing process could potentially solve the issue.

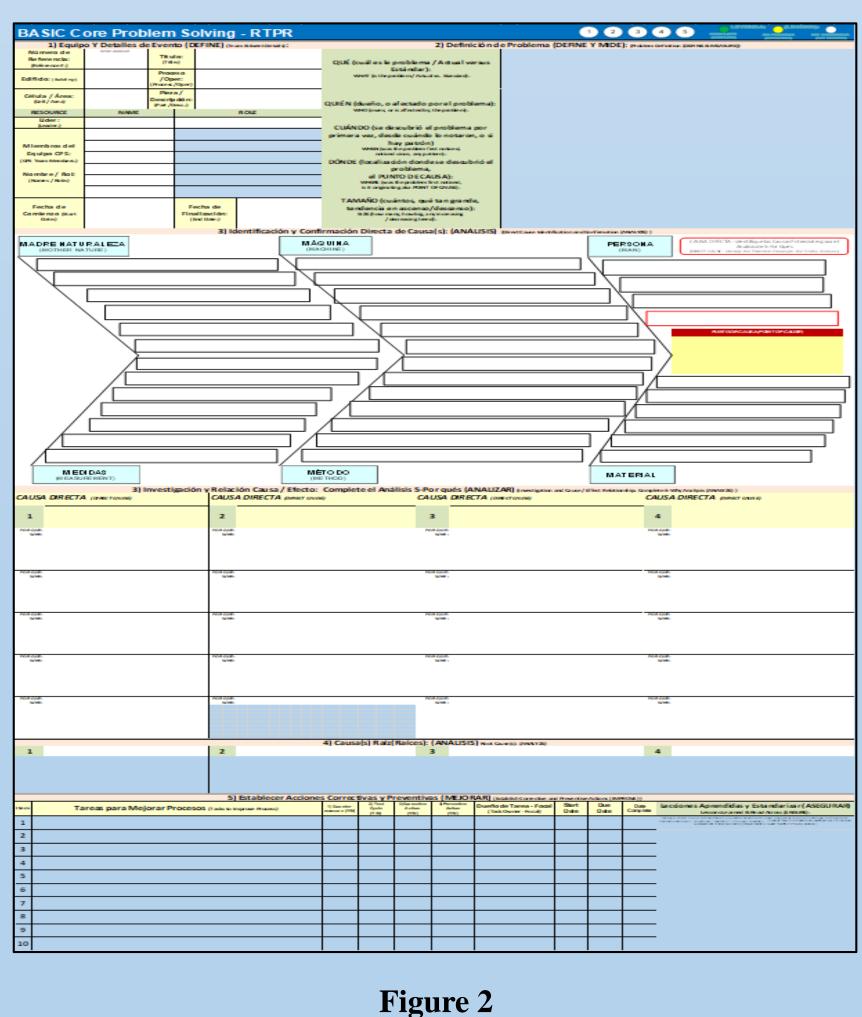
CPS Tool use for RCA

Root cause analysis (RCA) played a crucial role in analyzing rejection data and identifying opportunities for improvement in the manufacturing process. Crossfunctional teams were formed to conduct a comprehensive RCA using a structured problem-solving tool known as the Core Problem Solving form demonstrated in figure 2, which uses fishbone diagrams, 5 why analysis, and a corrective action board tracker. This allowed for a systematic exploration of potential root causes contributing to the occurrence of rejections due to nicked magnet wires.

Through the RCA process, the teams discovered that the manual-intensive removal process itself was a key factor leading to the defects. This finding led to further investigation and brainstorming sessions, where the idea of protecting the magnet wires during the removal process emerged as a potential solution.

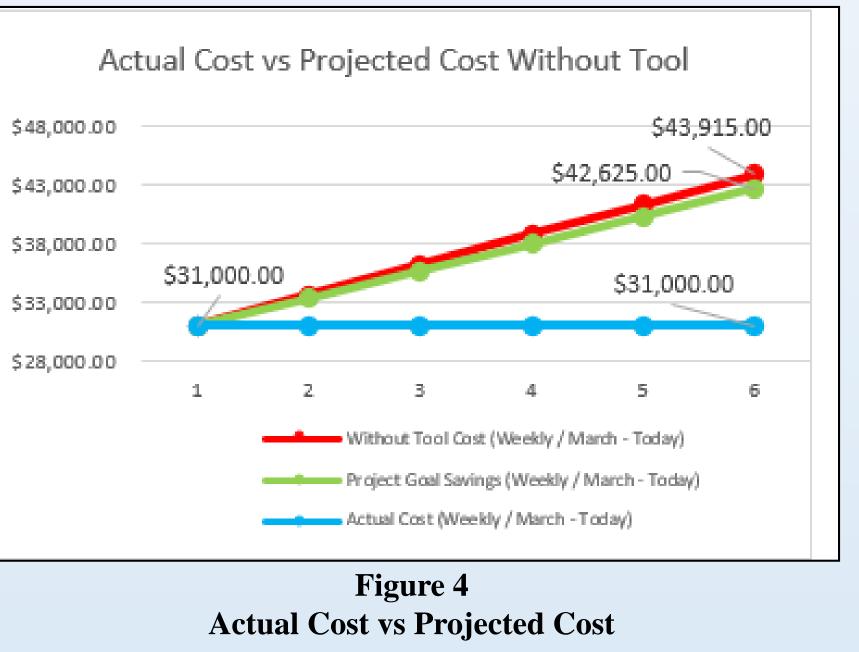
figure 3, occurred after an evaluation process that determined the optimal dimensional thickness of 0.015". This thickness was selected based on the slot walls' thickness in the stator space, ensuring effective protection for the magnet wires during the removal process. Financial progress is greater than the projected 52,700\$ by the end of May. Figure 4 demonstrates the actual financial progress vs the projected progress of the project.

recurrence of the incidence, but after implementation of the tool proposed, no incidence was currently recorded resulting in a 100% reduction after implementation. The differential between the without tool trendline and the actual cost trendline, by the end of April is \$12,915.00 or the actual savings of the project. The project initially calculated a rework cost of 70% or \$9,045 by the day of this report, but project results are a 100% reduction in defect and a \$12,915 in overall cost avoidance.
