Structural Capacity Evaluation for Existing Building Previously Repaired

*Luis A. Rivera Hoffmann
Master of Engineering in Civil Engineering
Balhan Alsaadi Altayeb, Ph.D.
Civil and Environmental Engineering Department
Polytechnic University of Puerto Rico*

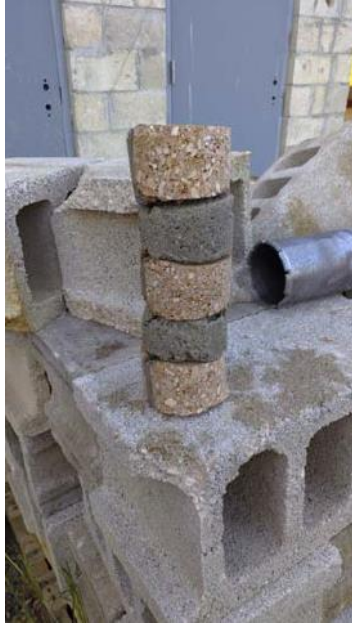
- There is poor or no bonding between grout and masonry elements and reinforcement. This condition can be observed on Figure 2.
- At some locations, various trials were required due to sample brittle conditions of the specimen.
- From observations on As-Built conditions and exploratory cores performed on the walls, the specified horizontal reinforcement was not installed.
- 6 out of the 13 samples taken from the walls to perform compressive strength taken on the in-place CMU walls were below the design requirements.

Table 2 summarizes the results of the cores taken on for additional testing on the walls. We can also explain the variations on the results of the compressive strength of the cores taken in additional field testing as a variation of moisture on the blocks. The in place mortar strength can varies as a results of a lower cement ratio since the units can draw excess moisture from the mortar. The field strength of mortar can be used should be used as quality control test rather than a quantification evaluation.

Figure 2
Core taken during Additional Field Testing

- The designer considered on the design 3,000 psi for the strength of the grout. Field testing of the in-place material and documented testing of the work in progress indicates that over 50% of those tests fail to comply with this minimum requirement of 2,500 psi. Hence it was decided that the grout cannot be considered an acceptable building product and therefore existing reinforcement cannot be accepted. The repair was to cut vertical slots in the masonry walls and install vertical bars, form over the slots, and pour grout. The details of the drawings of the repair sections shows # 8 installed at maximum spacing of 48 inches. Figure 2 shows core taken during additional field investigation, note the lack of bonding between the masonry unit and the grout.
- Analysis of the walls for loadings and minimum requirements for ductility mandated by code

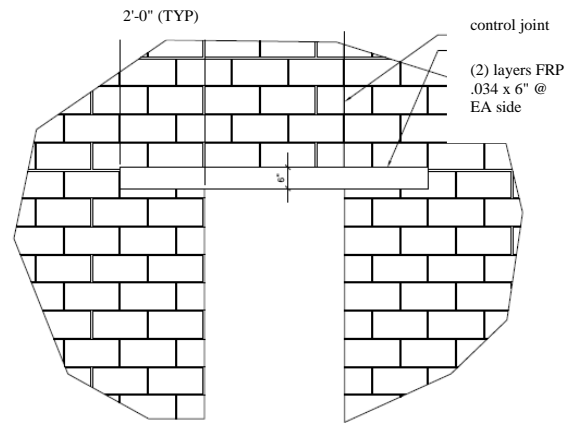
Figure 3
Lintel Reinforcement Details with Fiber Reinforcement

From observations of the As-Build and contract drawings and specifications, control joints were constructed at the edge of an opening without extending the lintel through the joint to provide bearing. The code defines control joints as movement joints that are used to allow dimensional changes in masonry, minimize random wall cracks, and other distress [2]. Contraction joints are used in concrete masonry to accommodate shrinkage. These joints are free to open as shrinkage occurs. As a general rule, control joints for concrete masonry

- At locations where the lintels do not have bearing, a bi-directional FRP product is being utilized to transfer shear loads across the joint and also serve as horizontal reinforcement, extending beyond the opening as required by code. Figure 3 shows details for the reinforcement using 2 layers 0.34 inch thick, 6" wide of fiber-reinforcement on each side extending the fibers 2'-0" on each side. The fiber reinforcement used for the repair was TYPO BC composite bonded with TYPO S epoxy.

For the lintels we design the beam to support the factored gravity loads for the openings present on the walls since ACI 530 code requirements design requirements for masonry beams shall apply to masonry lintels. Analysis shows that the use of #3 on the lintel will be sufficient amount of reinforcement. This is more than enough, if the grout could be acceptable. The designer recommends for the lintels to use of 2 layers with 0.034 inch thick, 6 inch wide of fiber reinforced of each side extending the fibers 2 feet on each side as shown on Figure 3. Our analysis shows that the lintels will require a width of fiber of 23 inches using a nominal laminate thickness of 0.34 inches one ply of the RFP reinforcement is adequate for the design which concurs with the designer recommendations for the fiber of 2 layers of 6 inches wide reinforcement on each side [10]-[11].

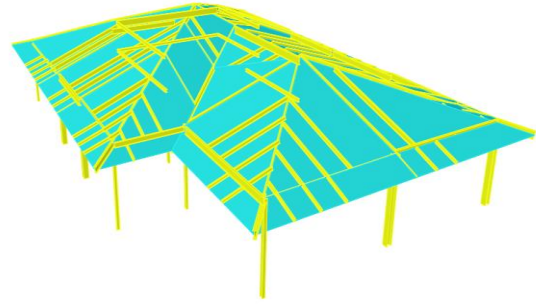
Figure 4
Analytical Model of the Building without CMU Walls

Structural analysis was performed on the steel frame without concrete masonry walls to verify the ductility of the steel frame. Model of the building is shown in Figure 4. Analysis was made for bare steel frame, neglecting the combined stiffness of the steel frame and the masonry walls and taking into consideration any vertical discontinuity created by the degraded wall [8]-[9]. Dummy areas were created for the analysis of the structure with no mass or stiffness was added to the model to apply wind loads. Results from the analysis shows that the steel frame is capable to withstand alone all the lateral loading without the contribution of the masonry walls.

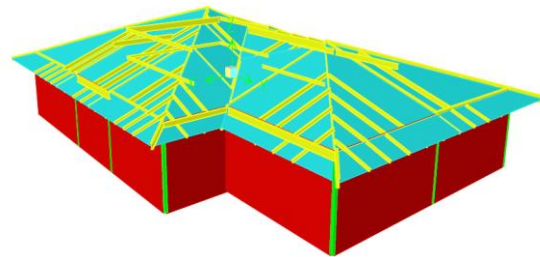
Figure 5
Analytical Model of the Building with CMU Walls

Structural analysis was then performed with CMU wall as show in Figure 5. To simulate the use of CMU walls we reduced the thickness of the walls and reduce the weight of the wall to be able to properly represent the CMU walls for analysis purposes. This was used to find the reactions and stresses present on the walls for structural design purposes.

Nonetheless it was determined that for CMU walls are no part of the lateral resisting system of the building, they can be designed to resist axial loads and moments parallel to the wall. From the output of the analytical model of ETABS program of the Building with the CMU walls, we designed the wall with the most severe loading condition that applied to the structure. This gives us a vertical reinforcement of one # 8 bar every 48 inches. The designer recommends the use of #8 at no more than 48 inches along the wall which is the maximum permitted for the code. This coincides with the design verification performed on our analysis. Documented from the contract and field observations have indicated that the horizontal reinforcement present on the walls was wire size for cross rod: W1.7 or 0.148-inch diameter. By using this as horizontal reinforcement the area of the steel for the horizontal reinforcement 4.44 square inches which exceeds the required horizontal reinforcement of the walls and meets with the code requirements for structures assigned to Seismic Design Category D.
