Assembly Fit-up Issue: Investigation of a First Stage High Pressure Gas Turbine Rotor

Antonio Miranda Rivera
Master of Engineering in Mechanical Engineering
Advisor: Rafael Nieves, PharmD.
Mechanical Engineering Department
Polytechnic University of Puerto Rico

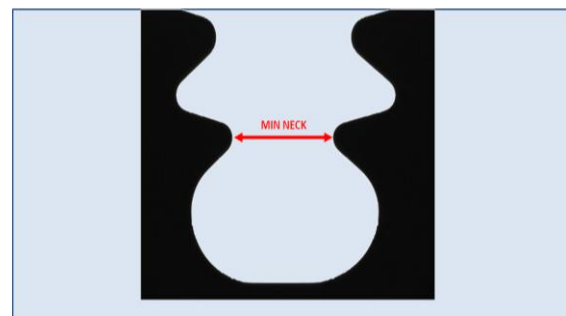
Figure 3
Disk Dovetail Sketch – MIN Neck

Preliminary engineering visual review of parts at the customer assembly facility indicated high risk of interference located along the MIN Neck region interface (see Figure 3).

This meant that either the high-pressure turbine blades were at or beyond max material condition (MMC) and/or disk were at least material condition (LMC). Inspections were therefore focused on the MIN neck area.

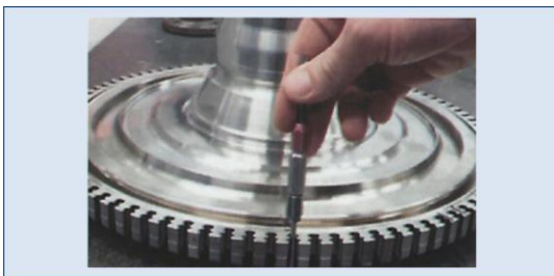
Figure 4
Disk Inspection – Calibrated Pin Checks

Since it was only the MIN neck region that was intended to be inspected, calibrated pins were selected to measure the maximum width of the MIN neck opening on the disk at all 92plc (see figure 4). The calibrated pins are precise to the third significant figure and provide accurate measures for the disk. In addition, these are set to the plus side of the applicable tolerance meaning that a 0.192in pin diameter could be offset to the max side by up to 0.0002in (e.g 0.1922in). Correlation between pin checks and inspection technique selected for the blades was proven with a 0.00001 delta difference.

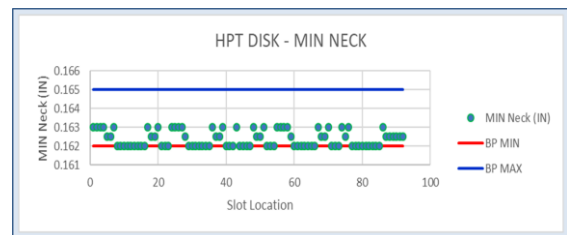
Chart 1
Disk MIN Neck Measurements (Data collected using Calibrated Pins)

Inspection results for the high-pressure turbine disk are summarized on Chart 1. From this chart it can be seen that the MIN neck circumferential width met the drawing requirements but results are consistently running towards the lower end of the drawing tolerance band.

This data excludes the disk as the root cause for the fit-up issues given that measurements fall within the drawing specification limits (0.162-0.165). However, measurements run consistently on the lower side which closes to a minimum the amount of circumferential room to install the high-pressure turbine blades.

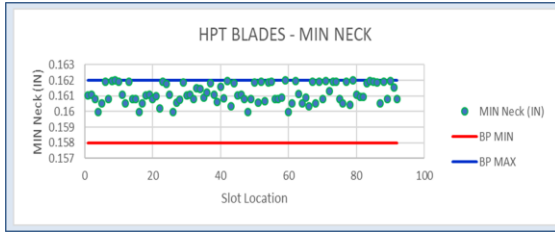
Chart 2
Blades MIN Neck Measurements (Data collected using CMM)

For the blades, results summarized on Chart 2 shows that the MIN neck circumferential thickness met the drawing requirements but was running on the higher end of the drawing tolerance band. This data excludes the blades as the root cause for the fit-up issues given that measurements fall within the drawing specification limits (0.158-0.162). However, measurements run consistently on the higher side which closes to a minimum the amount of circumferential room for installation. Opposite to the disk, the blades were new make.

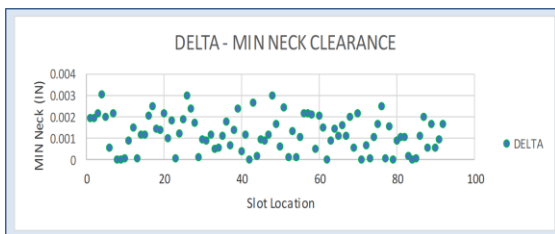
Chart 3
MIN Neck Resultant Circumferential Clearance at the MIN Neck Region between Blades and Disk

Chart 3 shows the resultant circumferential clearance at the MIN neck region between the disk and blades (92pcs) based on the individual data collected for each component and summarized on Charts 1 and 2. Results demonstrate that the circumferential clearance between blades and disk at the MIN neck region on several slot locations is negligible.

DRAWING TOLERANCE STACKUP: The final fix to eliminate any future fit-up events is to reduce the MIN neck thickness of the blades by 0.002in. This change will increase the current worst-case minimum clearance from line on line (0.000 clearance) to 0.002in. This minimum limit will provide adequate clearance to prevent future fit-up events.

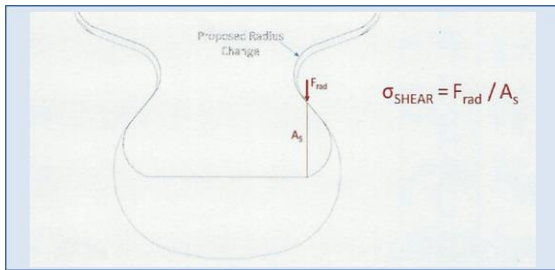
Figure 6
Shear Stress

In addition, the proposed radius change does not affect the transition from the MIN neck radius to the lower tangs, therefore, there is no impact to Shear through the Lower or Upper Tangs, therefore, there is no impact to Shear Stresses. This is shown on Figure 6.
