# SICD Manufacturing Scrap Yield Improvement

Jean Franco Mulero Rivera  
 Engineering Management Graduate Program  
 Hector J. Cruzado, PhD  
 Department of Civil & Environmental Engineering and Land Surveying  
 Polytechnic University of Puerto Rico

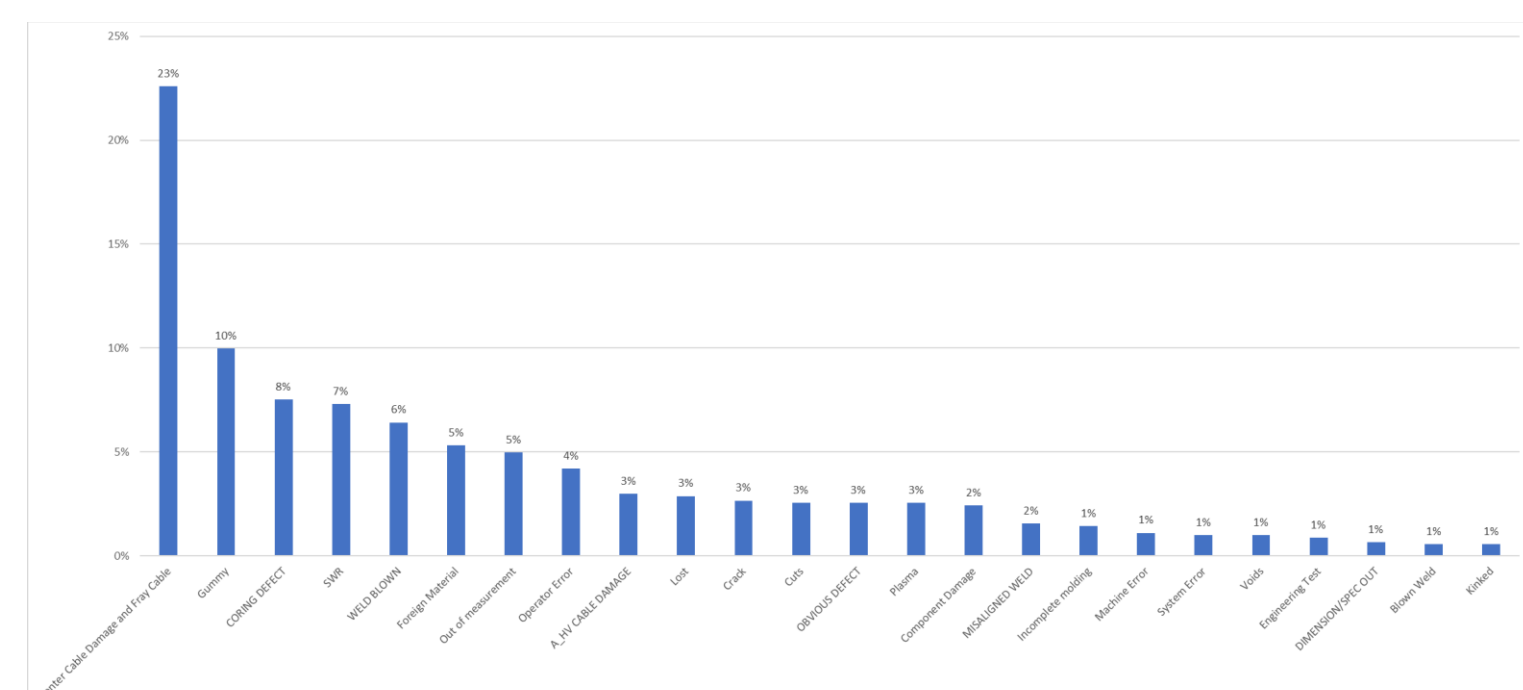
Based on the manufacturing engineering essentials, a scrap yield analysis was developed to identify the reject rate per defects by prioritizing the improvement tasks by the highest reject rate to achieve the yield goal. During the analysis executed in mid-Q1 of FY2021, a 23% of the rejected units were identified as Center Cable Damage or Fray Cable defects, which represents an impact of approximately \$400.00 per unit (refer to Figure 2). This defect was analyzed and, as a result, it represented a total of 1.36% of scrap yield rate reported on FY2020.

Figure 2  
 Scrap Fallout Analysis - Mid Q1-FY2021

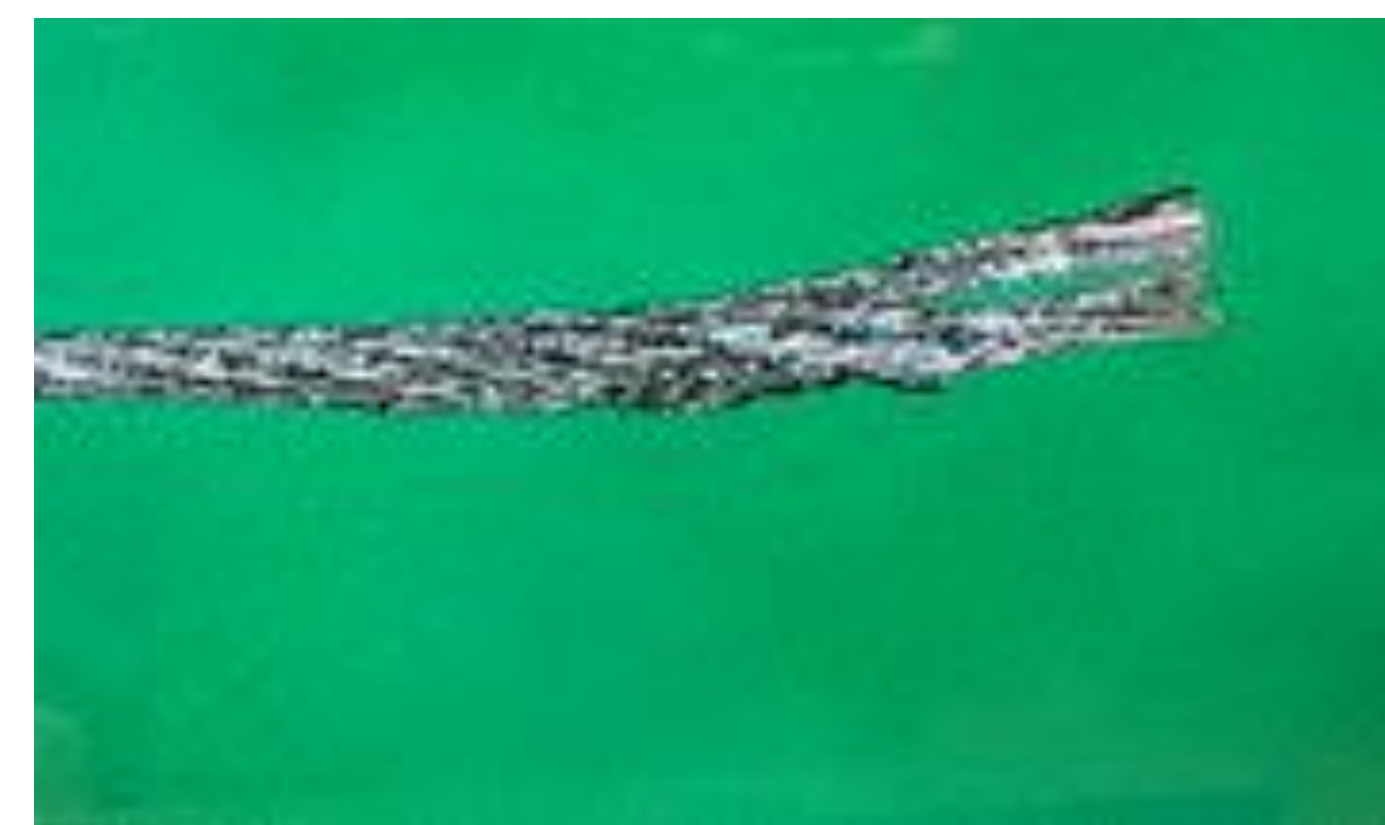
During the investigations, activities using the DMAIC process from the Lean Six Sigma methodology were executed, and it was detected that the defects were caused by the effects reflected from the output of the swaging process. This process consists of compressing the center cable diameter from 0.018" to 0.0140" ± 0.005". Therefore, the units processed through the swaging machine passed through the swaging die part to compress the center cable of the unit and reduces its diameter. The intent is to compress the center cable to make possible the assembly of the center cable inside the terminal of the unit. The terminal is an additional component that is assembled to the unit with the purpose of create conductivity through the center cable, high voltage cables; and anode cable. All responsible to transmit the signal shot from the SICD device to the heart.

Therefore, if the center cable braiding of the unit suffered of any damage during the manufacturing flow, the central cable will be compromised due to protuberance in the braid defined as fray cable defect (refer to Figure 3). Consequently, the fray cable defect could be reworked by processing the unit through the swaging process. However, if the center cable have a drastically protuberance, the center cable tends to break when swaging die try to compress the center cable.

Figure 3  
 Center Cable Fray Defect

- Machine vibration caused by a swaging hub part that was not adjusted inside the machine.
- Swaging die wear.
- Handling of the units through the process flow.

IMPROVE; once the variables that caused the defect were identified, multiple conversations were carried out to establish the changes required to improve to the swaging process. Interim actions that only require to be documented and not to be approved were executed. Those actions were identified as a) replace the swaging die, and b) adjust the part of the hub that was identified as not adjusted.

Regarding the process changes, a Go / No Go Gauge was initially designed and built based on the dimensions of the product in order to identify if the center cable was compressed correctly after being processed by the machine. Therefore, a new process change was established on the manufacturing procedure to include a new inspection of the center cable. This inspection consists in using the Go / No Go Gauge to confirm if the compression of the swaging die to the center wire achieved the goal of reducing the center wire to 0.0140" ± 0.005" per product specification. Refer to Image 5.

As a second process change, a pin gauge capable of holding a material called heat shrink was designed and built; it is assembled over the center cable of the lead as protection (refer to Figure 6). This protection mitigates the damage that the center cable suffers during handling of the unit throughout all the processes within the manufacturing flow. The intent of the pin gauge is to maintain the heat shrink material fixed while heated air is transmitted in order to be compressed. After the material has been compressed, it is then removed from the pin gauge and then assembled into the unit to protect the center cable.

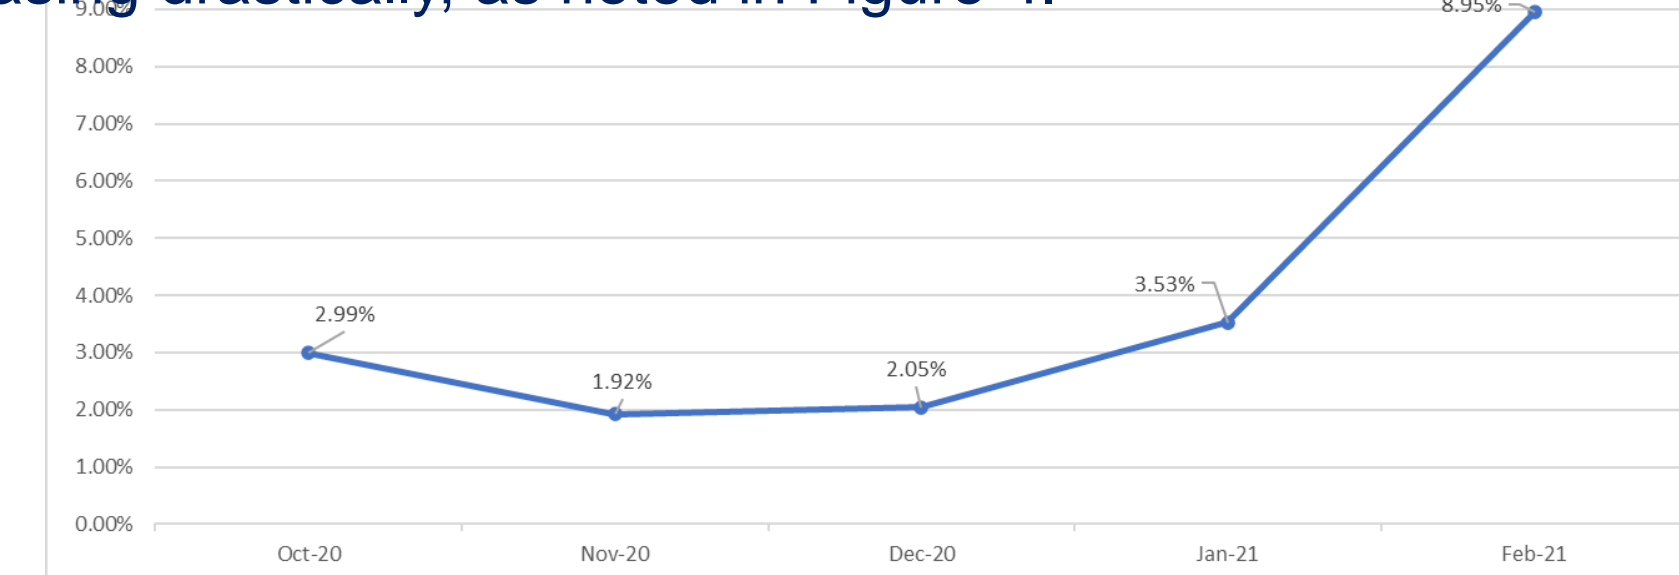
MEASURE; with the use of normalized data, the fallout was statistically evaluated comparing the fallout quantity of the defined defects within the total of completions units. As a result, the rejected rate evaluated in mid Q1 of FY2021 reflect a total of 3.53% for January 2021 and 8.95% for February 2021 (refer to Figure 4). Therefore, it was identified that the fallout reject rate of the defined defects were increasing drastically, as noted in Figure 4.

Figure 4  
 Scrap Percentage of Center Cable Damage and Fray Cable Defect

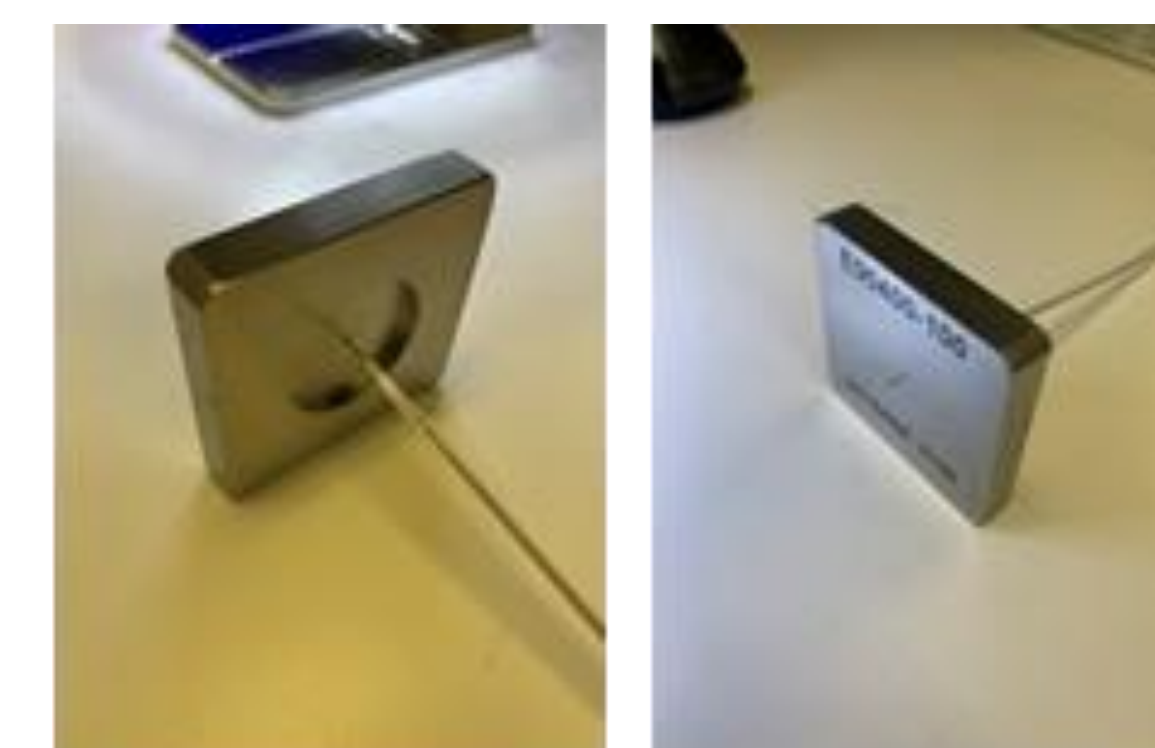
Figure 5  
 Inspection of the center cable by the Go/No Go Gauge

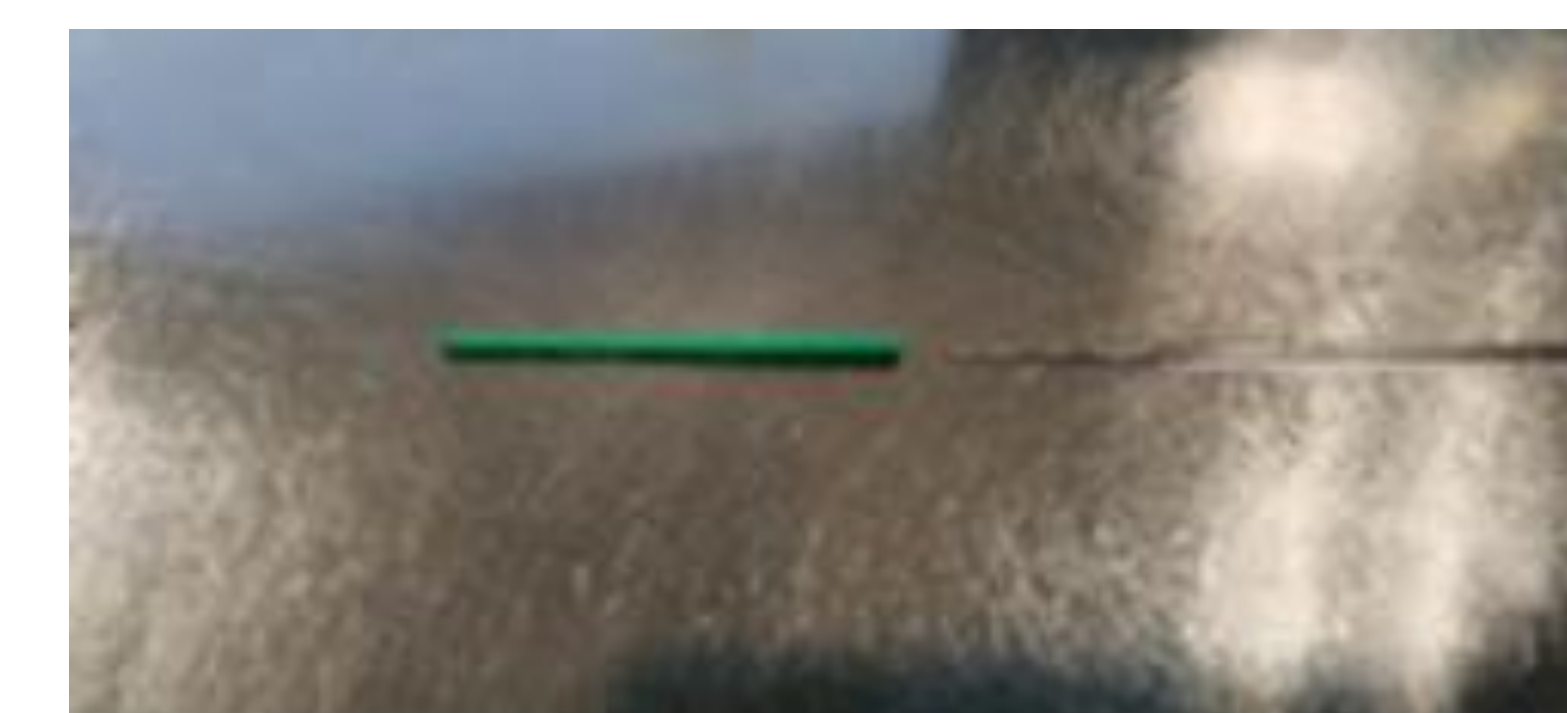
Heat Shrink protection to center cable

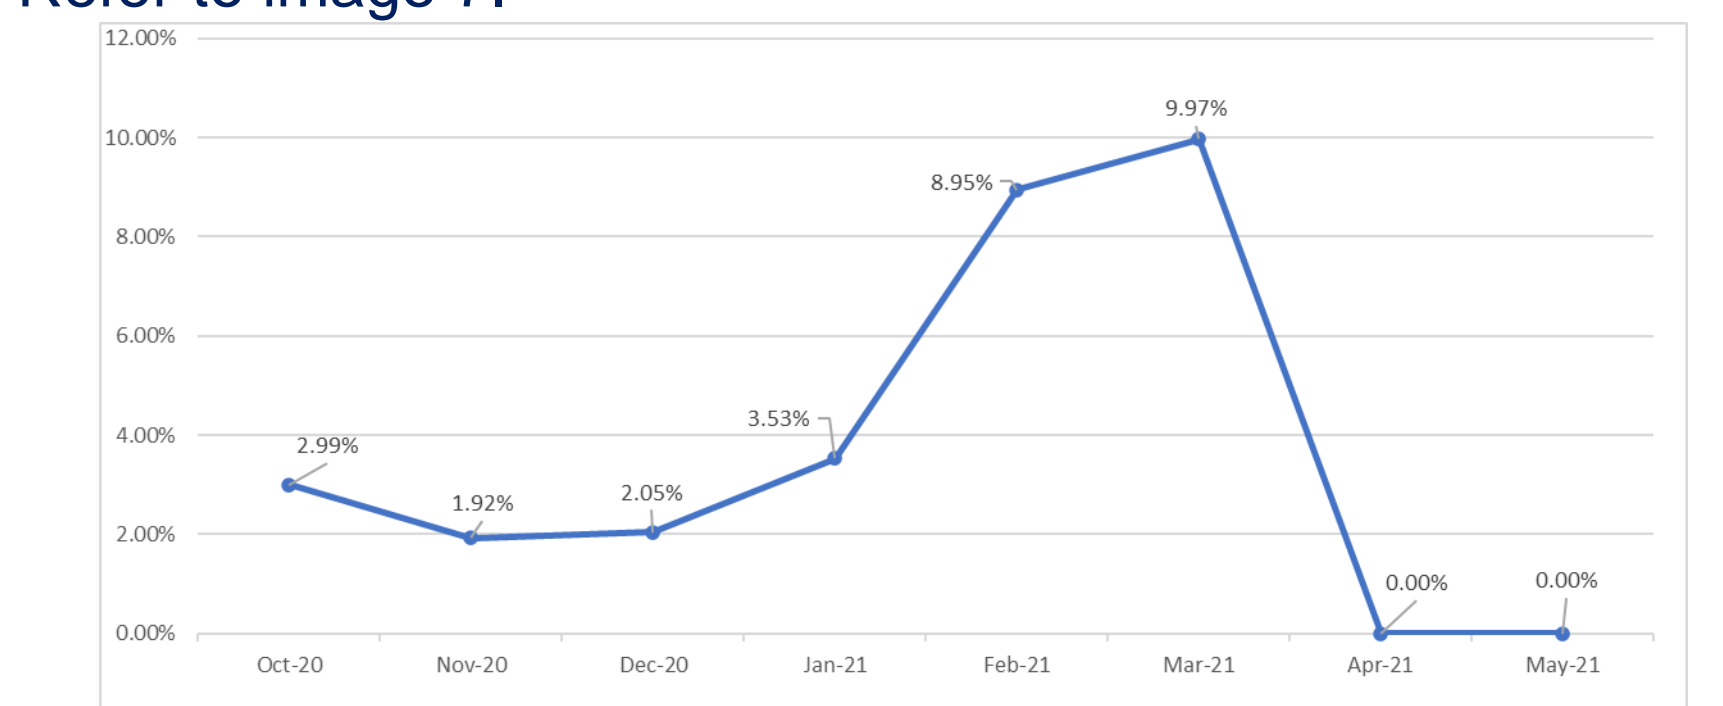
Currently, the defect is individually monitored for a period of one year by the manufacturing engineer and lead of the project. Since mid of March 2021, when the interim actions were completed, the defect was fully mitigated. Basically, there is no fallout of units by center cable damage and fray cable defect. Refer to image 7.

Figure 7  
 Scrap Percentage of Center Cable Damage and Fray Cable Defect  
 Cost Benefits
