Automobile Cabin Water Leak Resolution

Jean A. Ortiz Sánchez

Advisor: Héctor J. Cruzado, PhD, PE
Polytechnic University of Puerto Rico

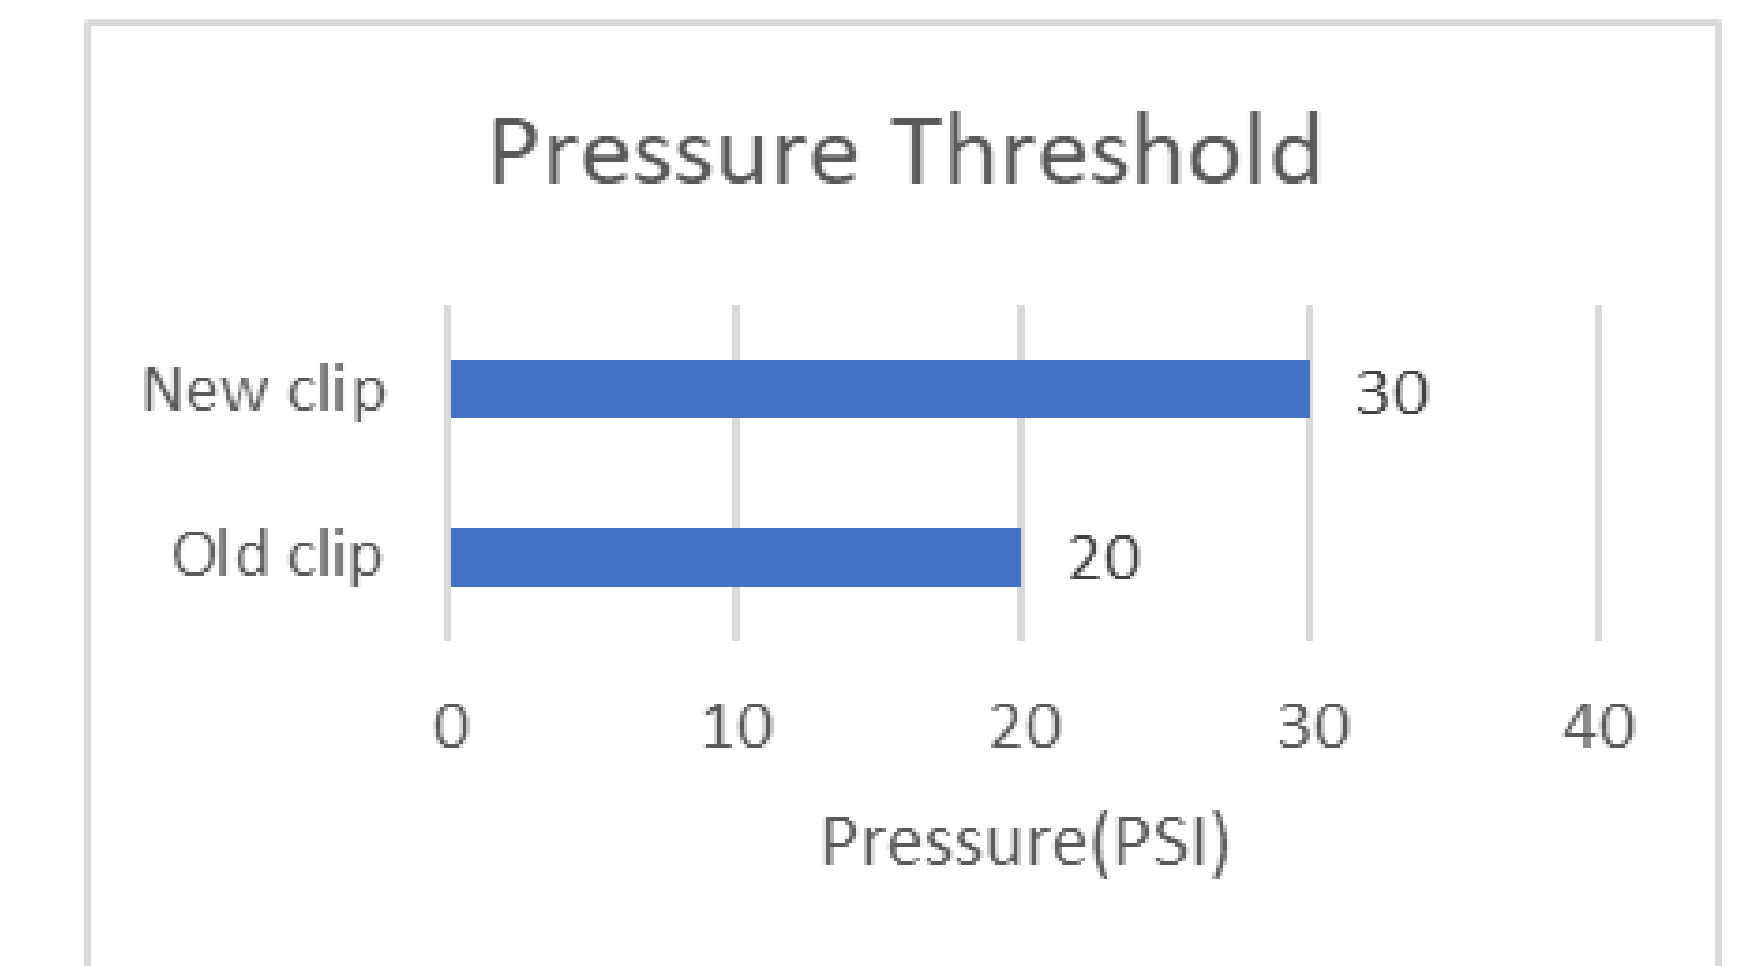
Figure 1
Pressure comparison

The last solution tested was the replacement of the holding that creates pressure between the roof of the vehicle and the gasket. After changing the clip and creating a tighter seal, the seal was tested by using a pressure washer with a pressure of 30 psi. The cost for the new clip is \$4.32. Figure 1, shows that the new seal can handle 50% more pressure than the one using the old clip, increasing from 20 psi to 30 psi. In Figure 2, a side by side comparison for the cost can be seen. Showing that the solution with the lowest cost is the clip replacement.

The most cost-effective solution is the clip replacement. It is the least costly and it does not require taking the entire antenna assembly apart.
