# *Analysis of Billboards Signs Collapse Due to Intensive Wind of Hurricane Maria*

*Ernesto J. Santiago Caraballo, B.S.C.E., P.E.  
Master of Engineering in Civil Engineering  
Advisor: Gustavo E. Pacheco-Crosetti, Ph.D.  
Civil and Environmental Engineering & Land Surveying Department  
Polytechnic University of Puerto Rico*

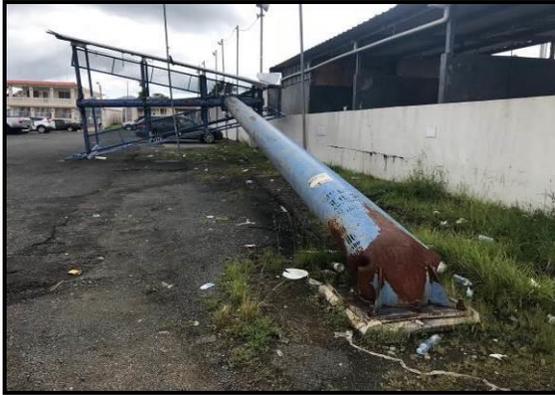
**Figure 1**

For this project, a tour was made and different places at the metropolitan area were inspected to find different signs collapsed study cases. As shown in Figure 1 wind force acting on existing 15’ x 30’ signs face was excessive enough to produce apparently local buckling and plastic yielding failures at the base of the free-standing structure. Wind speeds of 155 mph were recorded by weather

agencies in different places of Puerto Rico without mentioning that at the mountainous area some reports specify that the winds reached speeds of over 200 mph (Category V Hurricane) [3]. Therefore this kind of wind forces will cause several failures at the base of billboard signs structure where the maximum stress concentration occurs.

**15' x 30' Collapsed Sign on Fitness Parking, Bayamon P.R.**

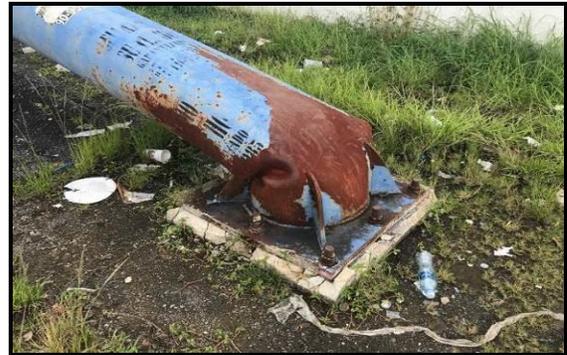
**Figure 2**

As shown in Figure 2 and 3 local buckling and plastic yielding like failures were noted at the lower end of the pole on different cases. The wind force that causes this type of failure could be estimated determining the load that may have caused such failure, and then use actual codes to backward computing the wind speed that may produce such loads. At the time that Hurricane Maria passed through Puerto Rico, the current Building Code was the International Building Code 2009 (IBC 2009)

**Local Inelastic Buckling Failure noted on Billboard Signs Lower Ends Pole**

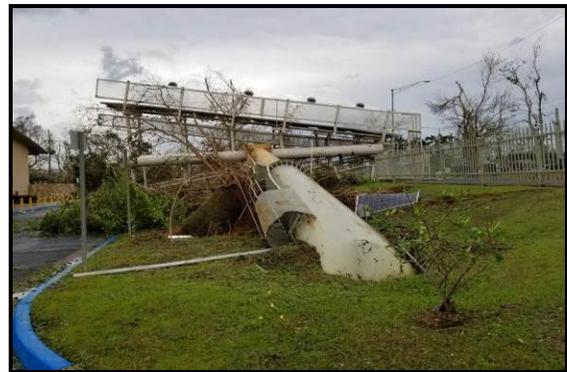
**Figure 3**

**14' x 48' Billboard Signs at Christian Church Site, Bayamon P.R.**

The case study selected was the evaluation of the collapsed billboard signs shown in Figure 3 that is located at Christian Church site in the Municipality of Bayamon. A refined Finite Element Model was developed, and two Finite Element

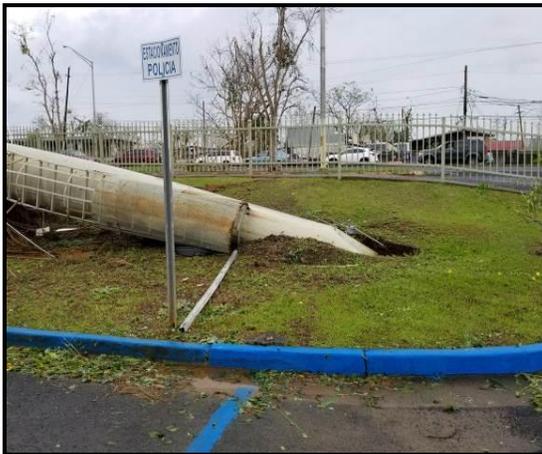
**Figure 4**  
Yielding or Inelastic Buckling Failure, Bayamon P.R.

Advance analysis modeling was performed using a Finite Element Analysis (FEA) software SAP2000 R19 for the case under study. The expected result is to find the “critical load” that caused the sign failure at the lower end of the column. First is important to know that the critical loads are the highest load that will cause lateral instability due to compressive forces (or buckling) of the structure. Loads greater than the critical load are not possible, since the structure will become unstable when reaching the critical loads, and the structure will deflect laterally (increasing the buckling modal shape) until collapsing, as it seems to occur on this situation that is under analysis Figure 4.

The Pushover analysis results as compared to the buckling analysis results clearly indicate that the yielding failure controlled in this case, and the failure sequence was yielding accompanied by inelastic local buckling after larger strains occurred.

It is recommended to obtain more information about the properties of the material, the original design specifications and perform laboratory tests, in order to be able to do additional analysis of "pushover" and determine the wind speed more assertively.

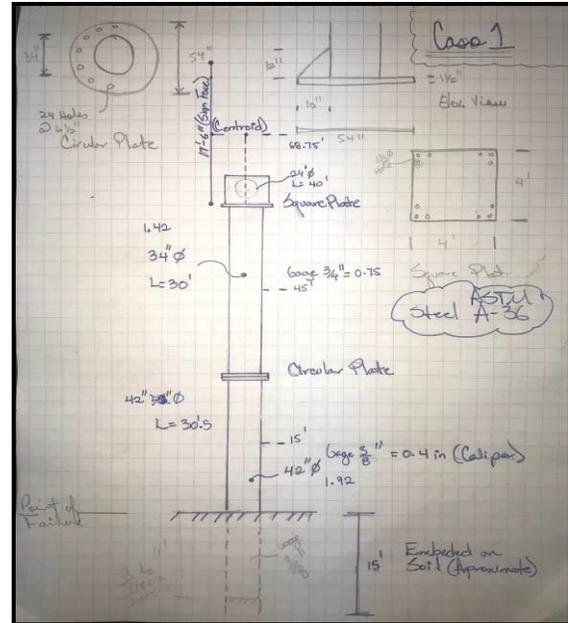
**Figure 5**  
Field Sketch Prepared at Site

Then it contains another circular pole of 30 inches in diameter and 3/4 inches thickness that goes from this point ( $H = 30.5$  feet) to a height of 60.5 feet above the ground level as shown in Figure 5 and 6. Both poles support the sign face of 14 feet height and 48 feet wide at 68.5 feet above ground (Centroid). For specific detail see Figure 5a. These field information obtained on the site visit is important to develop the analytical model of sign using a finite element software.

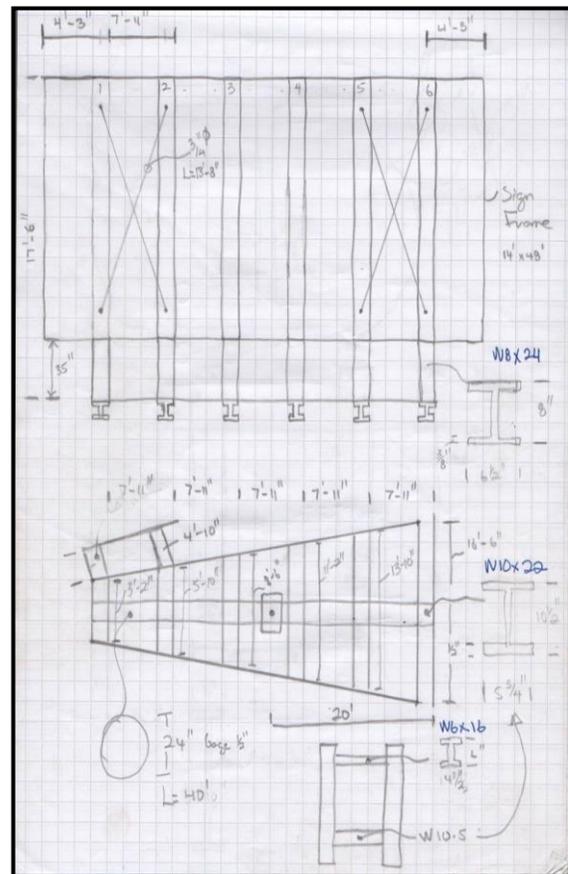
**Figure 5a**  
Field Sketch Prepared at Site

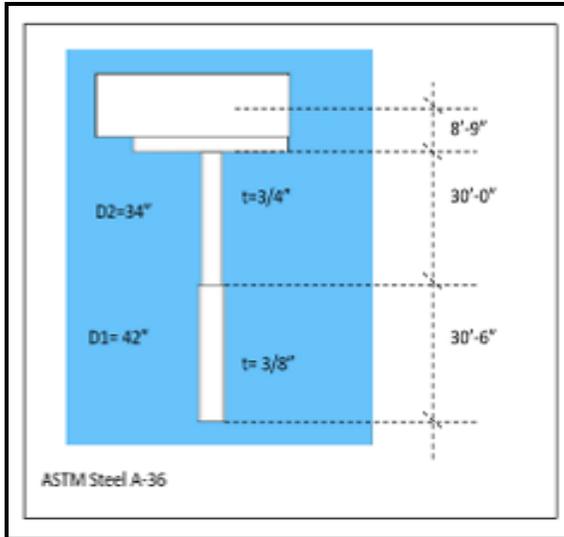
**Figure 6**  
**Field Data Recorded on Site, Bayamon P.R.**

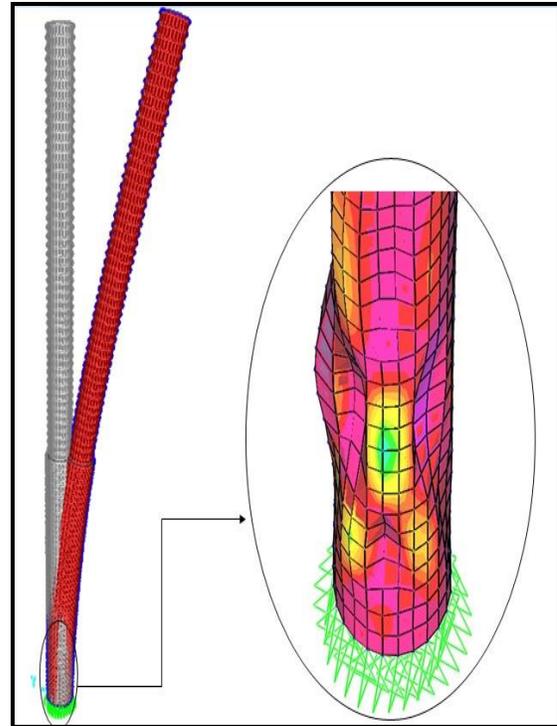
Different forms of deformed were obtained during the analysis model. We cannot forget that two trials were conducted to find the most similar case to the actual field conditions behavior. Fig. 8 shows an example of a deformed shape for linear buckling analysis. A critical load factor of 14.24 was obtained for the Trial No.2 were torsional moment  $M_z = 96 \text{ kip*ft.}$  was applied at the top of structure pole. When you compare the deformed shape obtained on Figure 8 and 4 we can appreciate some similarities on the failed structural elements. The consideration of the torsional moment governs since the critical load factor is smaller.

**Figure 8**  
Buckling Analysis Deformed Shape for Trials 2

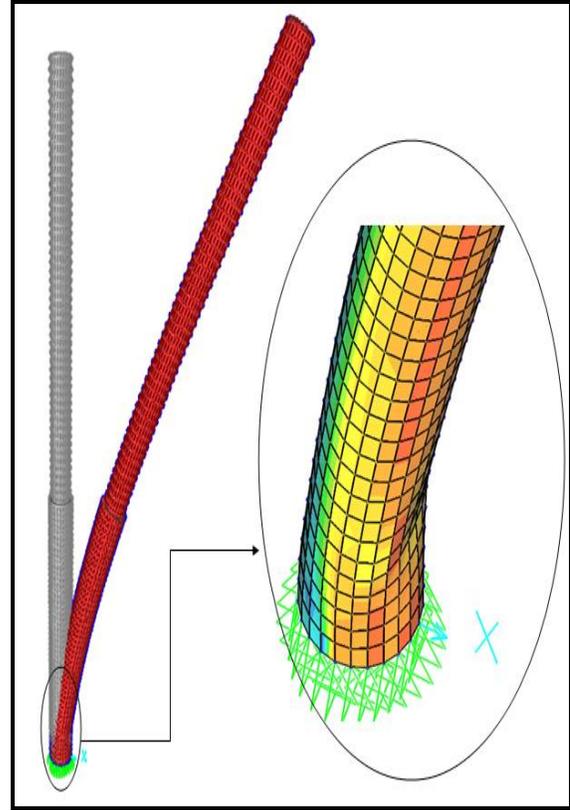
On this case under study, pushover analysis was applied to analyze the behavior of sign structure before mentioned under lateral wind condition and not for seismic purpose. The shell elements are adapted to model behavior of sign structure. In the analysis, the non-linear behavior and local buckling of sign pole appear when it reaches its peak load, which result in a sudden decrease in bearing capacity. The deformation shape based on buckling analysis results shown in Fig. 8 shows a similar location of the local buckling than the one observed in the deformation shape under pushover analysis on Figure 10.

**Figure 10**  
Pushover Analysis Deformed Shape for Trial 1

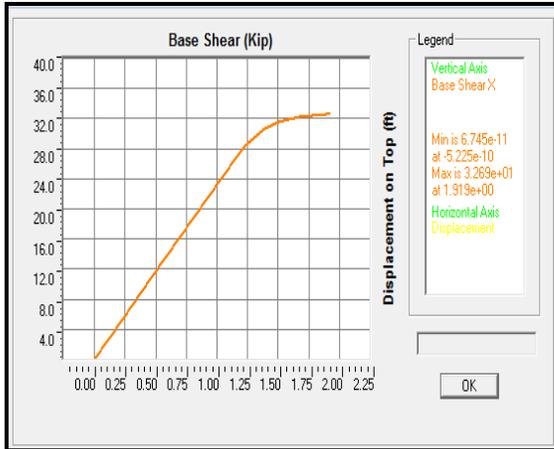
The Base Shear vs. Displacement Curve is plotted as shown in Figure 12. The behavior of the structure is observed until the failure occur. The sign pole is pushed well into the inelastic range.

**Figure 12**  
**Base Shear vs. Displacement on Top of the Structures**
