Building Rehabilitation of a Military Colonial Architecture: Miraflores Gunpowder Storage Building

Sadally Orama Figueroa

Master of Engineering in Civil Engineering

Polytechnic University of Puerto Rico

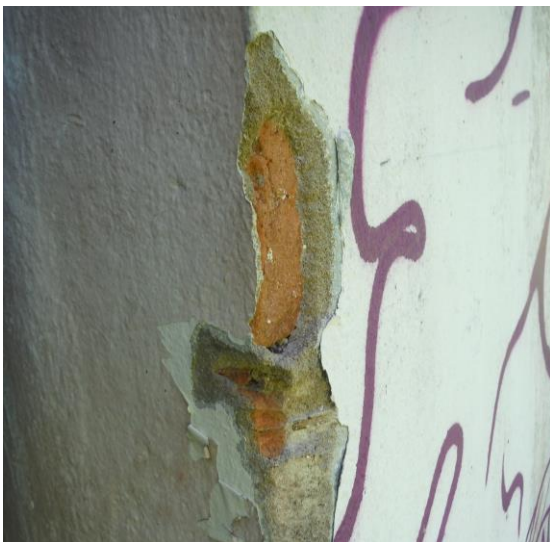
The first thing that attracts attention are the massive clay brick walls. External and internal walls are constructed predominantly in solid clay brick masonry and their measures are 22.25 and 28 inches respectively. It's important to make clear that the initial purpose of the exterior wall was to protect the main structure, the one who support the barrel vault. That's why the interior walls are thicker than the exterior. That's is a common military construction typology for Spanish gunpowder magazines in Puerto Rico. Added partition walls are of reinforced concrete and wood panels. The exterior walls have 21 opening, from floor to ceiling, 13 are open and 8 are bricked up. The interior walls have 18 openings to accommodate wood framed doors. Walls reach eight (8) feet high. Figure 3 shows that walls are covered with a thick layer of concrete coating from 0.25 to 0.50 of an inch. It is assumed that the coating is to protect the brick integrity and avoid mortar lost.

Section Area of an Exterior Wall Missing Concrete Cover

The walls will continue being protected with the concrete coating. A Repair will be needed to the interior and exterior wall, especially in areas that the coating is missing. Also, will need cover old small perforations. The barrel vault ceiling will also need the concrete coating in the missing area. The mechanical and electrical system for the main space will be anchored to the side wall and some time to the ceiling to accommodate lightings feature.

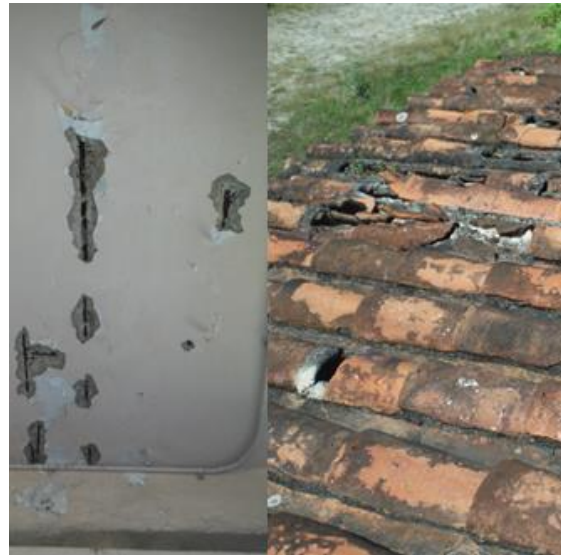
Above the outer wall there is a rectangular concrete beam, 19" x 8", which it is at the bottom where the slope of the roof rests that covers the corridor that surround the structure. Figure 4 shows the slab visible corrosion damage in the steel rebar at the northwest side of the ceiling. From the visual observation is concluded that the rebar doesn't have the required concrete cover for protection. But no rebar has more than 10% loss of its diameter. Other parts of the ceiling have visible deterioration presented by paint peeling assumed to be caused by moisture. At the top of the slab, the roof, is covered by Spanish clay tiles that are broken, missing or deteriorated. Those conditions could conduct to leakage through the concrete slab causing corrosion in the steel rebar.

Sloping Ceiling and Roof Covered My Spanish Clay Tiles

The concrete sloping slab roof will need repair in the area that the reinforcement protection cover is missing. The affected area is small compared to the entire building roof. Reference [8] recommend a few steps described as follows;

- Remove all unsound concrete
- Undercut the exposed corroded bars to provide clearance for under-bar cleaning and full bar embedment
- The clear space behind the reinforced steel should be greater than $\frac{1}{4}$ inch, plus the dimension of the maximum-sized aggregate in the repair material.
- The damage bar will require a gap from $\frac{3}{4}$ to 1 inch to inspect and cleaning (wire brushing or water-blasting).
- Place the repair material and encapsulate the bar with it. Reference [9] recommend types of coating for reinforcement.

The visual inspection of the area of corrosion determinates that the bar doesn't have lost more than the 10 % of its diameter. In that case, rebar will not require extra additional reinforcement [8]. Reference [9] recommend several materials for crack repair on concrete slabs.

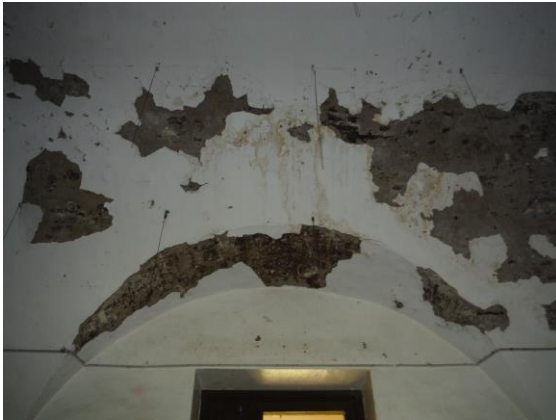
The inner wall also reaches 8 feet high and at that point starts the barrel vault curvature. That central space reaches a maximum height of 17 feet with 22 feet and 10 inches wide as interior measurements. Brick concrete coating loss are the most visible evidence of deterioration. There's no visual substantial damage to the curvature of the main roof. Pointing to a unit pattern, the exposed area shows a longitudinal configuration of the brickwork. This type of construction needs to be considered since there are studies that conclude that cases with concentrated and lateral loads, there is a

considerable increase in the load capacity of the structure [3]. Describing the geometry, it could be interpreted as a longitudinally extended arch or a laying half cylinder. Figure 5 shows that the doors opening, at the main space, are defined by lunettes, described as a half-moon shaped space recessed void. This architectural gesture doesn't compromise the load behavior of the structure.

Figure 5
Barrel Vault Missing Concrete Cover

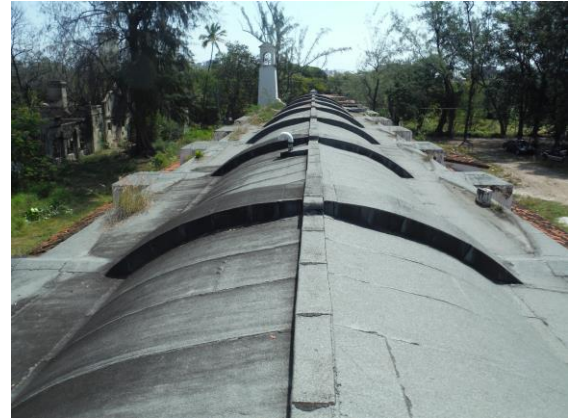
There is asphalt roof system waterproofing treatment at the exterior side of the barrel vault which is the main roof. There is evidence of lack of maintenance provoking obstruction, by dirt and vegetation that grow up through time, in the roof drainage. Figure 6 shows 8 inverted beam crossing the top of the barrel vault and resting in the buttresses; this connection cannot be seen. Each inverted beam is also connected with each other by a small longitudinal beam. That extra reinforcement element will be considered in addition to increase the load resistance capacity of the roof, as a military structure.

Figure 6
Barrel Vault Roof with Inverted Beam

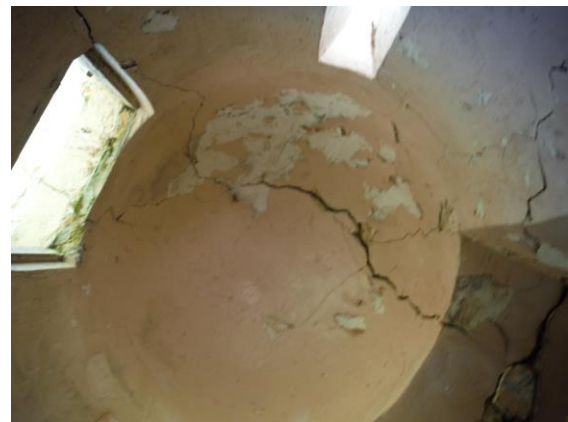
The only sentry box that is still in place has an evident problem with the settlement. Figure 7 shows that the half dome roof has cracks that cross the ceiling. The exposure of the base is evidence of erosion. It is assumed that the problem could be caused by unequal compression of its foundation. For purpose of this investigation, the structure foundation will not be considered.

Figure 7
Substantial Crack inside the Half Dome of the Sentry Box

The existing sentry box will need repair on its foundation to avoid interior and exterior cracking. To recommend a proper repair method will be necessary a detailed investigation about the existing soil and foundation. As a preliminary proposal is recommendable a helical pier repair method. The

technic has some advantage like ideal for compression force, little to no vibration, immediate load transfer upon installation, installed torque correlates to capacity, and can support 50,000 pounds per pile. This alternative only consists in screwed a pile into the ground until the desired bearing capacity is achieved [10].

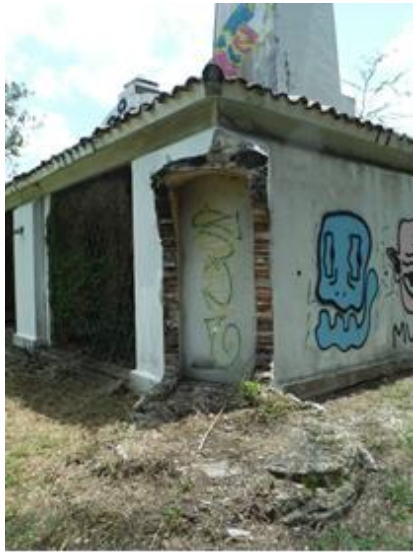
The other sentry box is 90% lost and the remaining pieces can be seen on the side wall and base, or floor. The entrance space was bricked up to avoid unwanted visitors. Near that is the bell tower that is constructed of reinforced concrete. It rests in an extension of the interior wall above and in the first buttress of that side. Figure 8 shows those remain elements in the actual condition of deterioration.

Figure 8
Missing Sentry Box

For the other side of the building, the proposal will be an imitation of the old sentry box. The material will be reinforced concrete, steel and glass for the opening. The intention is to create a small space with an own character that its contemporary material imposed on the old structure. This architectural gesture could be used as a privileged space of the corridor lounge or just to expose the restaurant menu.

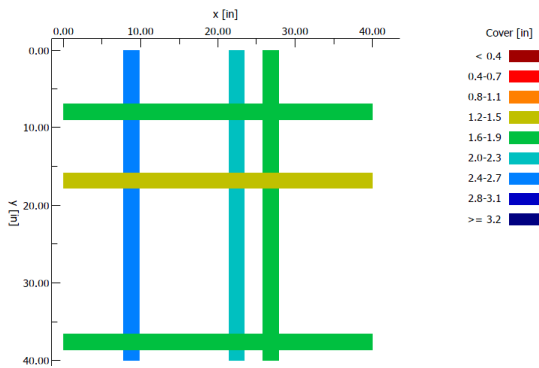
[7]. The equipment used with a rebar detection system was the *Profometer 5+* that utilizes non-destructive pulse-induction method. Testing areas were made on the concrete wall inside the sacristy space, the small chapel space and at the bathrooms. Figure 9 shows the scan result of the sloping roof ceiling. Figure 10 shows result of the concrete beam at the top of the exterior clay brick wall that support the lowest side of the sloping roof. Figure 11 and figure 12 shows the inverted longitudinal beam and the curvedly beam at the top of the barrel vault roof. Finally, figure 13 shows one side wall of the bell tower. The result of the scan shows that all concrete element was reinforced using steel rebar. The walls at the interior, main space's partitions, are of reinforced concrete but don't have major structural purpose for the existing building. That means that are free for modification including new space configuration.

Figure 9
Sloping Roof Slab

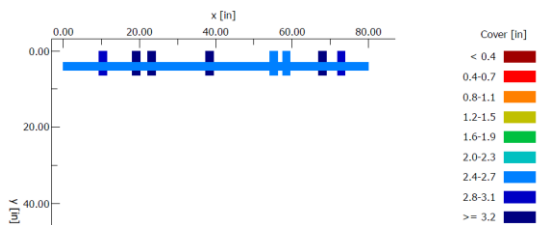
Figure 11
Inverted Longitudinal Roof Beam

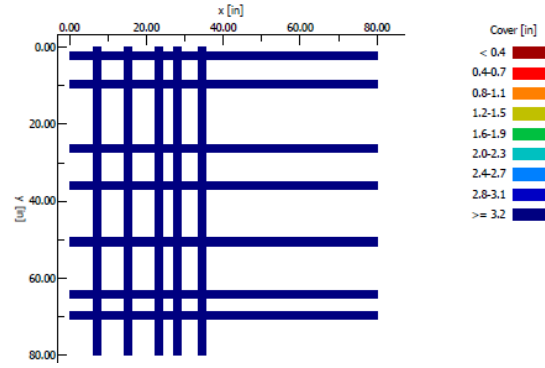
Figure 12
Inverted Cross Roof Beam

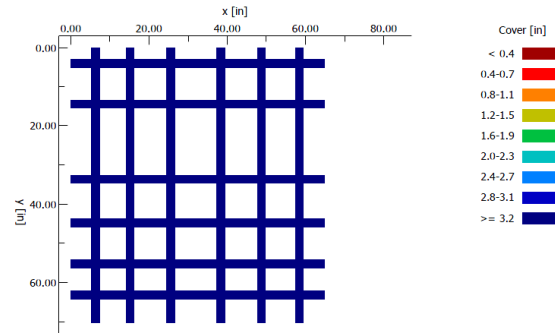
Figure 13
Bell Tower Rebar Location
