# ***Seismic Evaluation of the Main Building at the Polytechnic University of Puerto Rico***

*Héctor M. Vélez Cortés, PMP, PE  
Master of Engineering in Civil Engineering  
Gustavo Pacheco Crossetti, PhD, PE  
Civil and Environmental Engineering Department  
Polytechnic University of Puerto Rico*

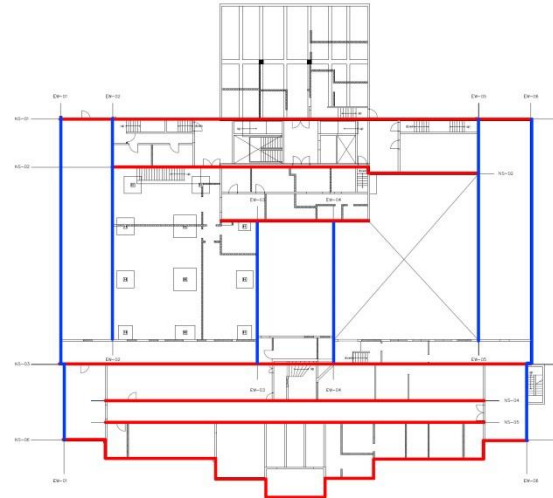
**Figure 2**  
**Lateral Force Resisting System, First Floor As-Built 2015**

A series of reinforced concrete walls, in both directions, were identified as part of the lateral-force-resisting system.

The thickness of these walls was measured to be 8 inches and the opening for the corridors, windows

and doors was considered when analyzing the shear strength of these walls.

In the north-south direction seven shear walls were identified marked as red in Figure 2 and in the east-west direction, six shear walls were identified marked as blue in Figure 2.

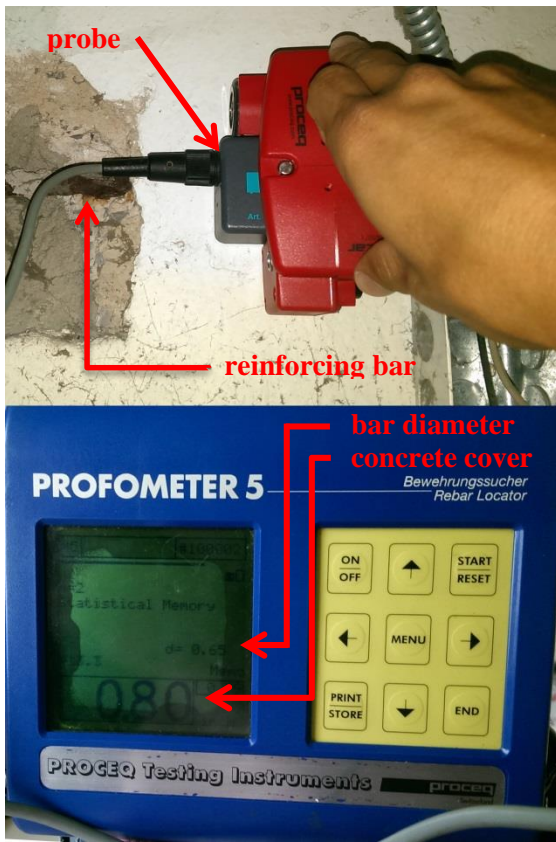
**Figure 3**  
**Non-Destructive Evaluation**

The non-destructive evaluation performed on the Main Building provided a clear understanding of the lateral-force-resisting system. A group of reinforced concrete walls were selected in order to assign the lateral loads to be applied as part of the quick checks, in addition to determine the vertical and horizontal reinforcement.

The analyses performed as part of this report adopts a reinforcement of #4 @ 12" e.w. as determined by the non-destructive testing.
