Vulnerability of Schools in Puerto Rico to Tsunami Events Case Studies: Loíza, Mayaguez, and Toa Baja

Polytechnic University of Puerto Rico – MVC 2023

João Victor Stedile Zolin, Civil Engineering Student | Advisors: Gustavo E. Pacheco-Crosetti, PhD, PE Héctor J. Cruzado, PhD, PE

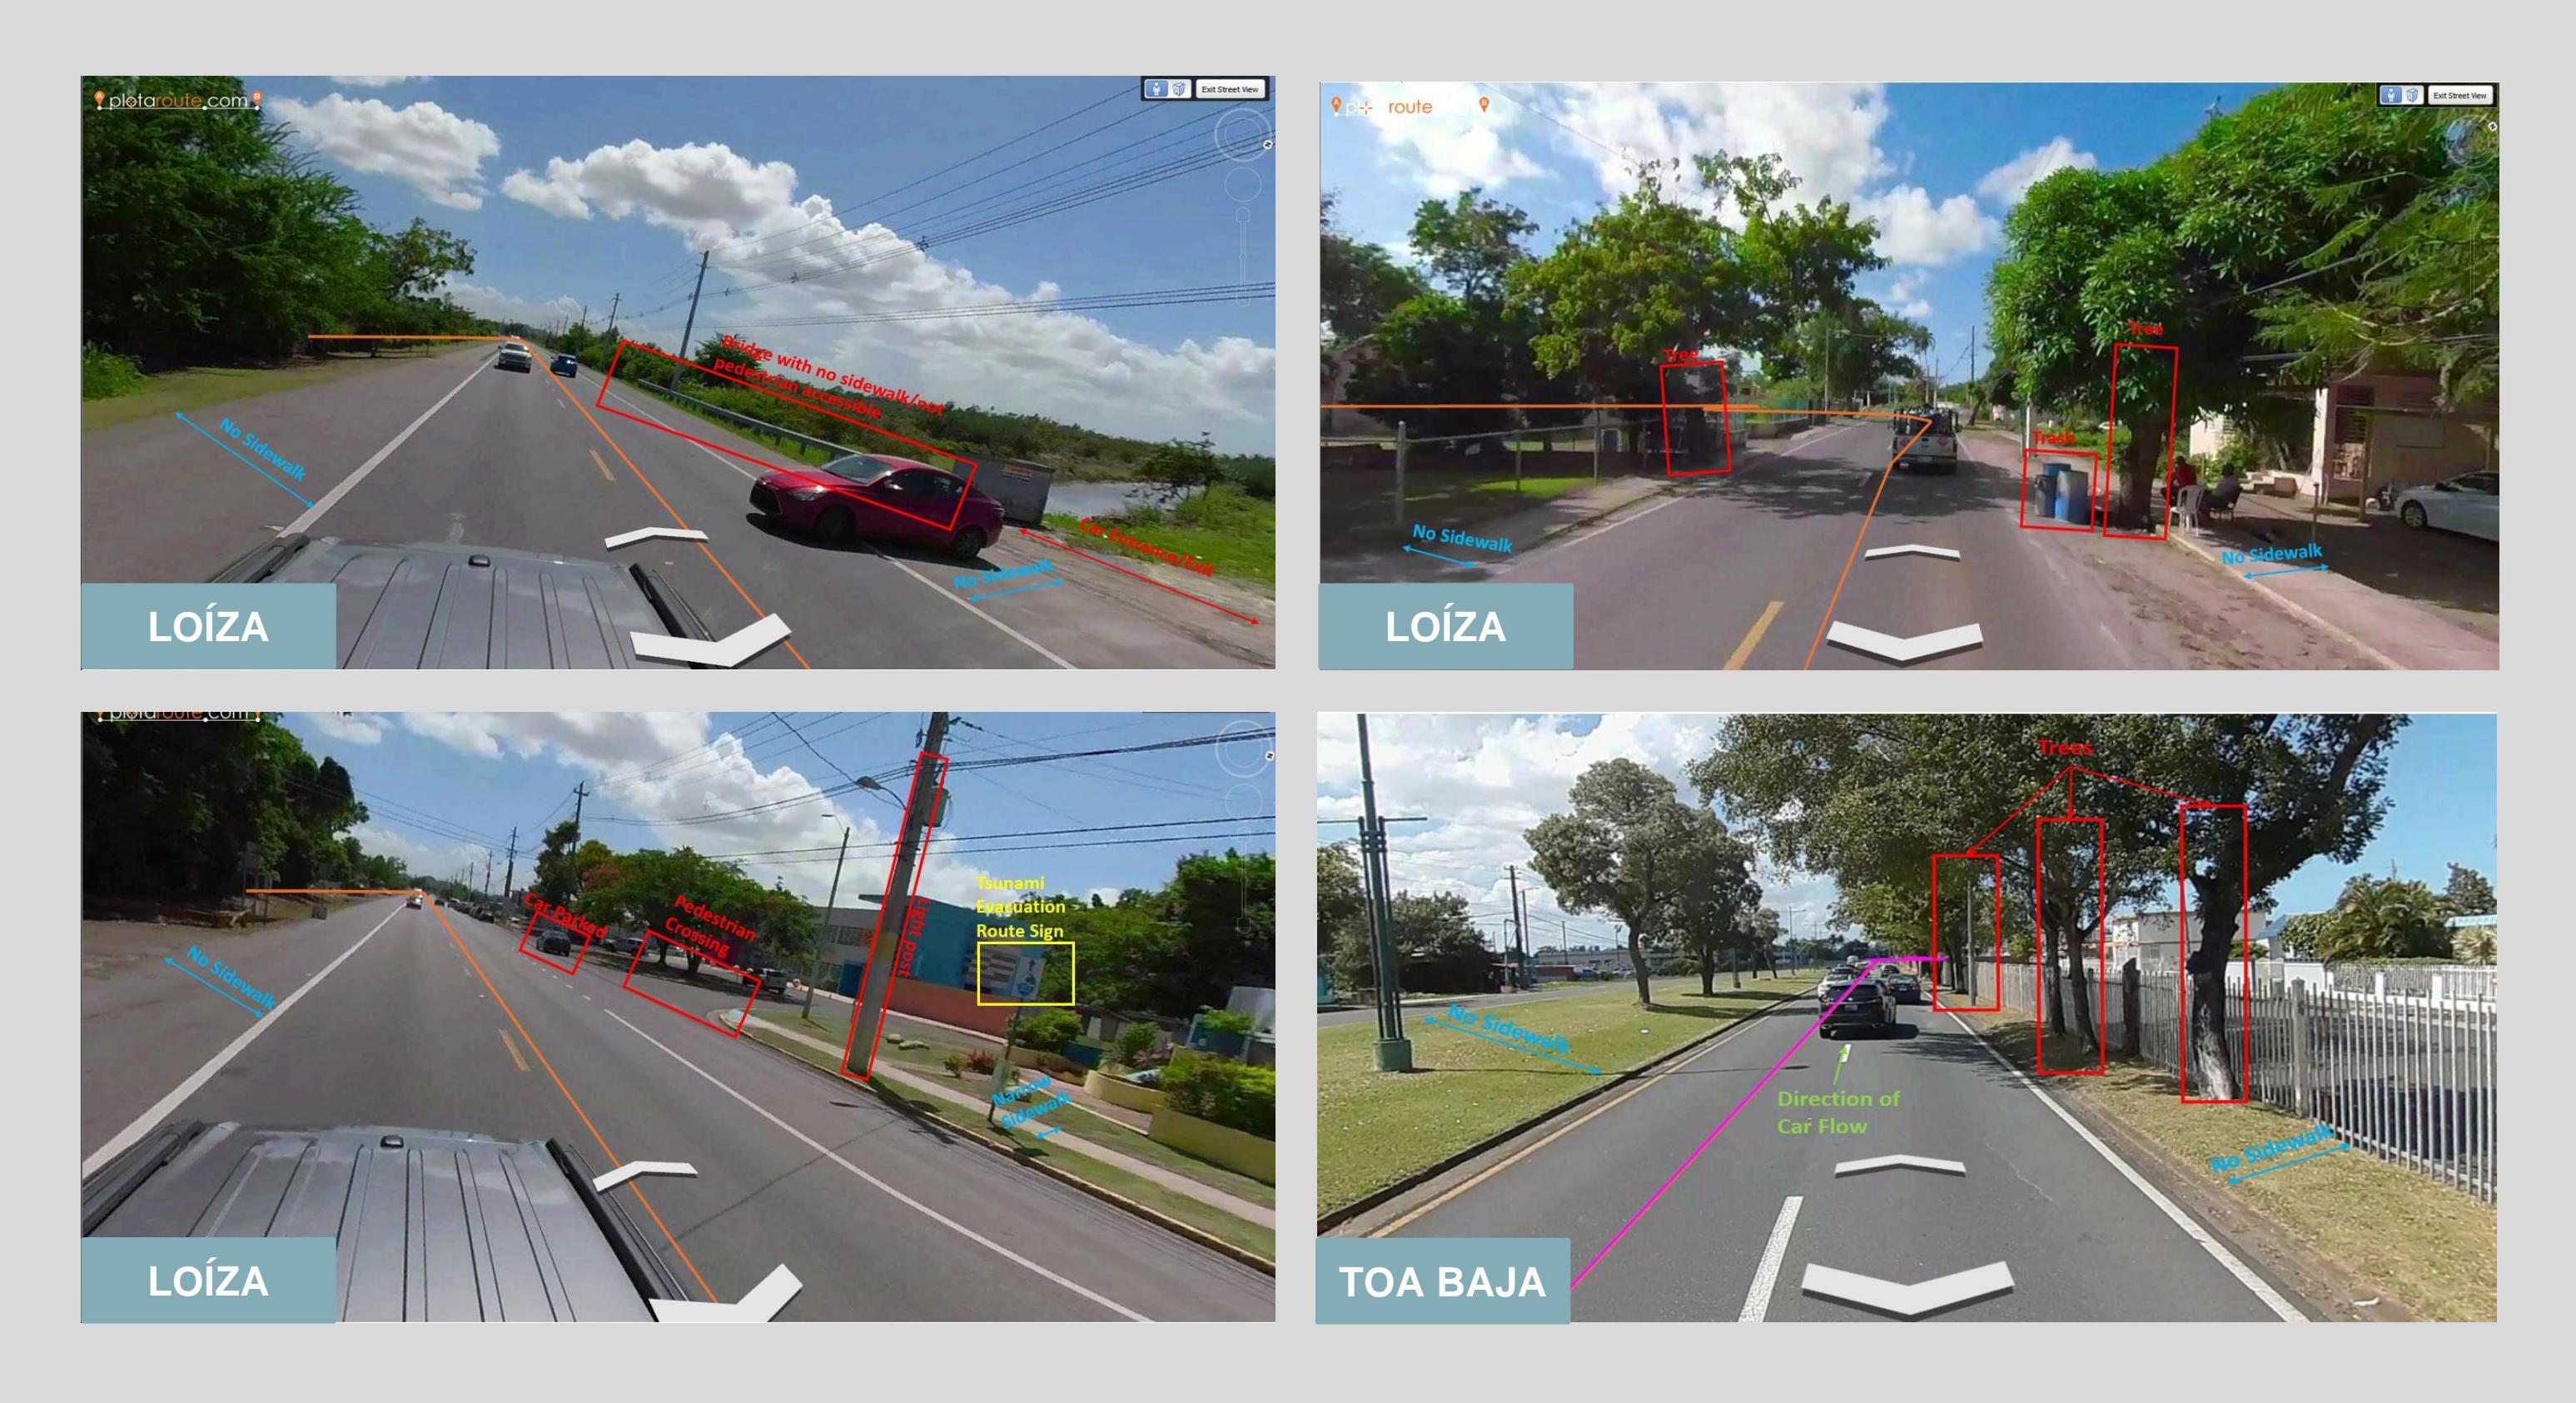
Evaluate Routes Conditions by Virtual Inspection

Also, there was noticed poor road conditions, lack of necessary infrastructure, and urban furniture/hazards that can cause delays during evacuation.

Improve the evacuation routes by reallocating urban furniture, improving signage, and adding sidewalks where they are nonexistent. Prioritizing pedestrian safety is essential to ensuring that they can evacuate the area safely and quickly in the event of a disaster, as an integral part of a resilience improvement analysis.
