Analysis of Estimated Scour vs Inspected Scour on a Bridge after Hurricane Maria, and their Impact on the Puerto Rico Bridge Program

Christian Berríos Soto

Master of Engineering in Civil Engineering

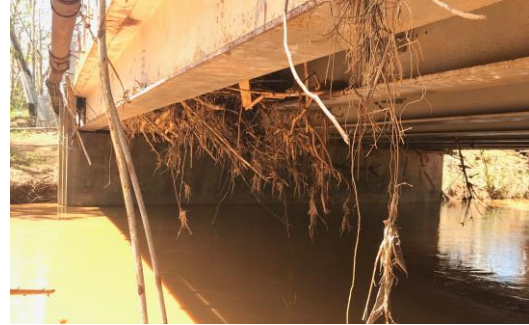
On October 4, 2017, Bridge No. 55 was inspected to assess any damage as a result of Hurricane Maria. During the inspection, moderate erosion at the river banks as well as light accumulation of debris was found at the bridge site. However, after inspecting for scour at abutments by

means of wading, no scour was found. Further, the detected conditions were similar to those noted in the last bridge inspection report, thus the inspected scour Post-Maria was determined to be 0.00 m.

Figure 9
Bridge No. 55 Inspection Photo Post-Maria [14]

during the storm. Nonetheless, neither the vertical contraction scour of 2.22 m for the design flood nor the 0.75 m for the check flood were observed during the Post-Maria inspection, implying that the scour evaluation results were indeed overestimated compared to its observed scour after the strike of a 100-year storm event.

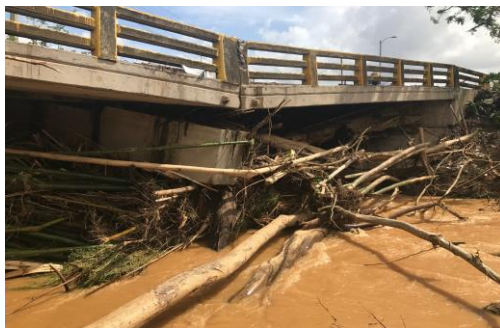
Figure 10

Furthermore, the inspections performed after Hurricane Maria have shown that most of the 26 bridges that collapsed during the storm may have been a consequence of floating debris being transported by the rivers and accumulating around the bridge elements, partially or totally blocking the opening. Large amounts of accumulated debris can generate significant lateral and vertical forces capable of pushing and carrying the structure away. Debris accumulation is more common in unstable streams with modest slopes, characteristics more comparable to the streams of Puerto Rico.

Debris Accumulation on Bridge after Hurricane Maria [14]
