# How the DMAIC Methodology was applied under the CAPA System with Effective Results

Mayda Haddock Ortiz  
 Master in Manufacturing Competitiveness  
 Wilfred Fonseca, Ph.D.  
 Industrial Engineering Department  
 Polytechnic University of Puerto Rico

**Key Terms** — CAPA, DMAIC, Proximal Spacing and Effectiveness.

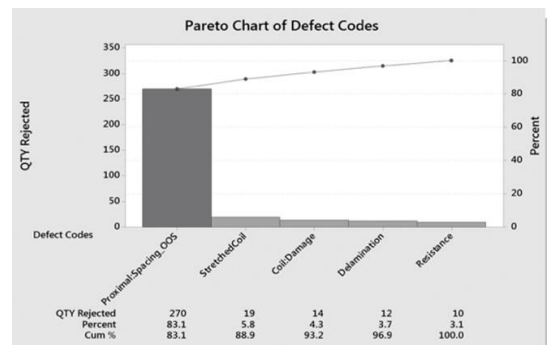
Figure 3  
 Pareto Chart

However, in the top five defects on Figure 3, the major contributor with an 83.1% was the proximal spacing out of specification (OOS).

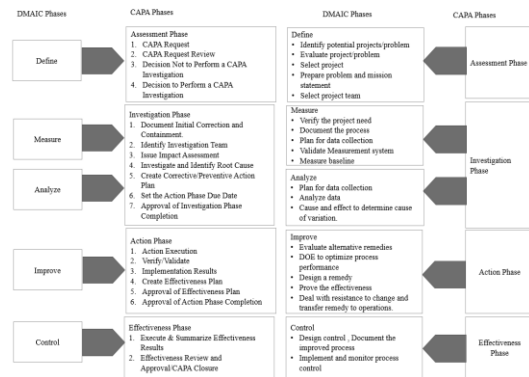
Figure 4  
Diagram for Reference

In Comparison of both systems, CAPA and DMAIC phases, they are systematics and structured. The measure and analyze phase is covered under the CAPA investigation phase. Figure 4, CAPA system and the DMAIC phases [1].

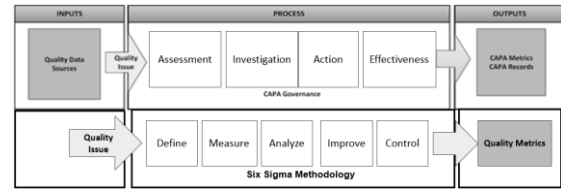
**Figure 5**  
**High Level Input Process Output (IPO)**

The methodologies explained in this project design were the key to get effective and sustainable results. The CAPA process was applied with the integration of six sigma DMAIC methodology to identify the root cause of the problem. The CAPA process followed by the Organization consist of four phases; (1) Assessment phase, (2) Investigation phase, (3) Action phase and (4) Effectiveness phase. The input process output (IPO) illustration on Figure 5 is a CAPA governance high level and six sigma methodologies

under a systematic and structured process that was followed.

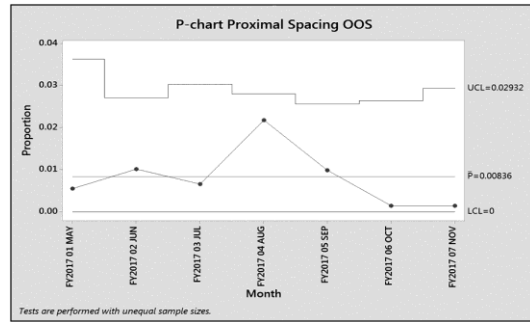
**Figure 8**  
**P-Chart Proximal Spacing OOS Baseline**

Meanwhile in the Six Sigma Measure phase data history of reject quantity was gather since the new fiscal month (FY2017) when the CAPA imitated, to establish a baseline (Figure 8). To measure the improvement, before and after chart

was traced resulting defect rate calculated of 270 quantity defects out of 32,303 completion units resulting a defect rate of 0.836%.

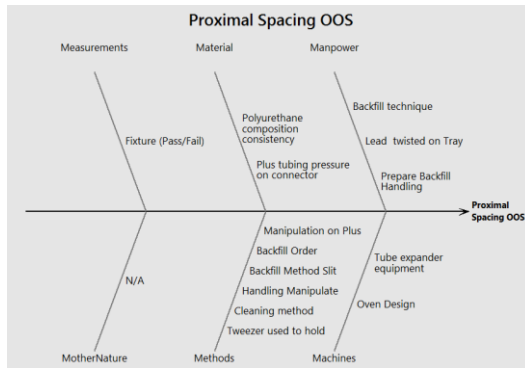
Figure 11 Cause and Effect Diagram

During the CAPA Investigation phase, the Cause and Effect diagram shown on Figure 11, was used to identify all the potential causes using the 6m (method, material, manpower, measurement, machine and mother nature) analysis.

- Cause and Effect Conclusion:** No primary root cause was identified. However, the following contributors of the proximal spacing OOS were identified:

1. Backfill method
2. Tray Design
3. Oven Design

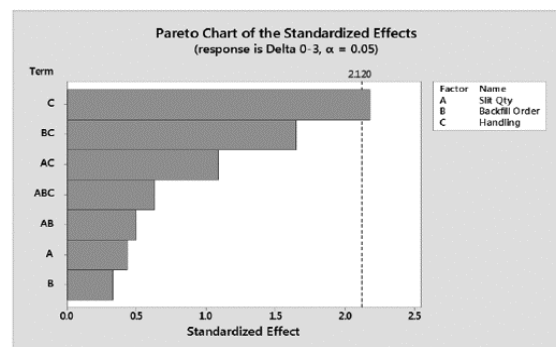
**Figure 16**  
**Pareto**

Two of the locations (i.e. spacing of location 2 and location 3), the handling (pull the plus tubing

wings while making backfill along the entire length) resulted as significant factor shown on Figure 16.

Contributor factors to address	Implemented actions
(1) Backfill Method	<p>While opening spring press the tube edge with finger so that the spring opens keeping uniformity of gap. Otherwise (check again) remove the wire and take care for the added wire part at device or program in machine to remove defective SPS.</p>
(2) Tray Design	
(3) Oven Design

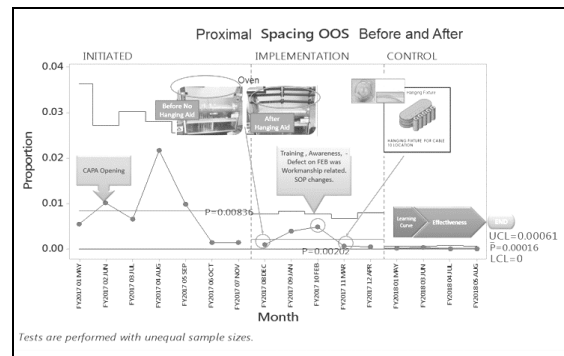
**Figure 18  
p-Chart Before and After**

Six Sigma Control Phase results - The initial baseline established in the measure phase of 0.836% defect rate was improved after the implemented process improvements to 0.016% defect rate. Figure 18 represent the implemented changes addressing the contributor factors.

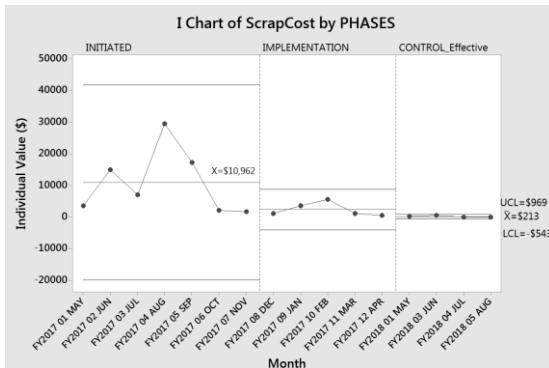
**Figure 19**  
**Cost Reduction**

The decrease in cost given the reduction of defect rate shown in figure 19 had a significative decrease from \$10,962 to \$213 average cost per defect rate.
