Lismarie Vargas Andino  
Master of Civil Engineering  
Héctor J. Cruzado, PhD, PE

Department of Civil & Environmental Engineering and Land Surveying

Puente Blanco is an arch bridge located in the municipality of Quebradillas, Puerto Rico. This reinforced concrete structure, which dates from 1922, was initially designed and built as a railroad bridge but was later renovated to be used by automobiles. Over the years, the structure has suffered severe damage due to exposure to coastal environment and lack of maintenance, causing the bridge to be closed to automobiles. Using a structural engineering program, a model of the bridge was developed to evaluate its design under current standards. Using the results, a rehabilitation that included reinforcement replacement and carbon fiber application was designed. The estimated cost of implementing the design is \$3,771,651.24. If this rehabilitation is not implemented, the historic bridge is at risk of collapsing.

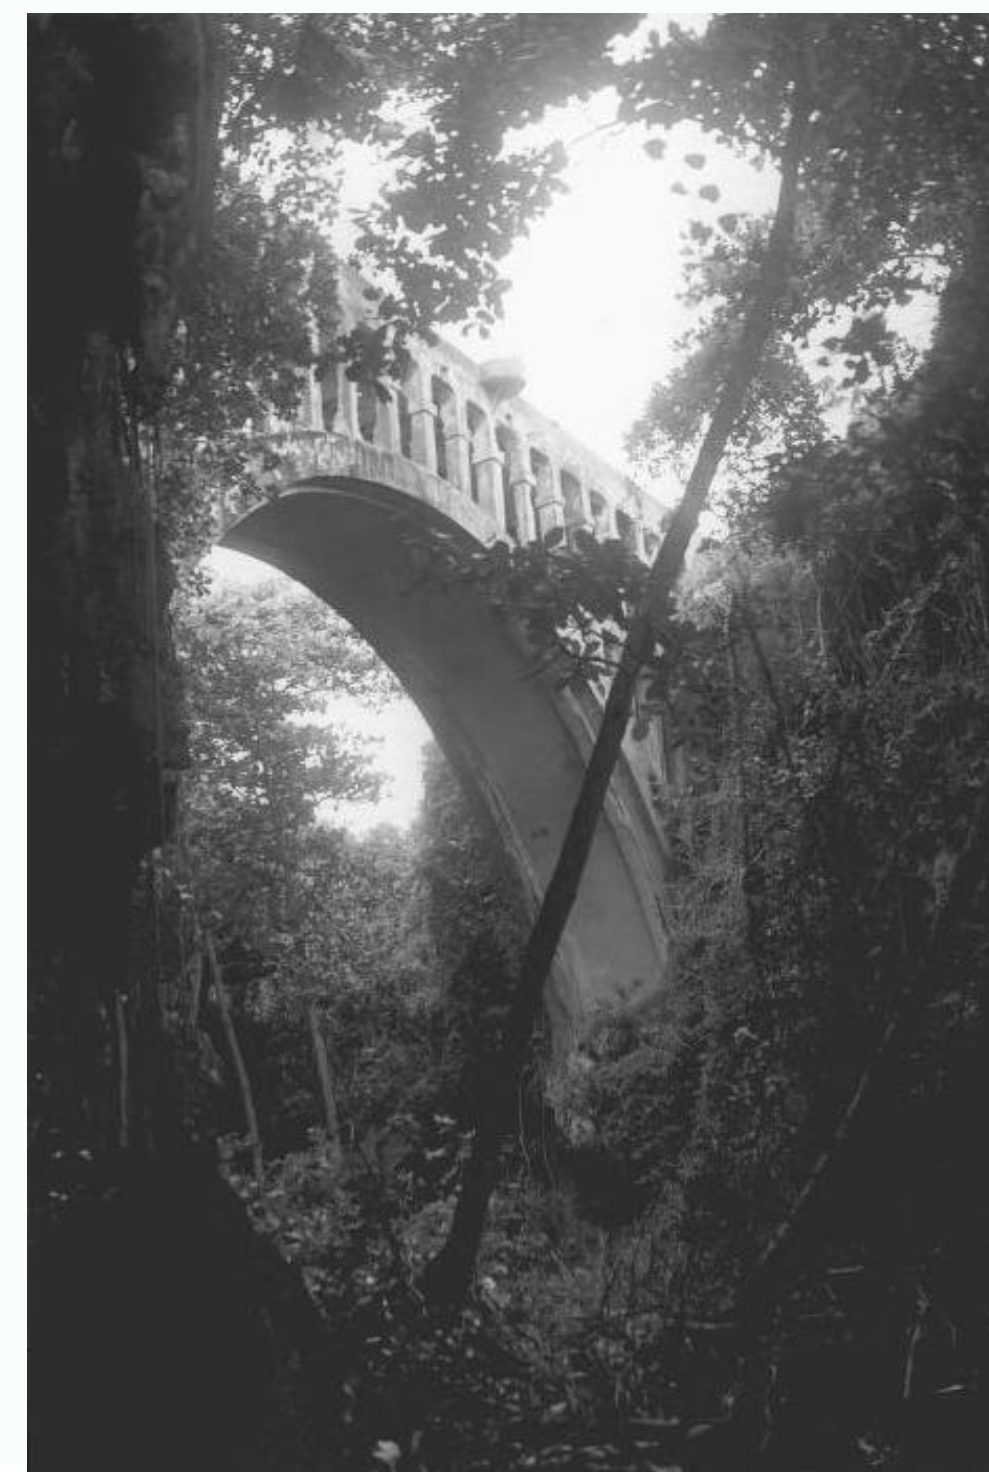
Figure 1  
Original condition of the bridge

Puente Blanco was originally built as part of the railroad in Puerto Rico owned by the American Railroad Company. At its location, there had been a steel bridge that had spanned that section since 1907, but this had to be replaced because it was in poor condition. Puente Blanco was designed by Etienne Totti, a native of the municipality of Yauco, who served as chief engineer for the American Railroad Company. Construction of the arch bridge was completed in 1922 with a cost of \$18,000. It supported the 84-ton weight of two locomotives crossing the bridge [1]. The original architecture of the bridge is presented in Figure 1.

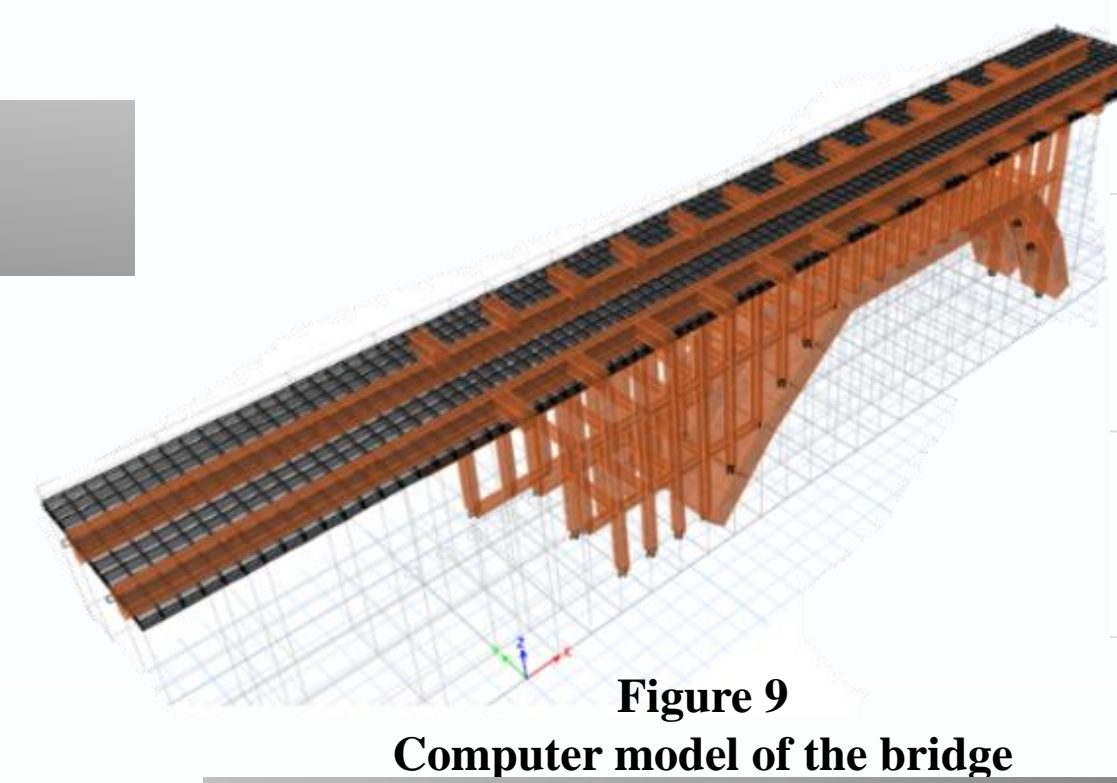
Figure 9  
Computer model of the bridge

For the structural analysis, a model was made using the computer program ETABS, as shown in Figure 9, with the main objective of comparing results and determining the appropriate use that could extend the useful life of the bridge. The following data was used in this analysis:

- Load combination and load factors in accordance with AASHTO [7].
- Live load of 85 psf, in accordance with the bridge being used by pedestrians and cyclists [7].
- Spectrum data for seismic analysis according to ATC Hazards by Location website.
- Soil type D - Stiff Soil (assumed).
- Dimensions of the beam, column, and arch elements according to their original condition.
- Compressive strength of concrete of 3,000 psi in the beams constructed for the 1985 renovation (assumed).
- Compressive strength of concrete of 5,500 psi in original columns and beams.
- Strength of Twisted Reinforcing Bars a yield strength of 50 ksi [8].

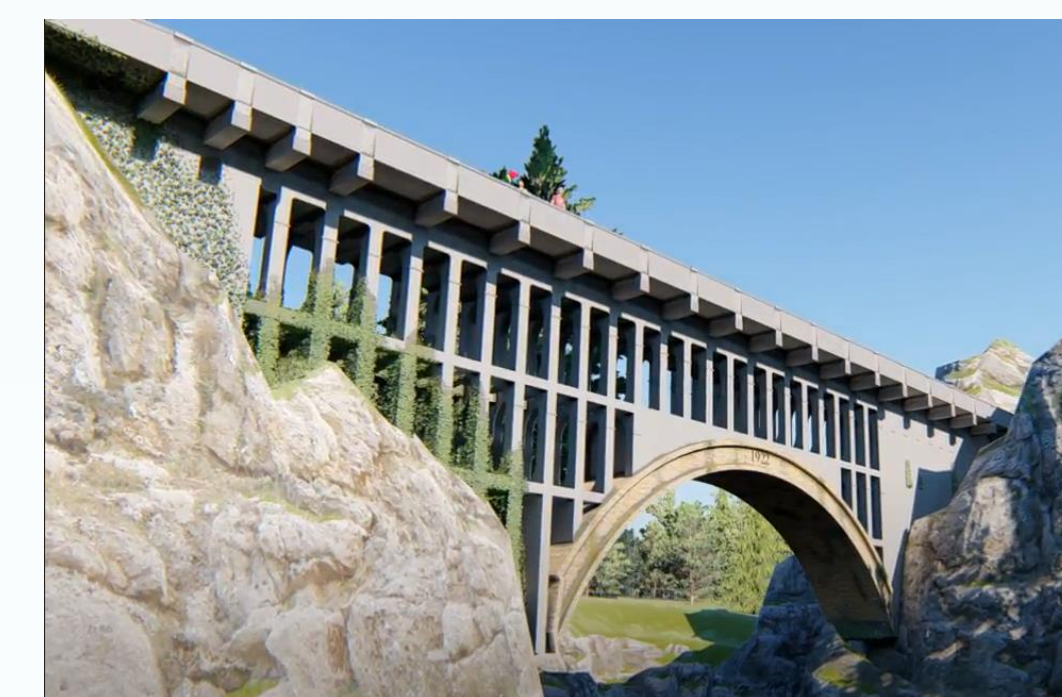
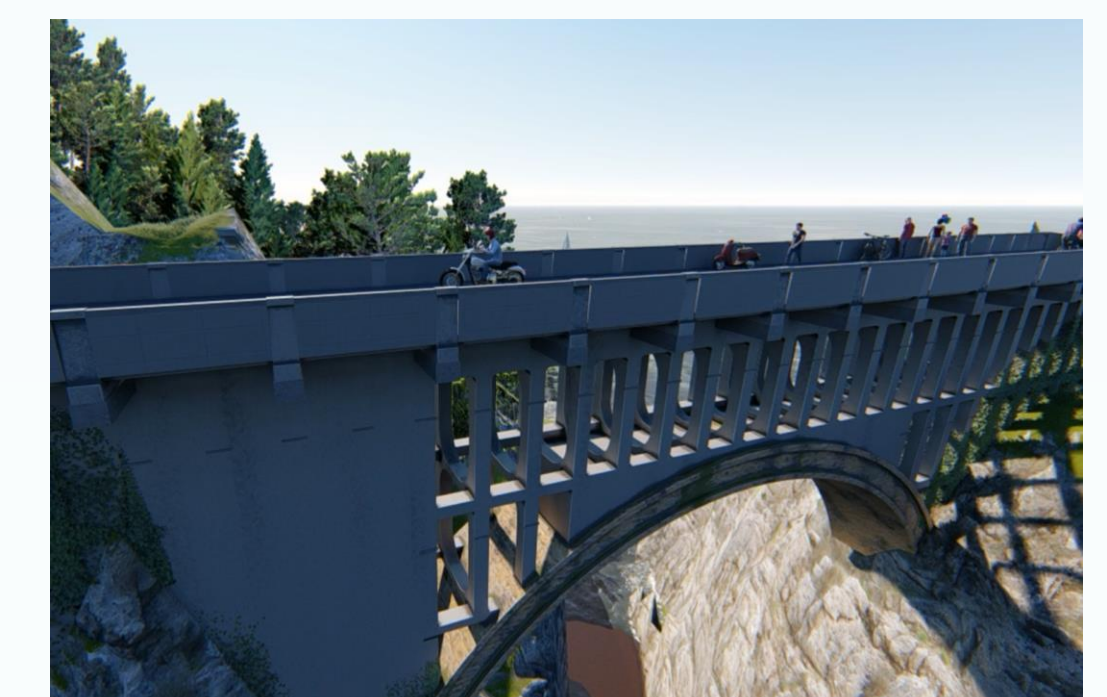
Figure 14  
Visual concept of the rehabilitated bridge

Puente Blanco is a historic concrete structure with severe damage and at risk of collapsing. Although it has been closed to automobiles, the structure is still in use and appreciated by pedestrian and cyclists. If the preservation of this structure is desired, action must be taken sooner than later. Figure 14 shows a visual concept of the final design, contemplating the proposed use of the bridge after it has been rehabilitated and is once again safe for visitors.
