CCL Label Puerto Rico process controls to maintain quality standards for high demanding pharmaceutical customer

Joe Michael Rivera Rosario
Master in Engineering Management
Prof. Héctor J. Cruzado, PhD
Graduate School
Polytechnic University of Puerto Rico

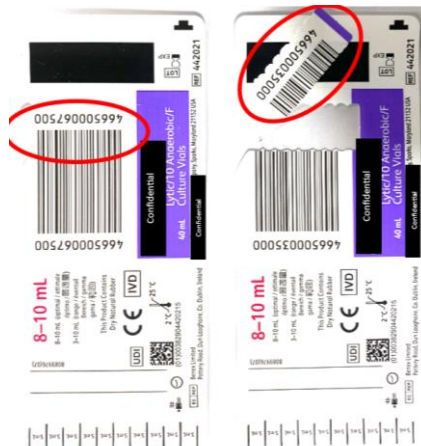
Figure 1
Label Pull Tab

demand is among the largest, ranging from 7 to 10 million units. Non-conforming label has reached losses of \$150,000 from January to February 2023. A non-conforming label is considered one that does not meet the client's quality standards or specifications. The label produced for this client is used on medical containers/serums. What makes it special is that it contains a pull tab, a portion of the label that comes off which contains critical information. Figure 1 shows the construction of label.

The label's pull tab is detaching constantly in the facility and reaching the client when not detected in the inspection process. The objective of this project is to minimize or eliminate this occurrence which will lead to cost prevention and maximize maintenance works to minimize downtime and improve output of good labels.

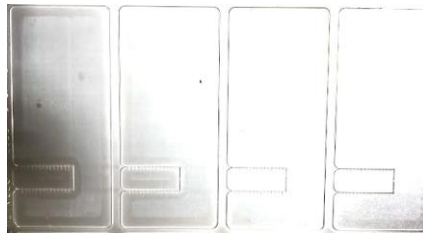
Figure 2
Flexible Die

The current process was visited and evaluated for data gathering. The first step was determining the totals losses year to date and production output. This was already done by QA and was the reason the project was begun. Losses came to a total of \$150,000 with a production output range of 7-10 million units (labels) per month. The first area visited was the flexible die station on the press. The flexible die is the component that performs the perforation/cut of the label. Please refer to Figures 2 and 3 to observe a flexible die sheet and station.

Since this piece is changed by operators from time to time, it was found there was not an initial guideline or study of the run life of the flexible dies. These were changed by operator's judgement and SOP mentioned it must be changed every 4 months. This period was assigned aleatory with no data gathering study. A logbook was located near the press where operators recorded each time they changed the flexible die. The logbook was utilized to calculate the data discussed in the analyze phase. Autonomous maintenance procedures were not in place in the operator's work instructions (WI) and preventive maintenance (PM) procedures were signed and "performed" by mechanics but not supervised. This was seen in the work order logbook presenting that specific equipment was the second highest machine with 20 tickets in the period of January to February for the flexo department. The first on the list is an old machine with plans of being decommissioned.
