Vent to Roof Rainwater Occlusion and Management

Roxana Ramirez Iglesias
Engineering Management
Dr. Hector J. Cruzado
Department of Civil & Environmental Engineering and Land Surveying
Polytechnic University of Puerto Rico

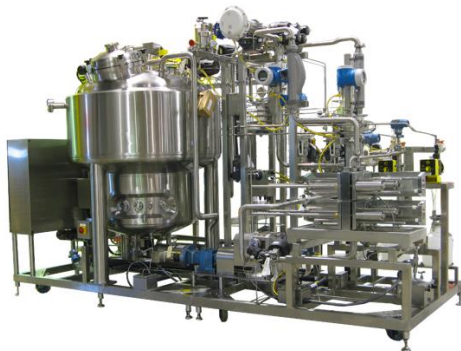
Figure 1
Purification skid [1]

As part of a vaccine manufacturing facility start-up, different processing tanks/skids were designed and installed, as shown in Figure 1. Two of the processing suites in the building are a purification room and a solvent charging room. During processing, these tanks contain hazardous chemicals like ethanol and isopropyl alcohol. In case of a safety incident, it is preferable for the safety relief devices on these skids to vent to the roof instead of venting inside the room, like in other processing suites.
