# Hurricane Resistant Curtain Wall

Claudia Pérez Muñoz  
Christian Villalta, Ph.D.

Civil & Environmental Engineering and Land Surveying  
Polytechnic University of Puerto Rico

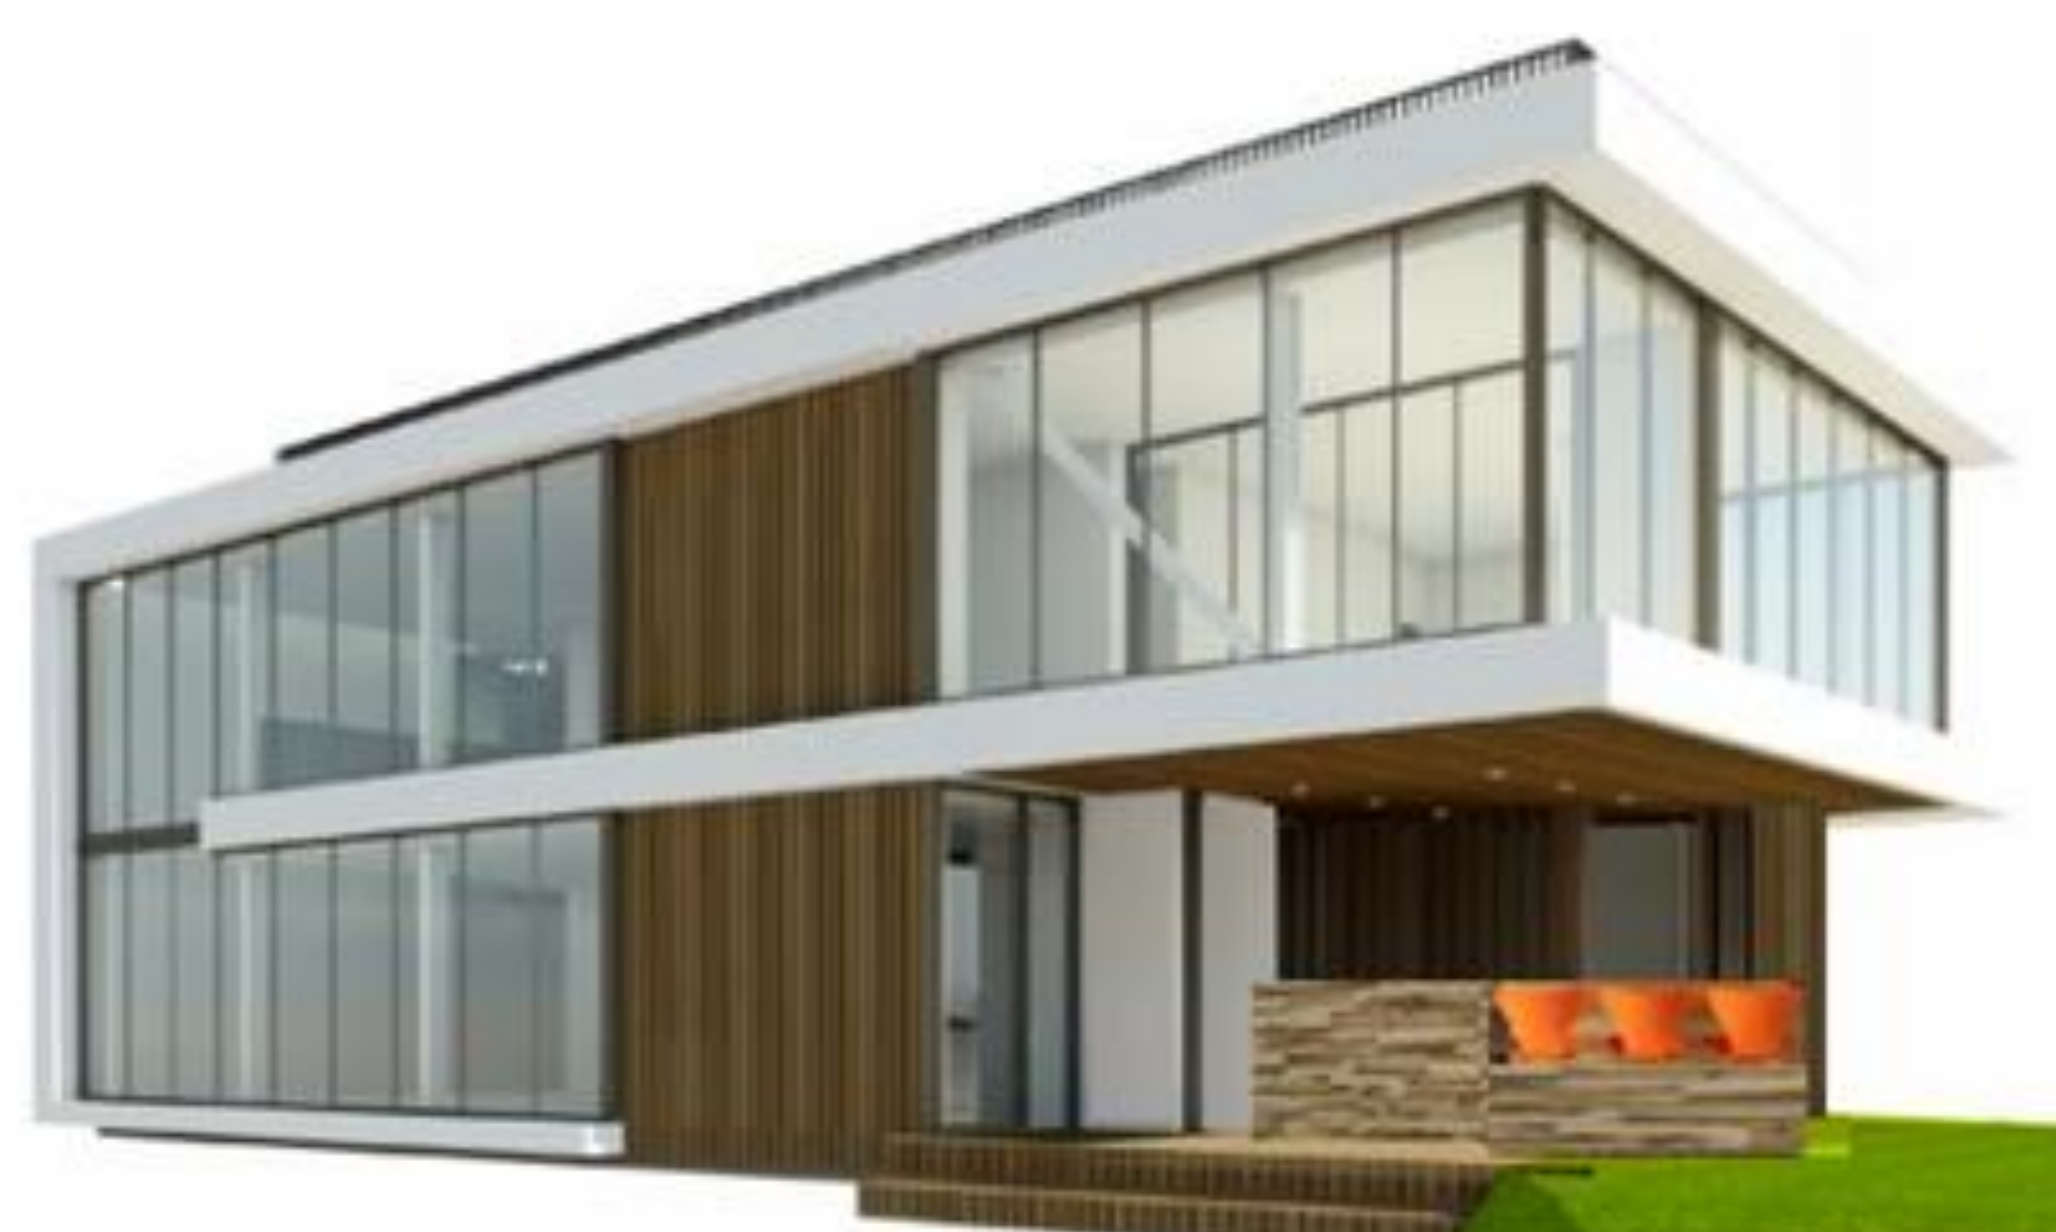
Figure No. 1  
Fitness Center  
Facilities

This project incorporates as principal methodology a literature review based on a case study of a fitness center constructed in The San Juan Hotel as part of the hotel renovation. This structure is a new three-story building made with concrete foundations, structural steel, and structural purlin. The first and second floor are surrounded with the StormWallXL™ Hurricane-Resistant Curtain Wall, as part of the building envelope. The location of this new facility is in the hotel backyard, in front of the Olympic Pool, approximately 110 ft from Isla Verde beach.

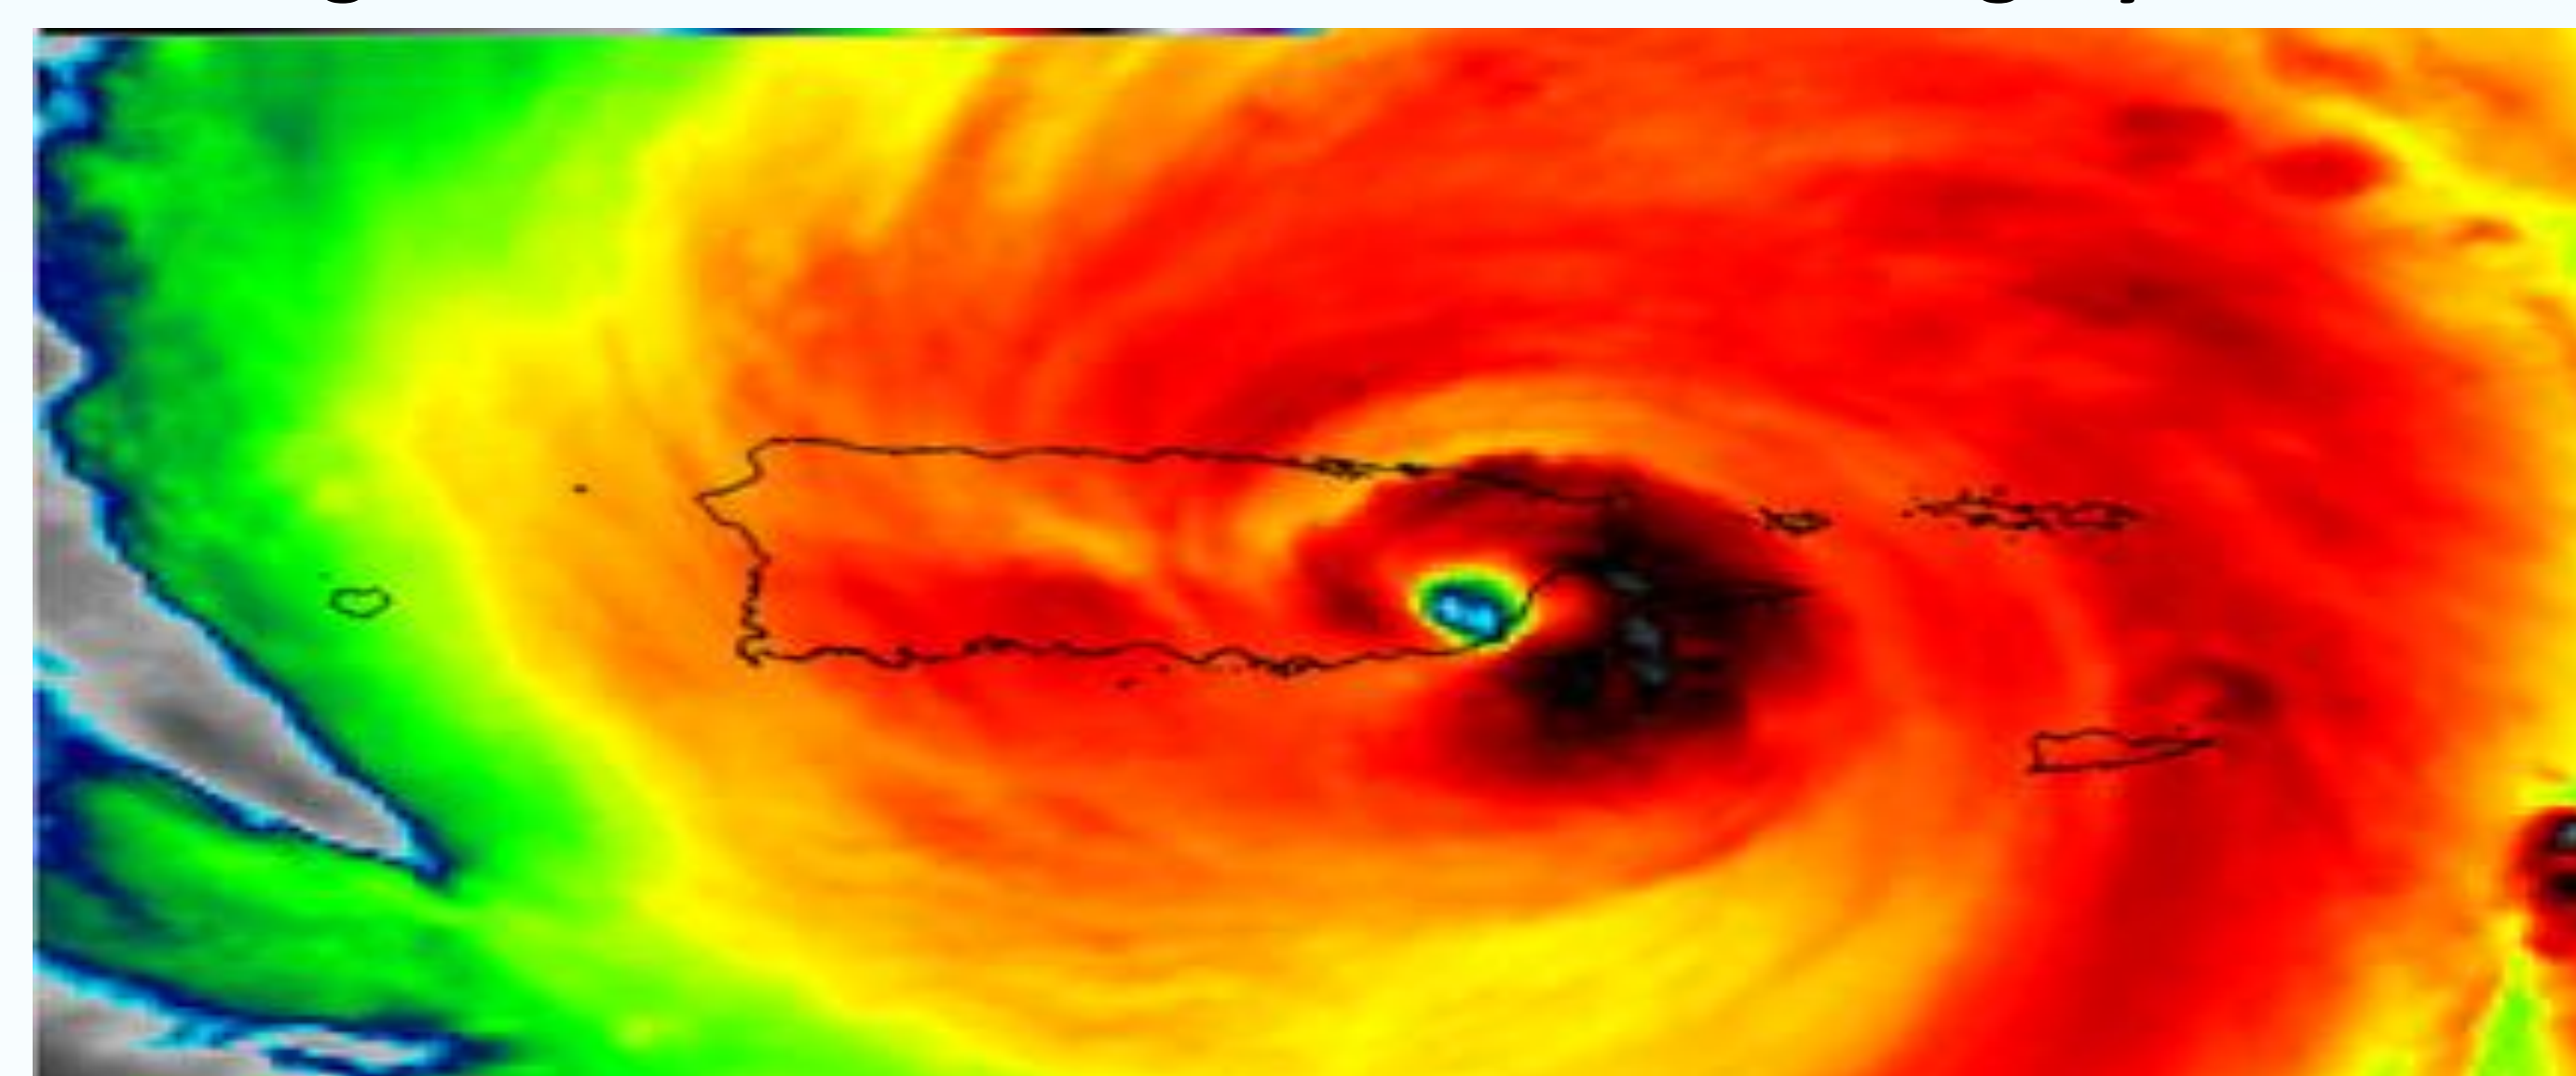
Figure No. 2 Hurricane Maria Satellite Imagery

Hurricane Maria, on Isla Verde Ave. Carolina, produced approximately 25 inches of rainfall, sustained winds of 155 mph and maximum wind gusts registered 175 mph up to 190 mph approximately. The maximum storm surge registered in this area was 2.35 ft above mean sea level. The San Juan buoy number 41053 reported on September 20, 2017 a significant wave height of 20 ft. The combined destructive power of storm surge and wave action from Maria produced extensive damage to buildings, homes, and roads along this avenue.

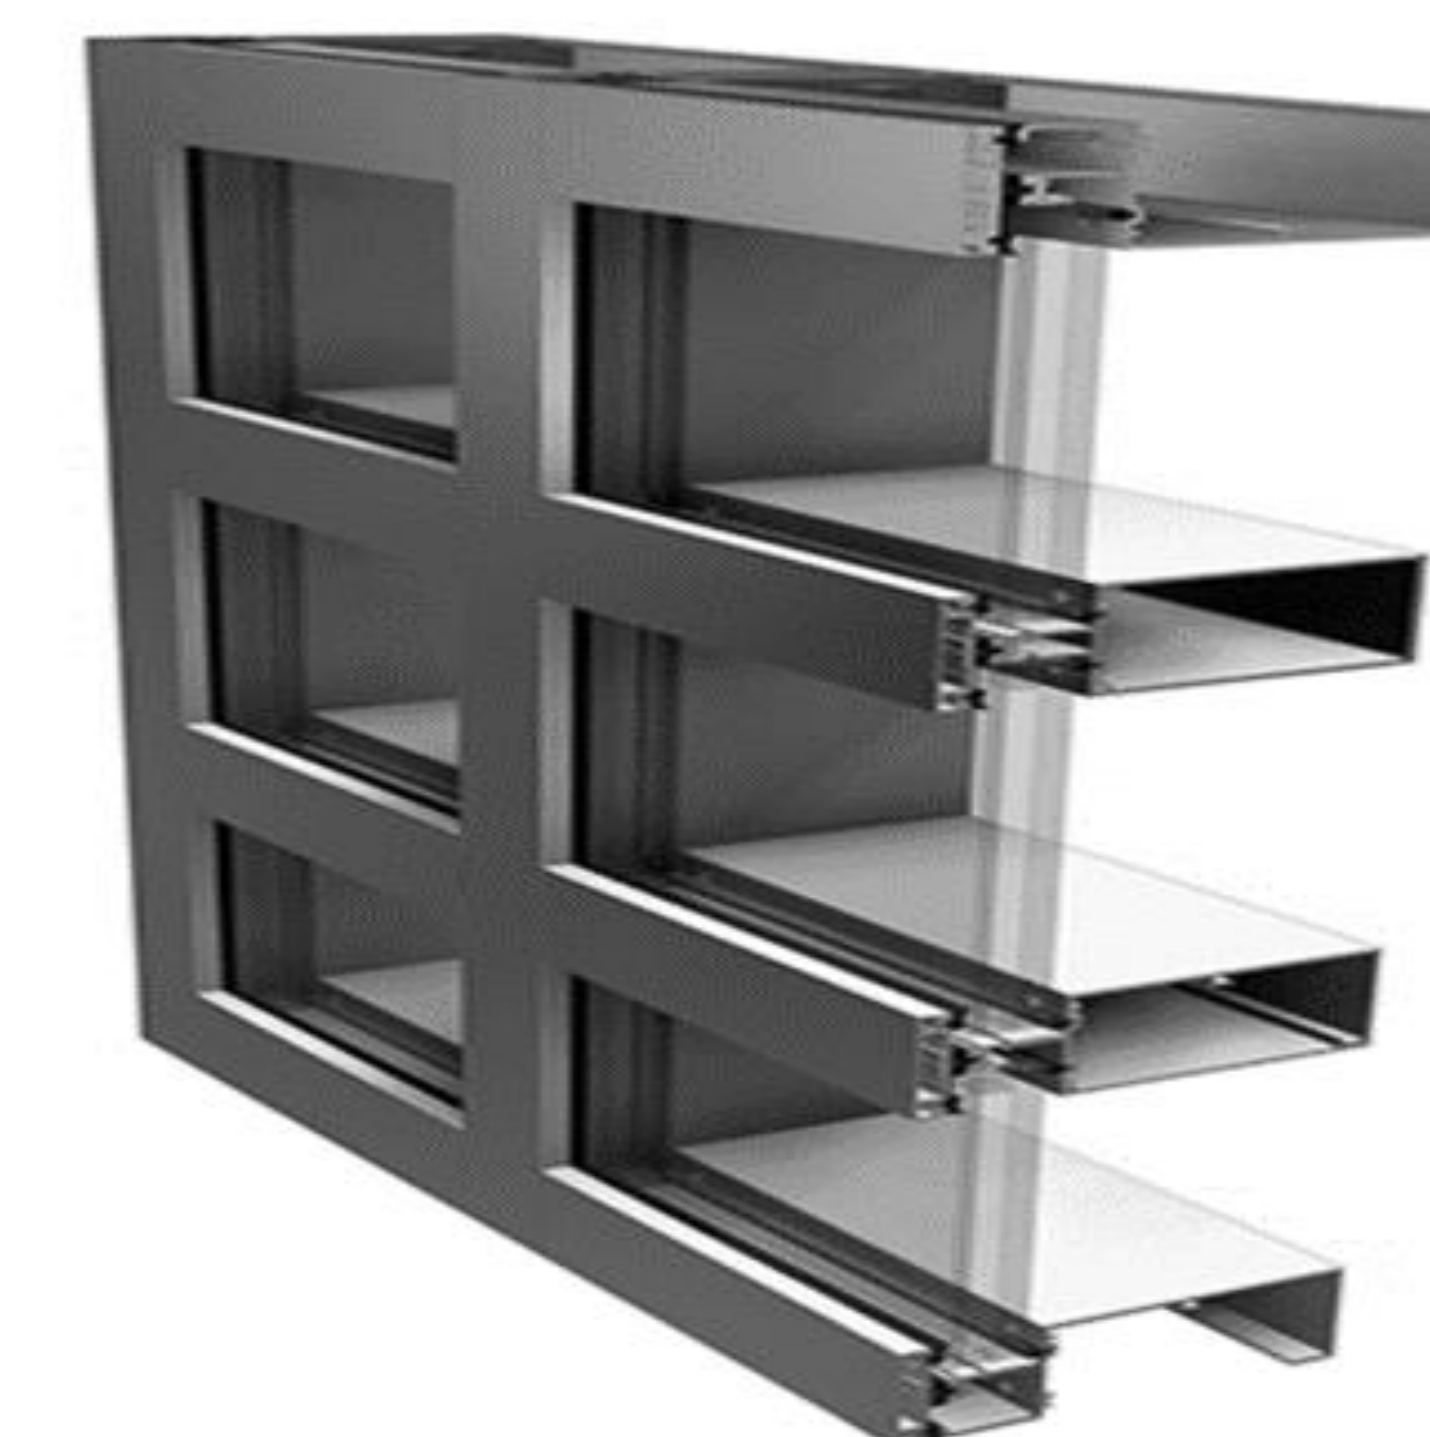
Figure No. 3  
Storm Wall XL System  
Assembly

Hurricane-Resistant Curtain Wall is designed to meet the most demanding performance requirements for areas exposed to hurricane and other severe weather. CR Laurence – U.S. Aluminum has introduced StormWallXL™ Hurricane-Resistant Curtain Wall. The curtain wall is engineered to provide steadfast protection against severe weather while meeting stringent building code requirements. It is NFRC-rated, has Florida Product Approval, Miami-Dade Certified (NOA), and is fully tested to ASTM and TAS Standards. This is an innovative system that meet unique regional requirements, presents a credentialed, impact-resistant glazing solution for coastal and vulnerable communities that completes a comprehensive product offering.

The San Juan Hotel remained closed a year and a half to complete all the repairs needed due to the damages caused by Hurricane Maria, after a major renovation investment. The fitness center was part of this renovation and was the only facility that was not affected by the disaster. This building resisted the hurricane's fury due to StormWallKL installed. It made the structure envelope strong enough to sustain winds beyond the design criteria of 145 mph. The performance obtained from this curtain wall system validated all the specifications and tests results obtained by the manufacturer.
