## ***Scour Evaluation of Bridge 2487 in Cayey, Puerto Rico***

*Alberto L Matta  
Civil Engineering  
Christian Villalta, Ph.D.  
Civil and Environmental Engineering Department  
Polytechnic University of Puerto Rico*

**Abstract** — *Scour at bridges should be monitored constantly using proper procedures in order to secure the safety of the public. According to The US Department of Transportation the most common cause of bridge failures is from floods scouring bed material from around bridge foundations. Bridge 2487 in Cayey, PR was analyzed in order to understand better how scour affects a bridge. Laboratory tests were conducted on bulk samples collected at the bridges general areas and later classified. This and other information gathered along the bridge was used to conduct a hydraulic and scour model to find out the potential for scouring along the bridge. A potential scour depth of 2.91 meters was calculated using the HEC-RAS (Hydrologic Engineering Center-River Analysis System) computer program. With this information proper countermeasures were elected in order to prevent further scouring along the studied area.*

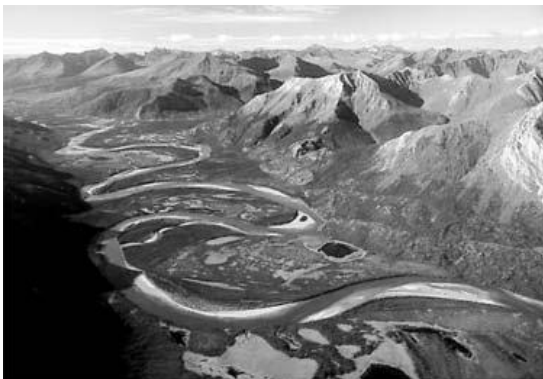
**Figure 1**  
**Meandering River**

Natural rivers are self-formed features whose shapes are the result of erosion, deposition and transport of sediments [3]. The path that a river takes depends mainly on the velocity or discharge of water and the erosion process created by the interaction between the water and the soils found at riverbeds and banks. This interaction along the river causes erosion on the outer banks of a river and deposition at its inner banks. With this action, rivers shape landscape while transporting sediment through the environment (Figure 1)[4].

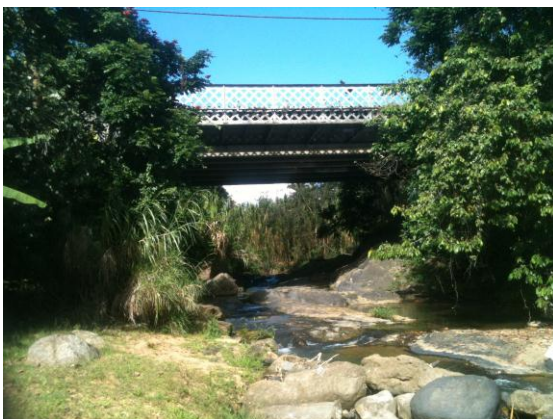
**Figure 7**  
**Bridge # 2487**

The next step was the selection of the specific bridge that would be suitable to study. Different bridges were analyzed and Bridge # 2487 was selected (Figure 7). This bridge was selected after visiting the location and observing that the structure could be susceptible to scour. Important information like channel measurement and flow rate were obtained from Stanley Consultants Scour Evaluation Reports [13]. During the field visit it was observed that severe scour had occurred along the base of the bridge right abutment (Figure 8). Scouring had exposed the abutment foundation. Most of the soil found at the affected areas consisted of fill placed for the construction of the abutment. A sharp constriction of the creek channel was observed due to the downstream presence of the old bridge (this constriction was not accounted for the scour calculations).

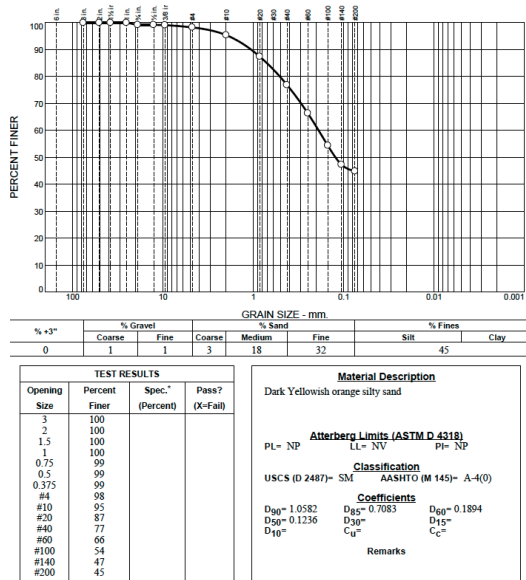
Figure 9  
BS # 1 Grain Size Distribution

- **Bulk Sample #1-** It was gathered just in front of the right abutment. According to ASTM D422 the sample was classified as GM (silty gravel with sand).
- **Bulk Sample #2-** It was gathered just in front of the left abutment. According to ASTM D422 the sample was classified as CL (Sandy clay of low plasticity).

Figures 9 and 10 represent the laboratory test results obtained after sieving and weighting the collected samples. The following figures illustrate the granulometric curves or grain size distribution for each bulk sample.

After analyzing both samples it was decided to calculate the hydraulic model using BS# 1 because it was the most scour susceptible sample do to its higher percentage of granular material (53% sand).
