Haemonetics Puerto Rico, a medical devices manufacturing site of blood filters, identified that approximately the 11% of the monthly plan of the manufacturing line #3 cannot be made using the available manufacturing time of the line. The objective of this project is to increase in at least 20% the manufacturing line output by identifying and eliminating the wastes in the manufacturing process of line #3. To achieve this goal, the DMAIC methodology will be used to identify the possible root causes and improve them adequately. After following DMAIC methodology and provide improvements, the line output increased in a 22%, which means that the line will only require 37 shifts per month to complete the manufacturing plan from the 40 shifts available. With this improvement, line #3 now can comply with the monthly plan.

Line #3 of Haemonetics Puerto Rico is producing 11% less good blood filters than was required. According to this, the research tries to increase the output of the line per shift, to comply with the monthly manufacturing plan for the line, without incurring in extra labor hours.

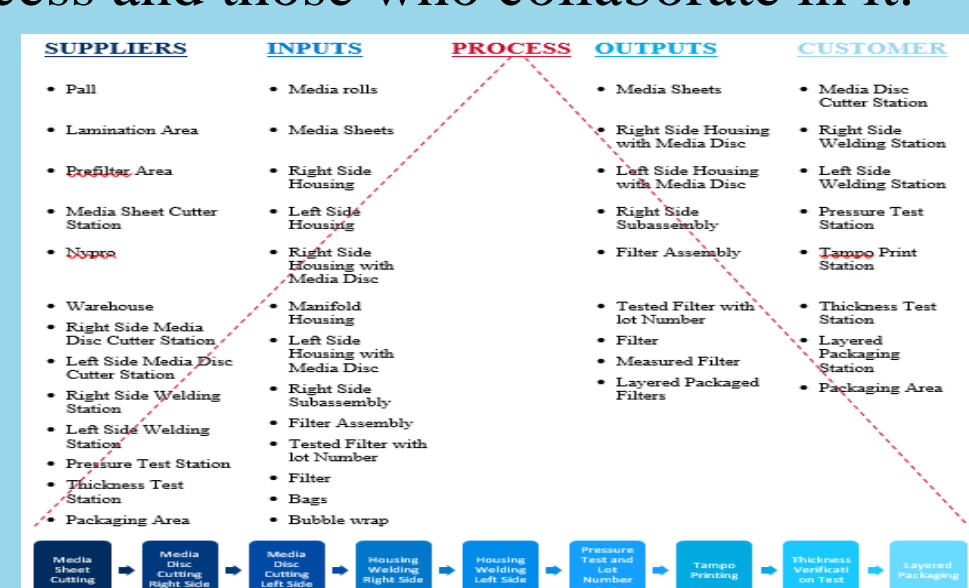
Figure 2
SIPOC Diagram

The SIPOC helps to understand the process by identifying the suppliers, customers, inputs, and outputs from the process, with the purpose of better visualize the process and those who collaborate in it.

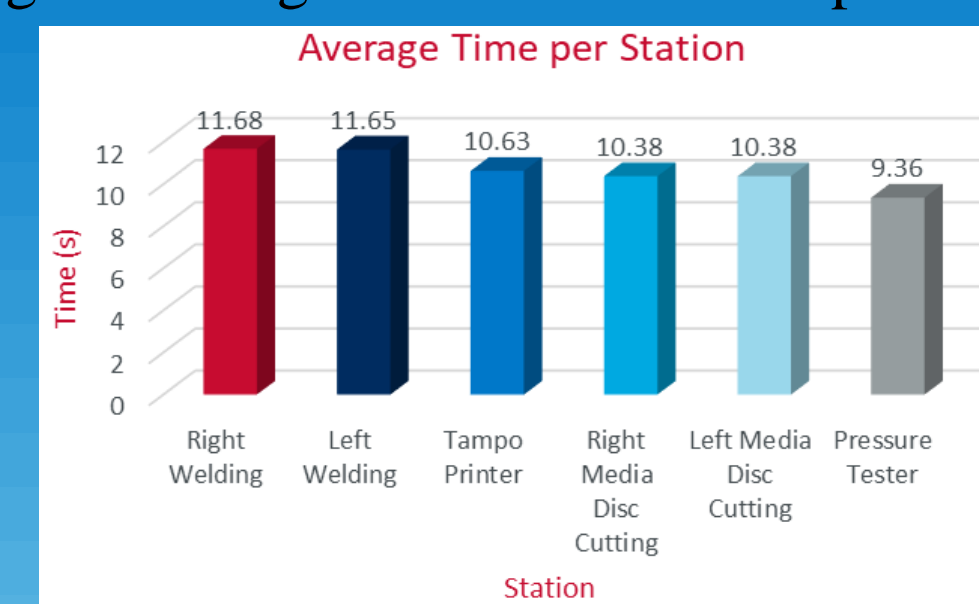
Figure 3
Average Time per Station Graph

The time per station was collected and was concluded that the bottleneck of the process is the right welding with 11.68 seconds per filter.

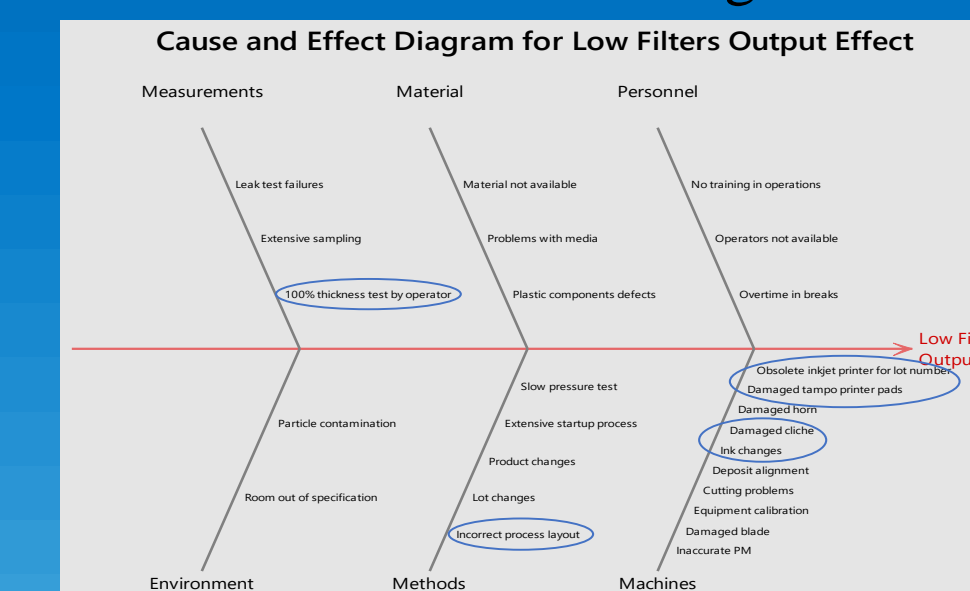
Figure 11
Cause and Effect Diagram

Twenty-six causes were identified for related to the low filters output effect where only six were taken to focus the investigation.

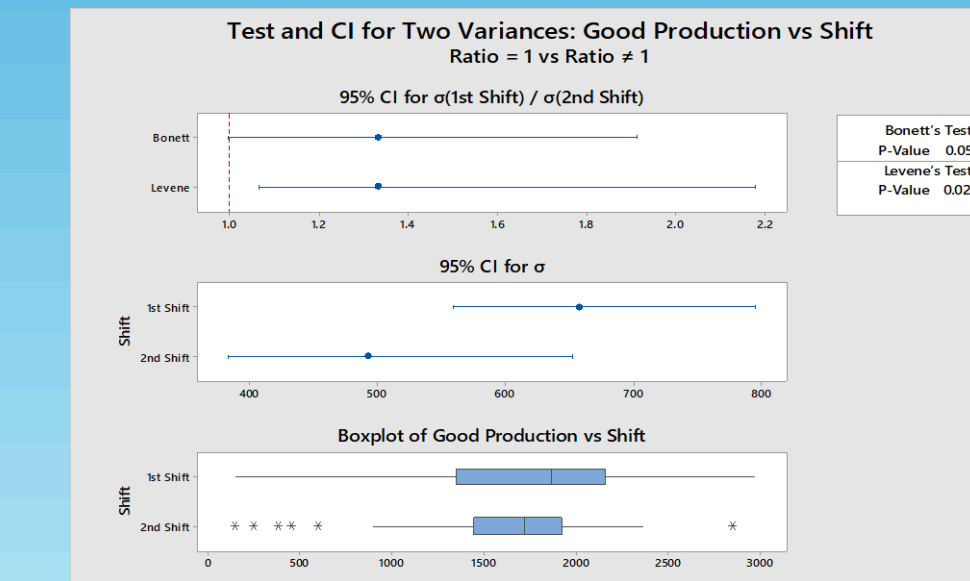
Figure 12

The P-Values obtained was 0.051 with a confidence level of 95%. Since the P-Value is greater than 0.05, the null hypothesis is accepted. Therefore, there is a relationship between the variances of the first shift and the second shift.

Hypothesis Test of Packaged Filters between First and Second Shifts

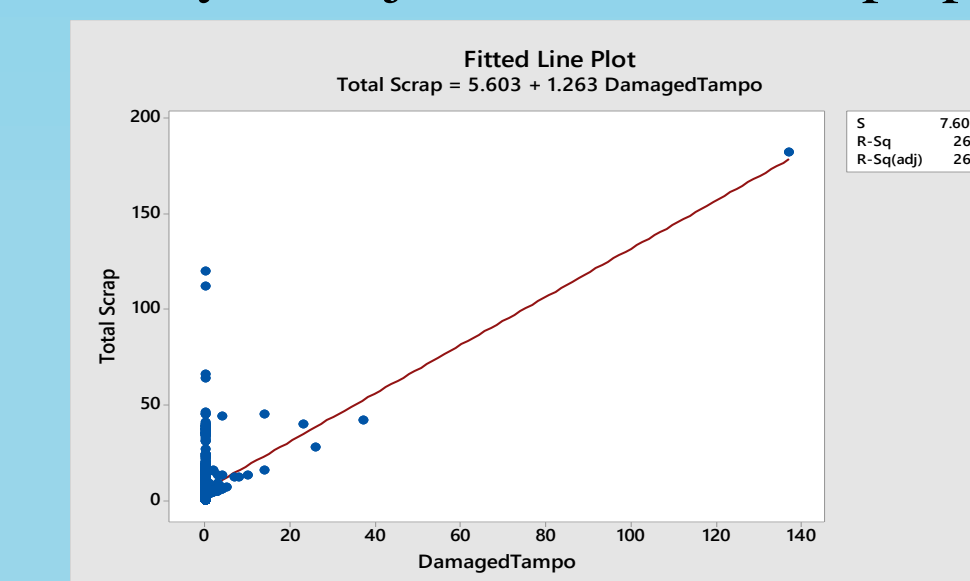
Figure 14

The P-Value obtained was less than α of 0.05. This indicates that there is a statistically significant effect on the total number of filters discarded due to the rejections obtained at the tampo printing station. Therefore, if filters are discarded due to damaged tampo print, the total scrapped filters quantity is affected significantly. According to the R-sq obtained, 26.21% of the variation is represented by the rejections of the tampo printing station.

Fitted Line Plot for Regression Analysis

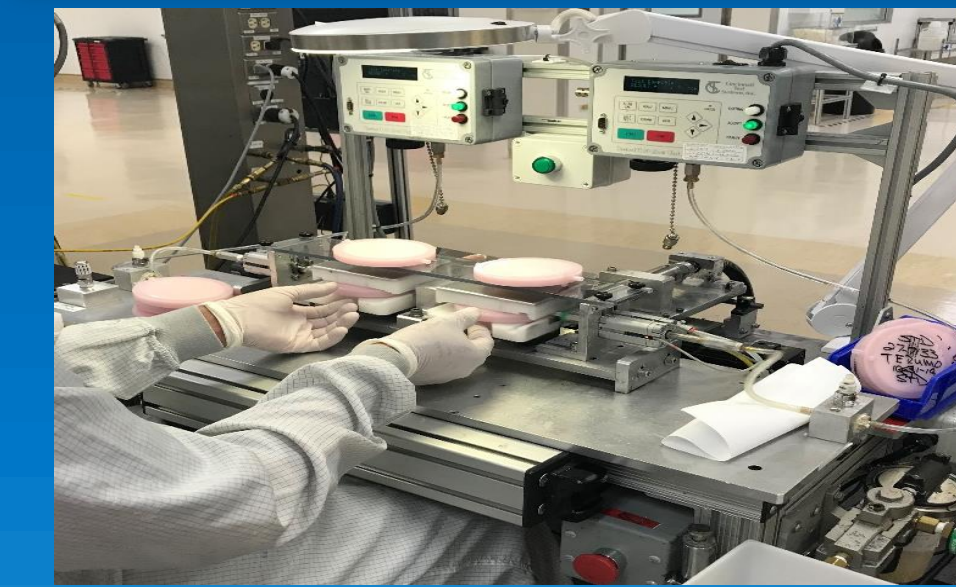
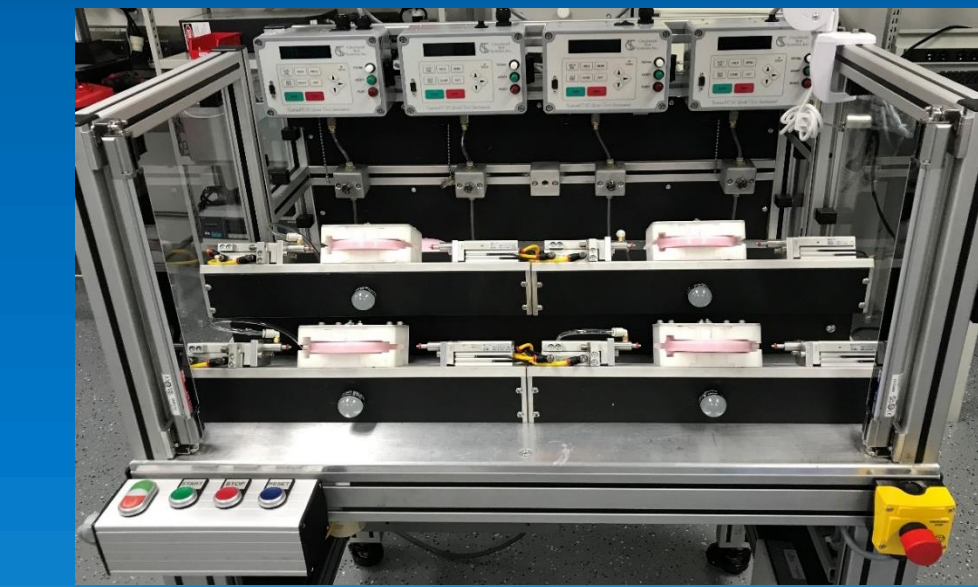
- Thickness Test Station:** Incorporate the test as part of the pressure test by designing nests that comply with the maximum height accepted for the filter thickness.
- Tampo Print Station:** Eliminate tampo print process and implement etched process to the plastic components at supplier level.
- Lot Number Printing Station:** Replace the current lot number inkjet printer by an automatic lot number printing station with a laser printer and eliminate the lot number defects.
- Pressure Test Station:** Replace the current pressure test station by an automatic pressure test station with capacity of four filters instead of two.

Current Pressure Test Station
Proposed Pressure Test Station
5. New Layout: Re-layout of line #3 that includes the elimination of the conveyor between right and left welding stations, the tampo print station, the current inkjet printer, the current pressure tester and the current thickness verification station. In addition, includes the introduction of the new lot number printing station and the new pressure and filter thickness tester and a relocation of each station. As a result the quantity of operator working in the line will be reduced from nine to seven.

- Poke-Yoke:** The nests of the pressure tester were designed as a Poke-Yoke tool. If the filter does not enter in the nest means that the filter is higher than the acceptance of the thickness verification test and filter need to be discarded by the operator. If the filter entered in the nest, the filter is considered as a good unit for thickness verification test.
