Assessment of Geomorphic Characteristics and Analysis at the Existing Bridge Site in Puerto Rico

Emanuel Moreno Isaac

Master of Engineering in Civil Engineering

Polytechnic University of Puerto Rico

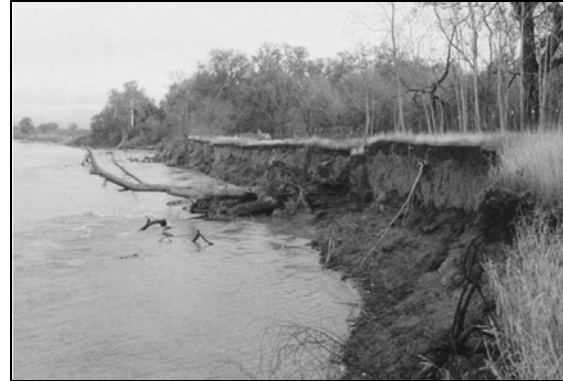
Figure 3
Active Bank Erosion Illustrated by Vertical Cut Banks

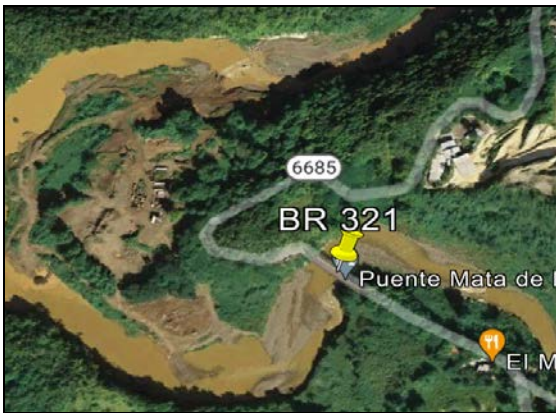
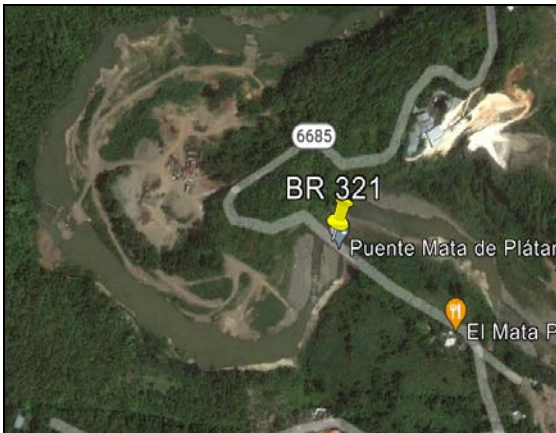
Figure 6
Google Earth Image 2006 Lateral Movement

Figure 7
Google Earth Image 2009 Lateral Movement

Figures 6 & 7, which were obtained by satellite image google earth, illustrate, and bridge with a

three-year difference, and it is possible to observe that lateral movement occurred during that time. Observing the image, a lateral movement on the river was shown which indicates that a possibility of lateral instability occurred at that time.

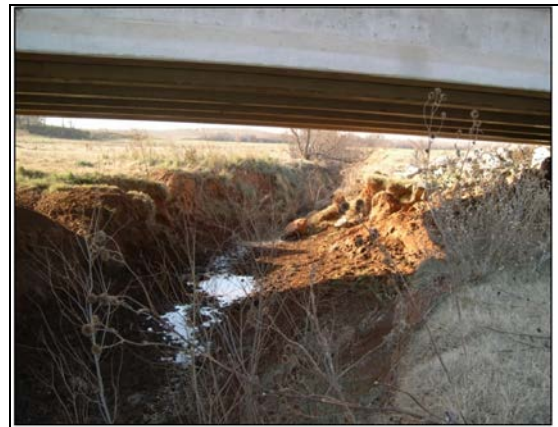
Figure 8
Poor Rating Classification Channel [9]

The stability indicators, descriptions, and ratings that were used to determine the stability of a channel are briefly described as shown. The classification determining the stability indicator gives a score on each category that is labeled as excellent (1-3), good (4-6), fair (7-9), and poor (10-12). After the evaluation of the 13 parameters, a score is determined, and a classification is assigned.

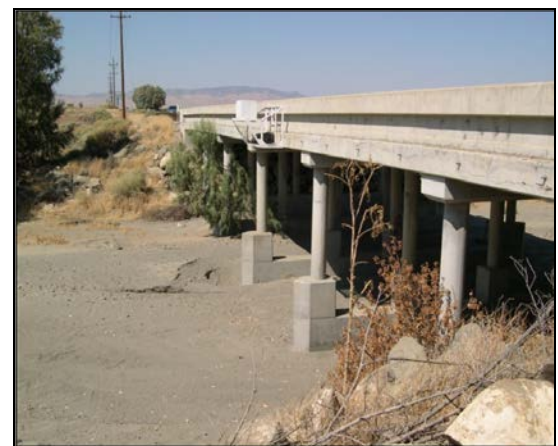
Figure 9
Fair Rating Classification Channel [9]

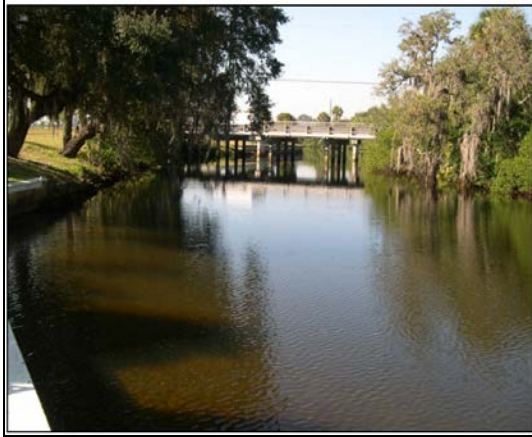
Figure 10
Good Rating Classification Channel [9]

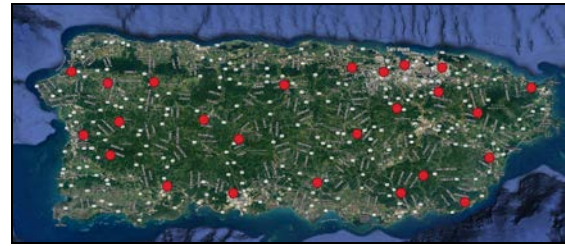
Figure 11
Bridges Location in Puerto Rico
Geomorphologic Analysis

A geomorphologic study was conducted for 26 bridges that were previously selected that were affected by scour. The geomorphologic study performed evaluated the bridges considering 11 factors of stream stability that were used as a starting point for the analysis. All the bridges were selected because, for the purpose of the analysis, it is important to consider all possibilities on the

evaluation as location, meandering of the river, sinuosity, type of material on the riverbed, and slope among other important factors.

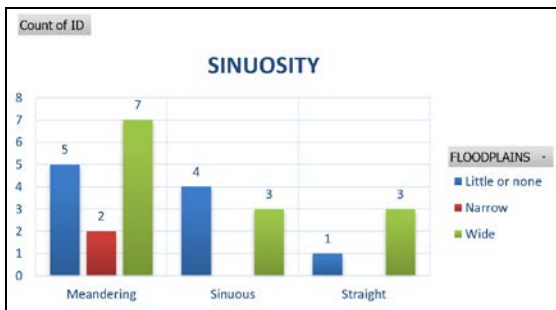
Figure 15
Sinuosity of Stream

Sinuosity is the ratio of the length of a stream reach measured along the centerline to the length that is measured along the valley [10]. On the bridges evaluated only 4 out of the 26 were straight. It is possible to conclude meandering and sinuous streams are more likely to show lateral movement over time due to the geomorphology of the river.

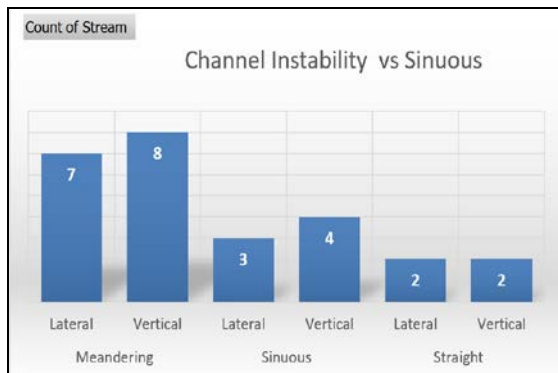
Figure 17
Channel Instability vs. Sinuous Result

In Figure 17, it is possible to identify that 15 of the stream channels analyzed were classified as meandering, and it is adequate to see that a lower number of streams were identified under the straight classification parameter.
