Renewable Energy in Historic Buildings; The Capitol of Puerto Rico and its Annexes

*Eng. Alex E. Martínez
Project Manager PR Capitol Superintendence
Master in Engineering Management
Dr. Hector Cruzado, PhD, PE
Department of Civil and Environmental Engineering
Polytechnic University of Puerto Rico*

Abstract — *The Puerto Rico State Capitol Superintendence (CS) is aligned with the new energy management challenges that the world is facing in order to reduce the energy consumption and CO2 emissions levels. A payback period of a 5 year minimum is required. The improvements options should be focused on the reduction of energy consumption and greenhouse emissions by the integration of new energy efficient technologies, including Renewable Solar Energy, and Feedback of the existing systems. The CS conducted an energy audit Level II ASHRAE (American Society of Heating, Refrigeration and Air Conditioning Engineers) at the Capitolio facilities which consisted on the evaluation of all installed systems that make use of available energy sources. The main objective of the energy audit is the identification of new improvement opportunities that can be deployed within the facilities by making us

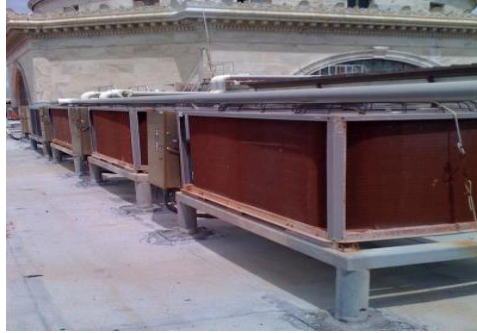
Some chillers and air conditioning units are located at the roof of the building (as shown in Picture 2), but they are not visible from the street level.

Picture 2
Existing A/C units at the roof.

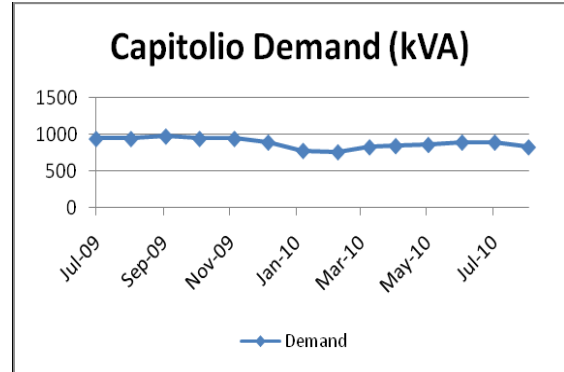
After the analysis of the data, a lighting retrofit initiative should be deployed or implemented. But, a combination of lighting with air conditioning (A/C) units’ retrofits with automatic A/C controls will provide similar benefits. After an estimate the capital investment would be from \$600,000.00. Graph 1 shows the electrical demand monitoring of the Main Building (Capitol) facilities from June 2009 to August 2010.

Graph 1
Capitol demand in KVA

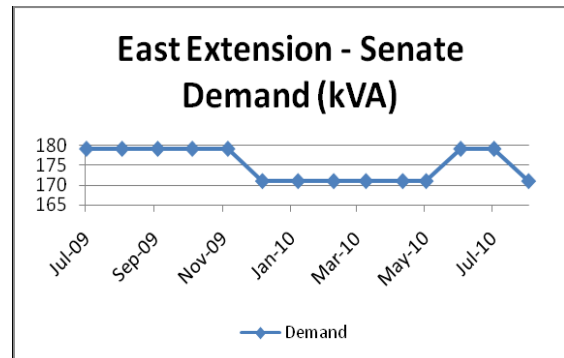
Graph 2 shows the electrical demand monitoring of the East Extension (Senate) facilities from June 2009 to August 2010. As it is observed, the demand was very steady from June 2009 up to November 2009. Then, it decreased down to 171kVA from November 2009 to May 2010. The average demand for the period of time under analysis is approximately 175kVA.

Graph 2
Senate Demand in Kva

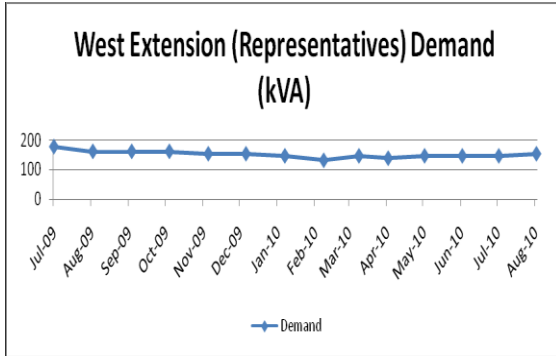
Graph 3 was developed for the West Extension (Representatives) facilities. The average demand for the period of time under analysis is approximately 153kVA (monthly).

Graph 3
House demand in Kva

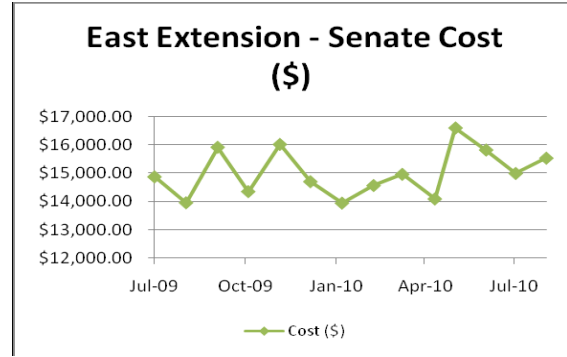
Graph 5
Senate Annex average energy cost

Graphs 4 to 6 show the energy costs tracking for each one of the facilities under analysis. Fluctuations of the costs are associated to fuel adjustment and energy consumption levels. These representations will be essential for comparison basis when the improvement alternatives are selected and implemented because the reduction of energy consumption will be traceable.

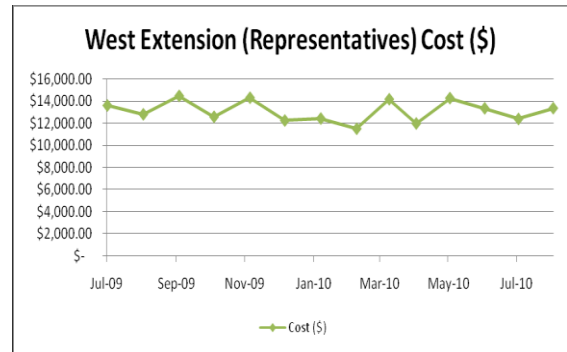
Graph 6
House Annex average energy cost

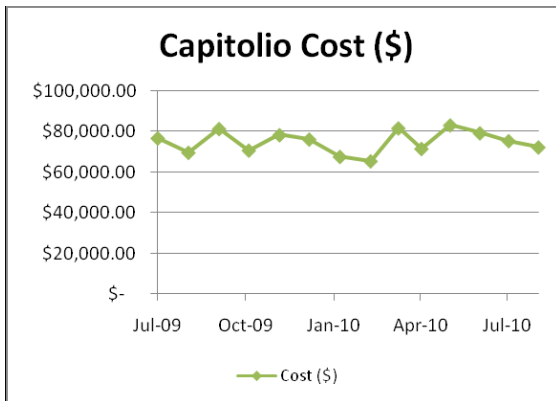
Graph 4
Capitol average energy cost

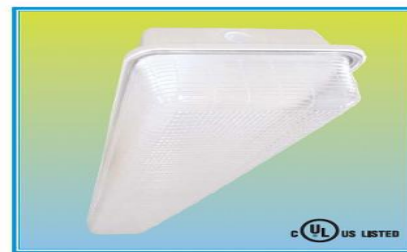
Another fixture that will be integrated is the VT1F32 (shown in Figure 2), which replaces the 70W ceiling mounted fixtures. This retrofit option makes use of a high output electronic ballast, reflector (95% polished) and T8 F32 tube. It reduces the energy consumption by up to fifty percent (50%).

Figure 2
VT1F32 high efficiency lighting fixture

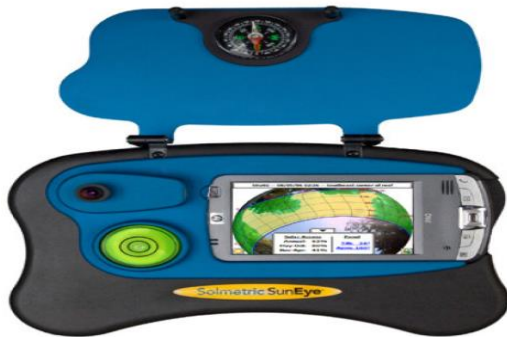
The first steps in a feasibility study for a photovoltaic system is the shading analysis.. The use of a Solmetric Suneye (shown in Figure 5) is recommended to view the solar window for the probable location of the pv array.

Figure 5
Solmetric SunEye equipment for shading analysis
