Damaged cable solution on F-35 electric motor on Aerospace Industry

Ariel Enrique Santos Sánchez
Master of Engineering Management
Prof. Héctor J. Cruzado
Graduate School
Polytechnic University of Puerto Rico

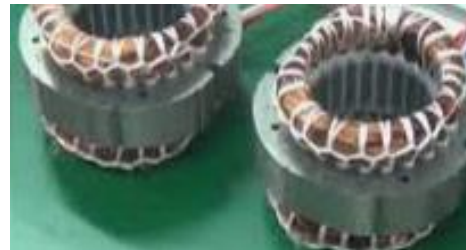
An electric or electromagnetic motor is an electrical machine that transforms electrical energy into mechanical energy. It takes advantage of the fact that when a conductor through which an electric current circulates is within the action of a magnetic field, it tends to move perpendicularly to the lines of action of said magnetic field.

Figure 1
Example of electromagnetic motors

The objective of this project is that these units Figure 1 are manufactured with the highest possible quality, attacking the major defect of this engine, which are the broken wires during manufacturing. To accomplish the objective, the DMAIC (Define, Measure, Analyze, Improve, Control) methodology was applied.

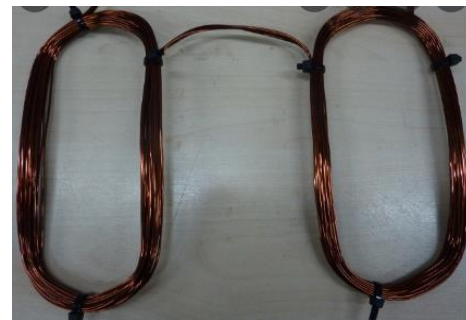
The first operation or step to start manufacturing a motor is copper group as shown on figure 2. These will be fed into the core of the unit as shown on figure 3.

Figure 2
Example of electromagnetic coils

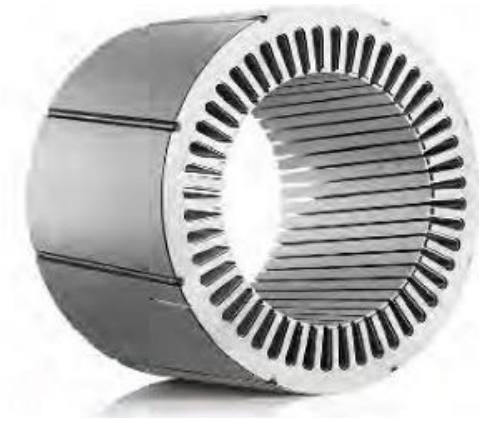
Figure 3
Example of core

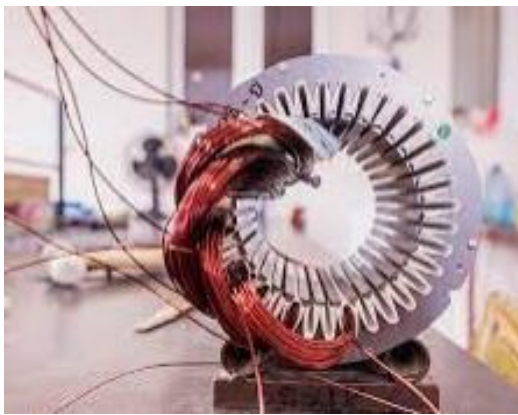
An employee who places the coil groups within the core, following a specific pattern per grouping, called a Winding Diagram. The coil grouping follows the assembly design specifications as shown on figure 4.

Figure 4
Example of insertion process

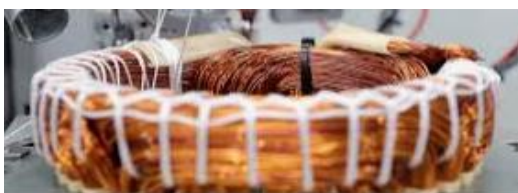
Next comes the forming process. Manufacturing process that configures, welds the wires, and joints, ties the ends of the wires, arranges them in a specific location and performs a forming process to control the dimensions as shown on figure 5.

Figure 5
Example of laced unit

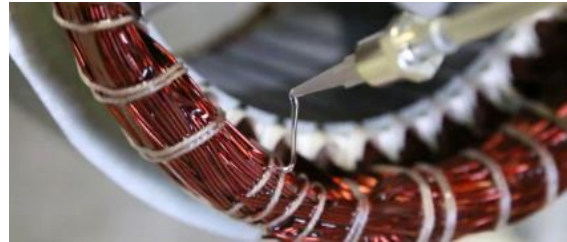
Next come the impregnation operation as shown on figure 6, which is a method or process that infuses a resin to fill the windings of the motor and electric generator components. It is in this process that the wires are broken. When the resin solidifies, it creates sharp edges that break the wires.

Figure 6
Example of impregnation process

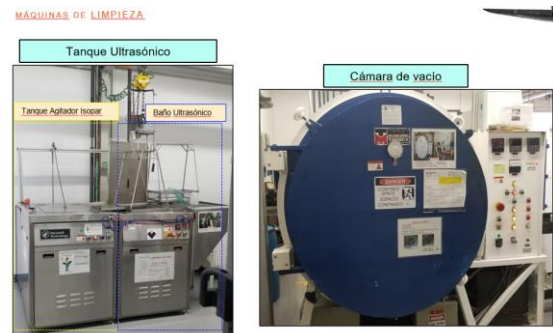
At the end of the impregnation process, the unit is left with residues that need to be removed. The ultrasonic cleaning process is a process that uses a chemical or solvent, in different stages and equipment: agitation, resting and drying, to remove the particulate from the unit after the impregnation operation and in turn, remove any foreign material ("FOD") from the unit as shown on figure 7.

Figure 7
Cleaning machines

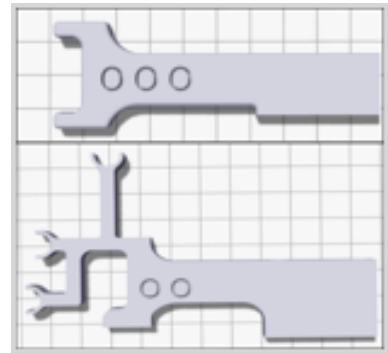
because the root causes that caused the wires to break were addressed. With the retainers shown in Figure 8, the wires could not move, thus helping the handling. With these retainers, space is also made, and the amount of resin build-up is drastically reduced because there is practically nowhere for it to stick to. The Teflon tape serves as a hardened resin protector. If any object touches the wires with the tape installed, it will not have as much chance of breaking them. And finally, the McLube oil, shown in Figure 9, plays a very important role because if resin falls on the oiled area, the resin will slide off and will not have a chance to damage the wires.

Figure 8
Cable retainers

The causes that were attacked to prevent the cables from breaking were to limit the movement of the cables with cable retainers. Another of the solutions was to protect the wires during the process with Teflon tape, and to add a special oil called McLube to prevent the resin from sticking near where it accumulated.

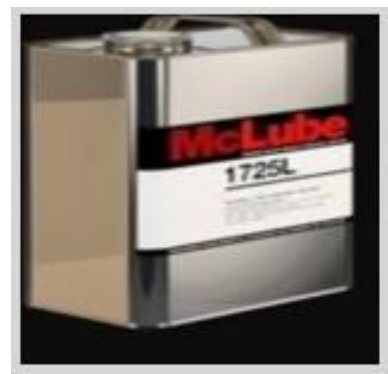
Figure 9
McLube
