Author: Emanuel Moreno Isaac  
 Advisor: Christian A. Villalta Calderón, Ph.D.  
 Master of Engineering in Civil Engineering

The scour on bridges is considered one of the main reasons for bridge failures. Scour is the consequence of the erosion action that is caused by the water flow. In pursuit of a possible direct relation to a water stream behavior a geomorphic analysis was conducted to a total of 26 bridges in Puerto Rico. A geomorphic analysis studies the plan and profile of a stream to understand the stream morphology of the river. The outcome will show if lateral or vertical movement has occurred on the river. After the analysis 88% of the bridges were meandering, 46% were classified as fair, 42% poor classification and only 12% were rated as good. The 46% lateral movement, 54% vertical movement, and none were stable.

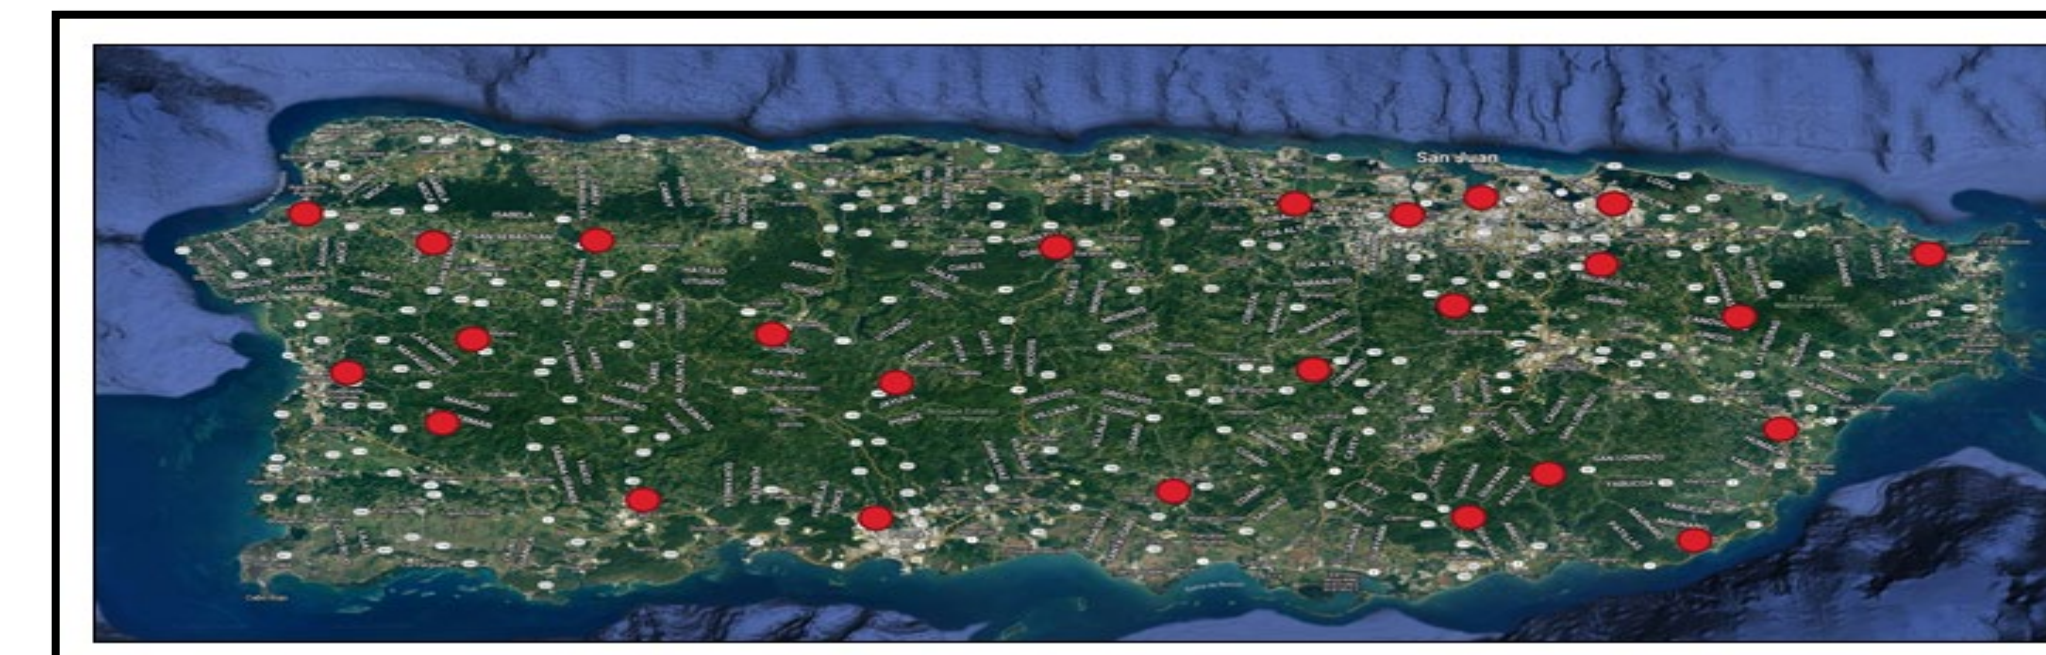
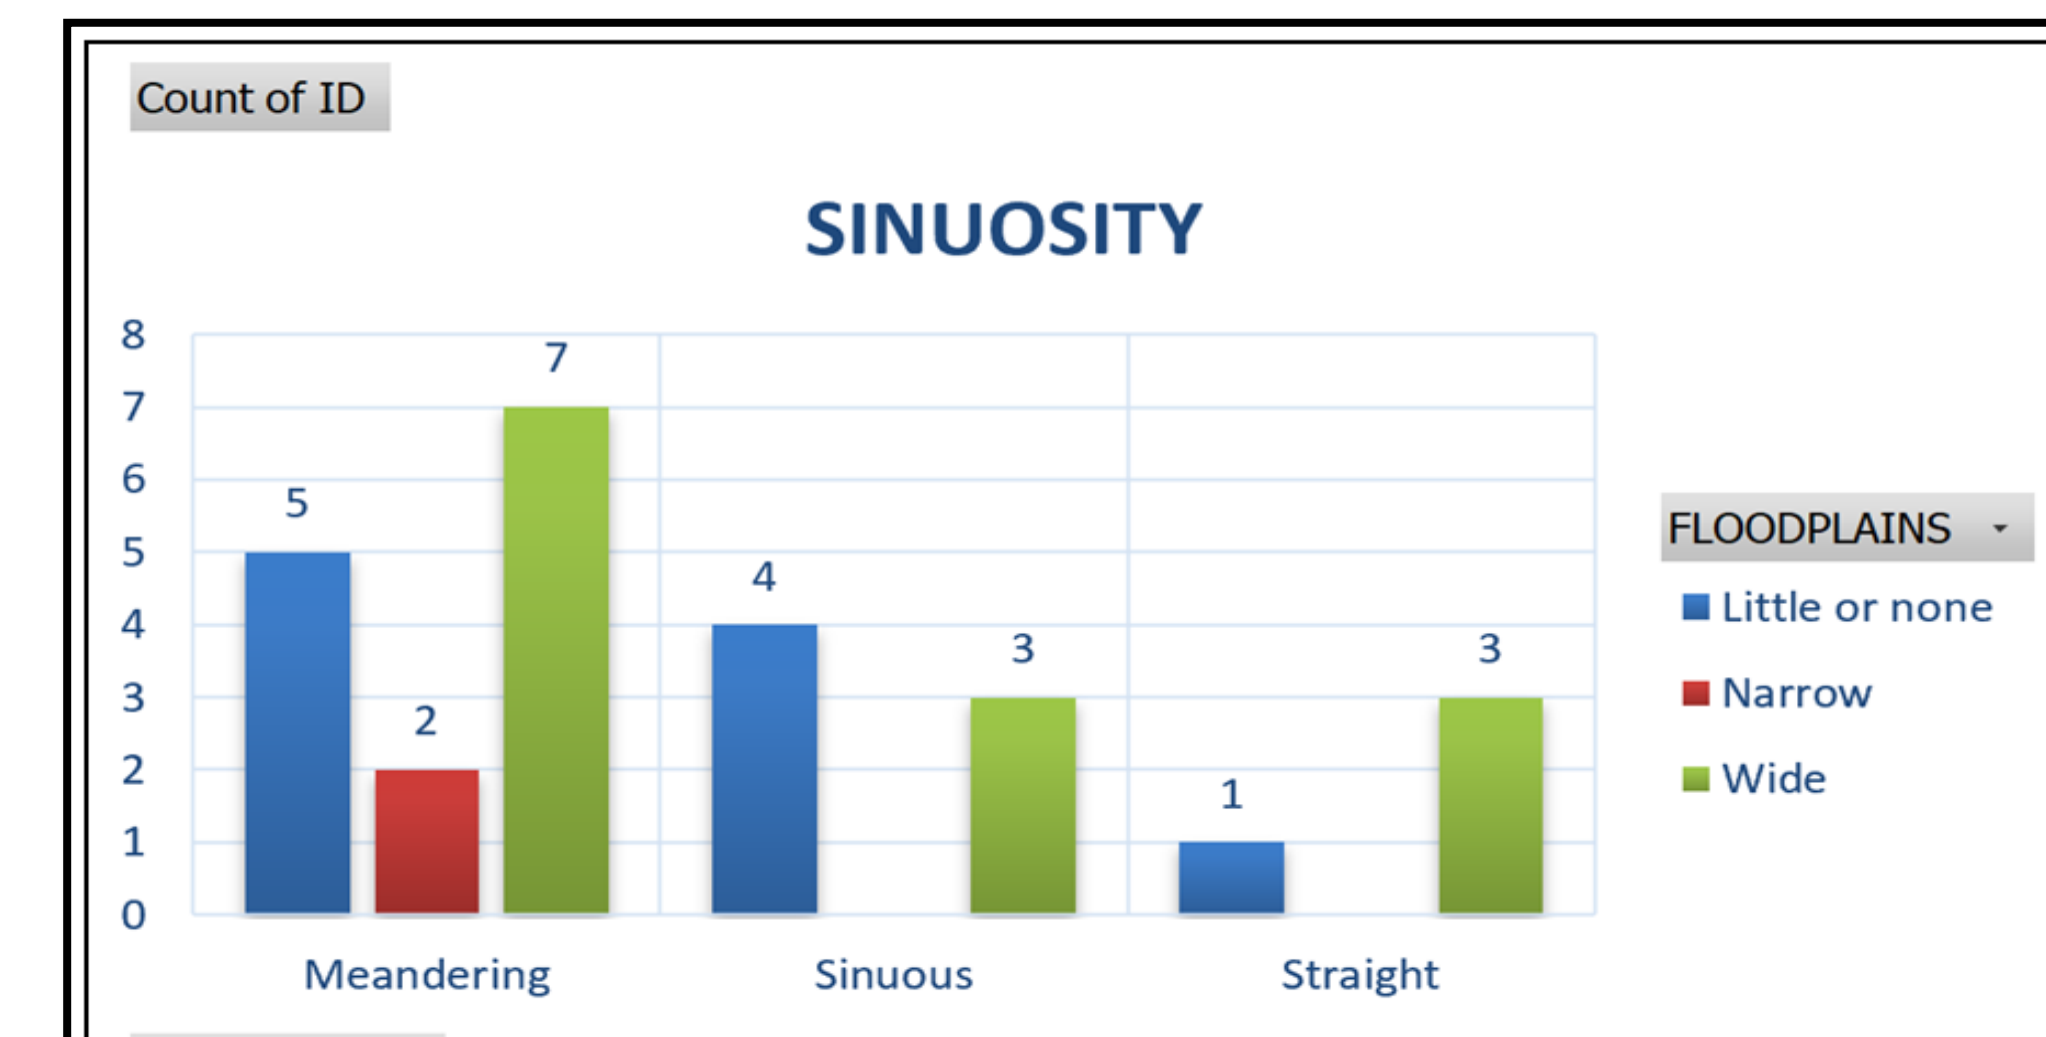
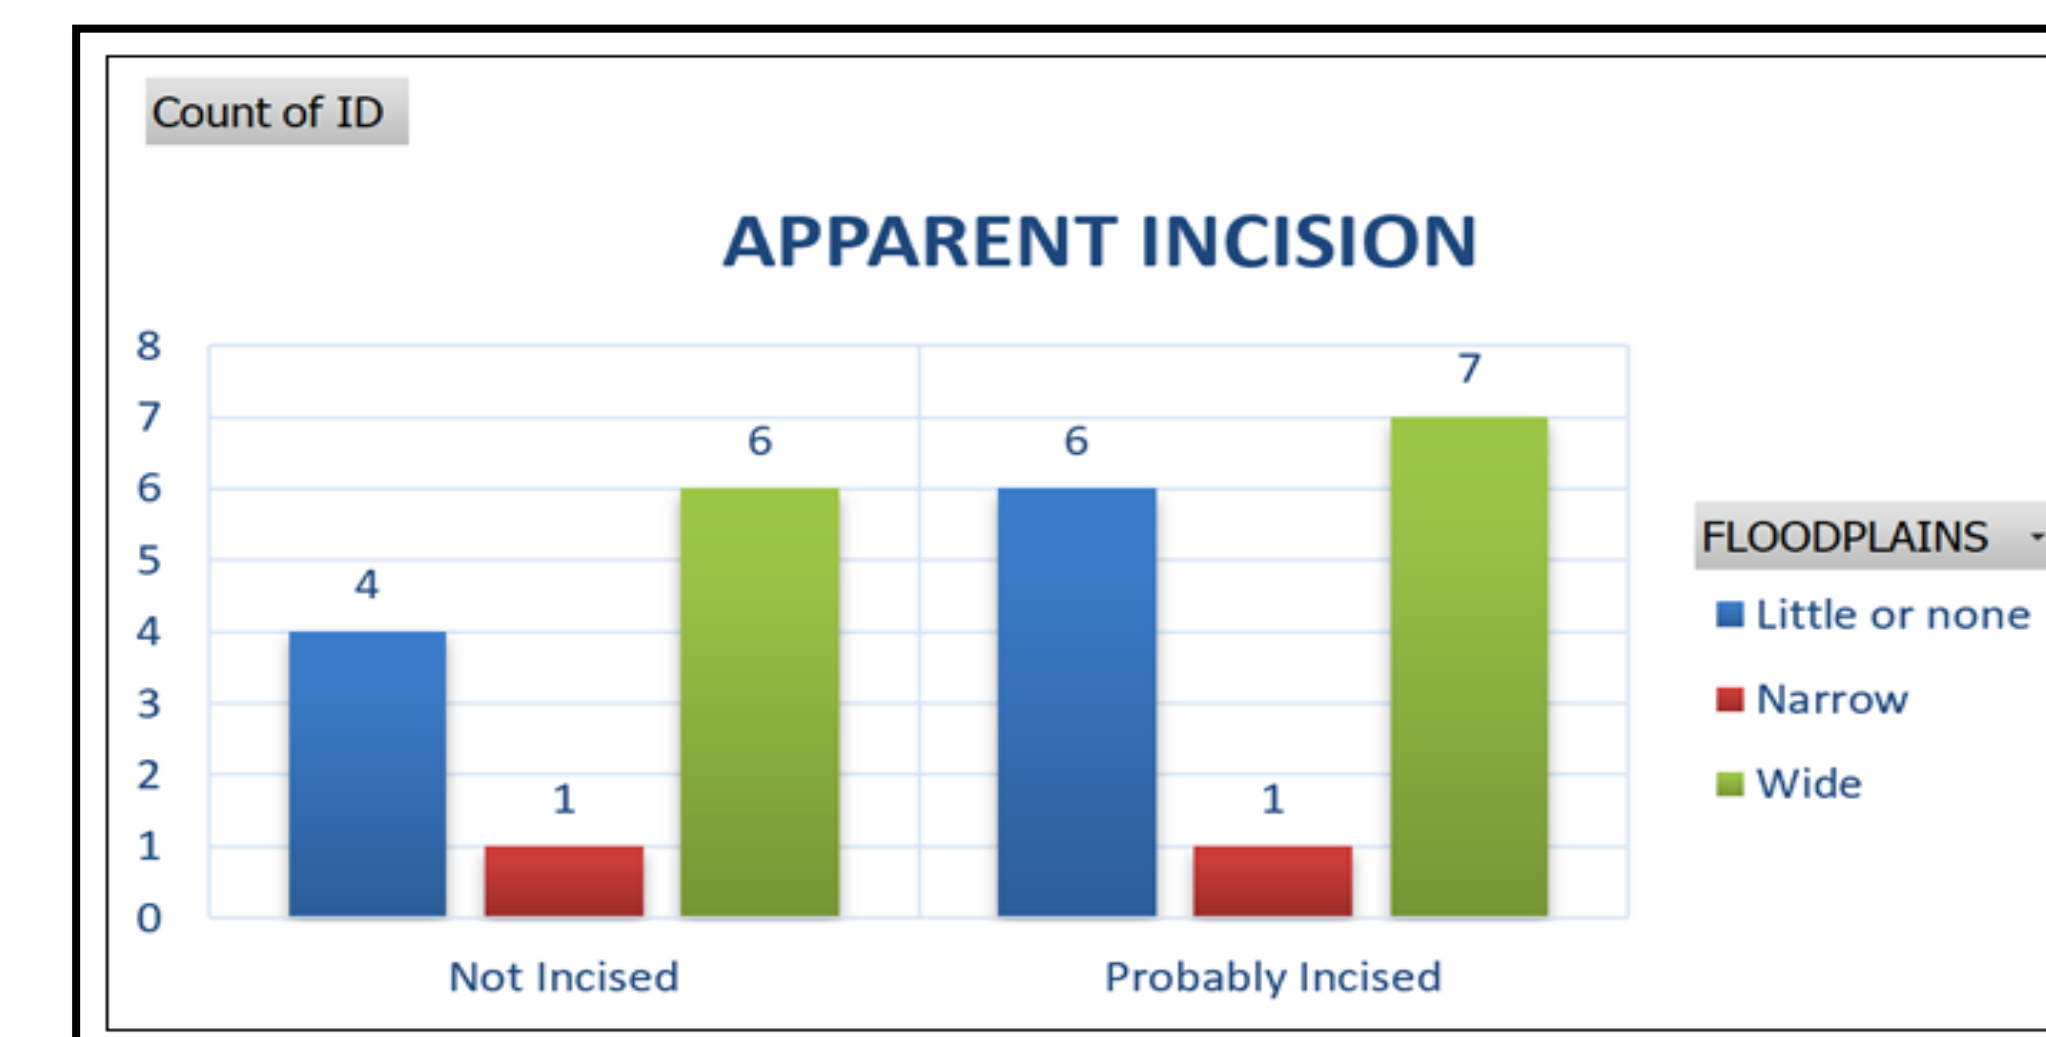
The results obtained on the study showed that all of the bridges had lateral or vertical movement by conducting the geomorphic analysis. None out of the 26 bridges were classified as stable when a lateral or vertical movement analysis was conducted. These findings show a direct relation with the scour that occurred at these locations. The stability analysis, which is the second part of the geomorphic analysis, provides the result of lateral or vertical movement.

Parameter	Num. of Stream
Poor	11
Fair	12
Good	3
Excellent	0

Parameter	Num. of Stream
Lateral	12
Vertical	14
