# Incorrect Band Spacing Cost Reduction

Kara N. Irizarry Otero  
 Advisor: Héctor J. Cruzado, Ph.D. P.E.

Key Terms - 5F CS model, Band Spacing Incorrect, Diagnostic Catheter, Process Improvement

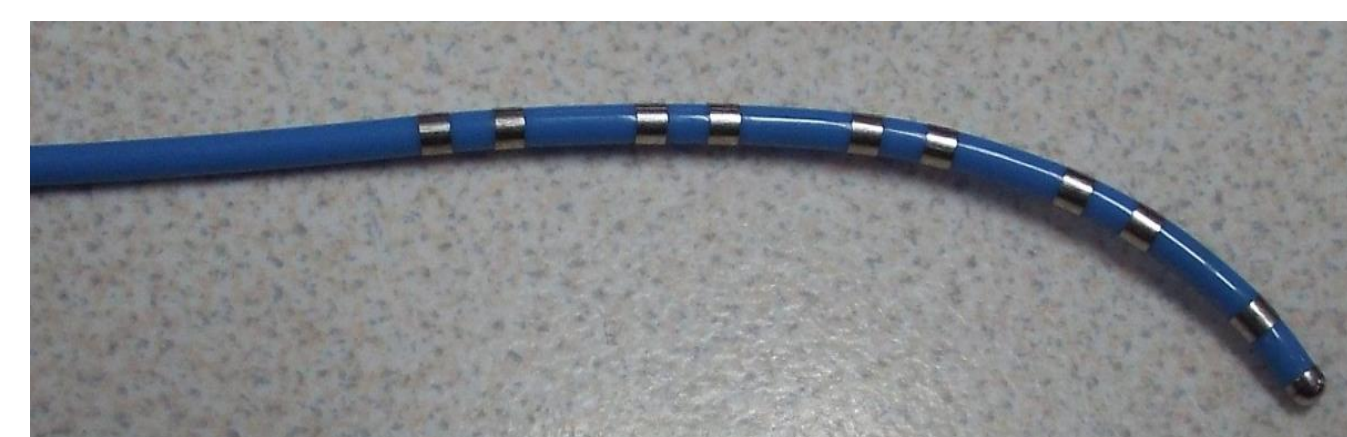
Figure 1  
5F CS Catheter Model

The incorrect band spacing defect became one of the business top offenders with a total of 111 units rejected in two months. All the rejected units with this defect belonged to a catheter family which is divided into two models: 5F CS and 6F. The defect was found only in model 5F CS and not in 6F. Model 5F CS is characterized for having a different diameter and for having more electrode bands than model 6F. Model 5F CS has a 5 French diameter and has 9 bands and 1 electrode tip resulting in 10 circuits passing inside its body. Because of having so many bands, this model is more likely to present the defect.

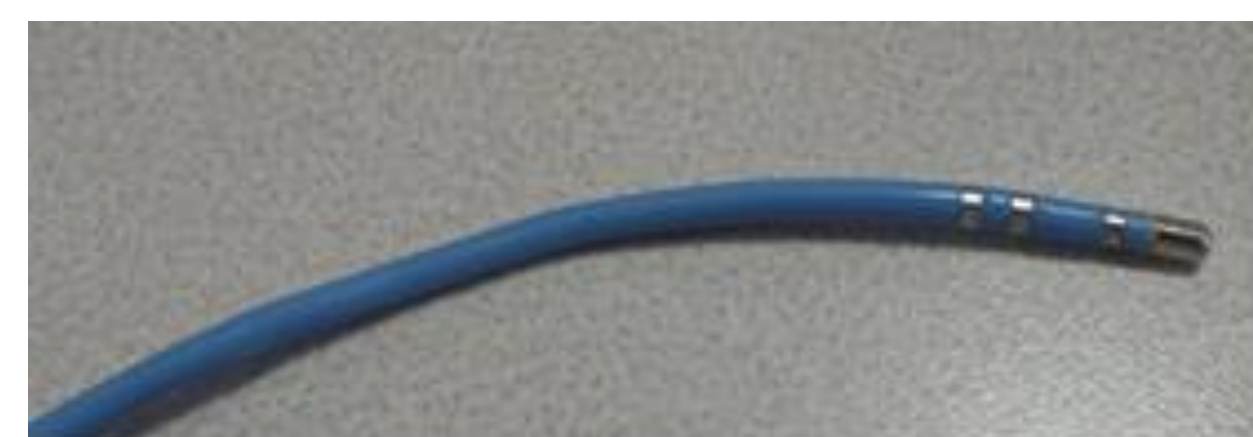
Figure 2  
Modelo 6F Catheter Model

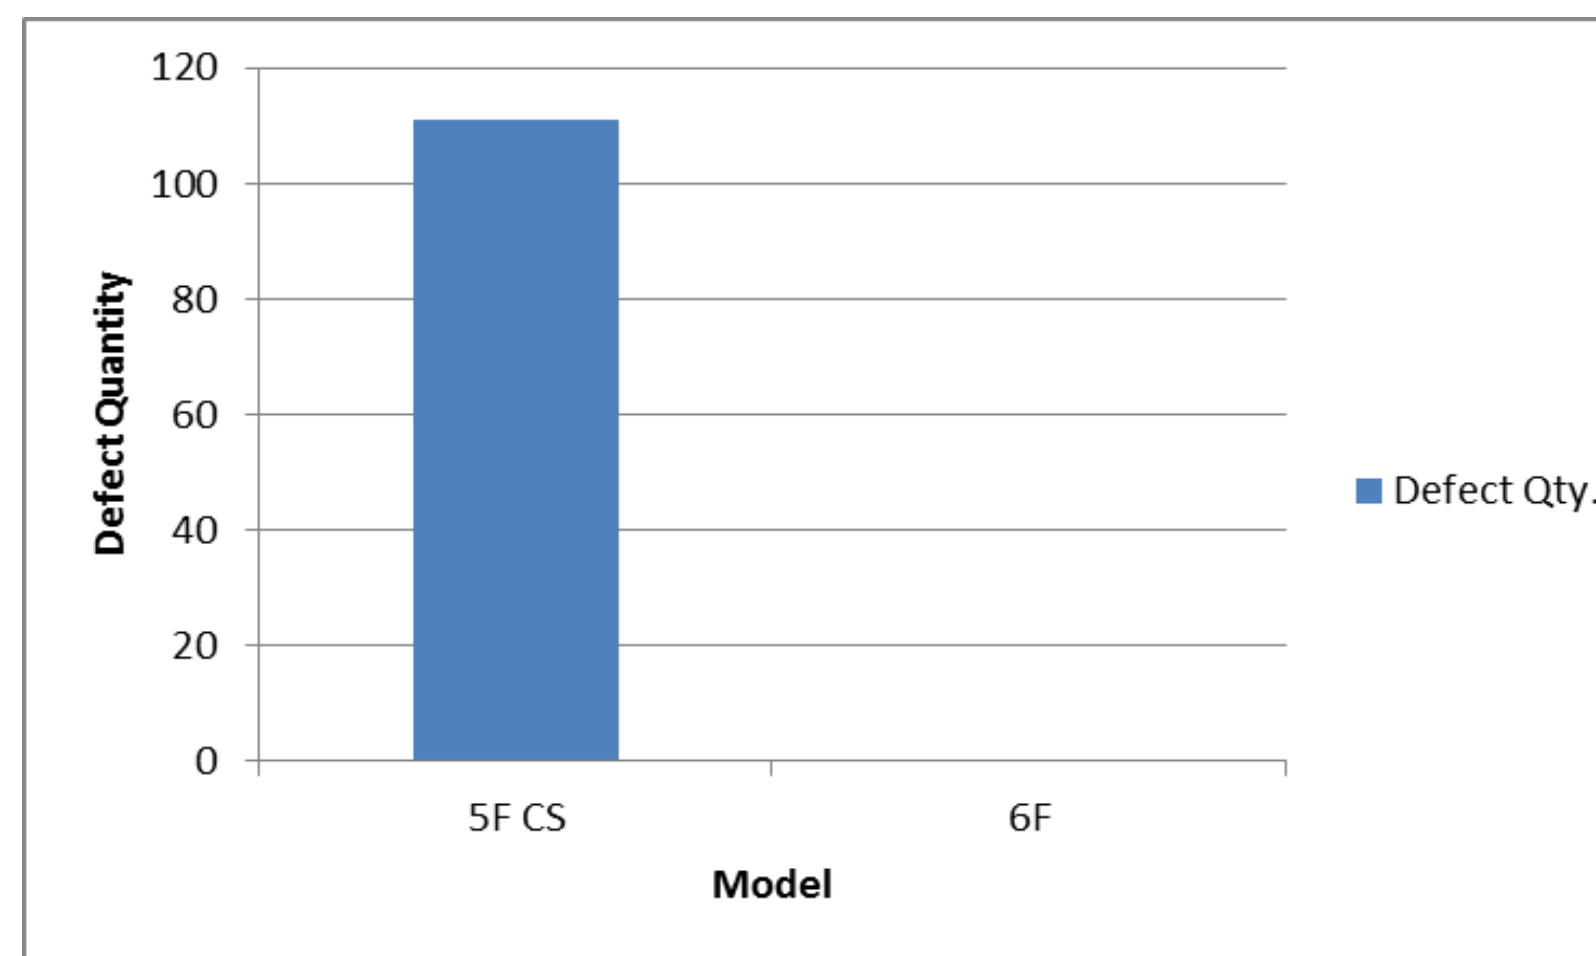
Figure 5  
Defect Quantity per Model

The defect became one of the business top offenders with a total of 111 units rejected in two months belonging to the model 5F CS. Important measures were evaluated in order to collect data to get to the root cause and the possible causes of the defect and they are the following:

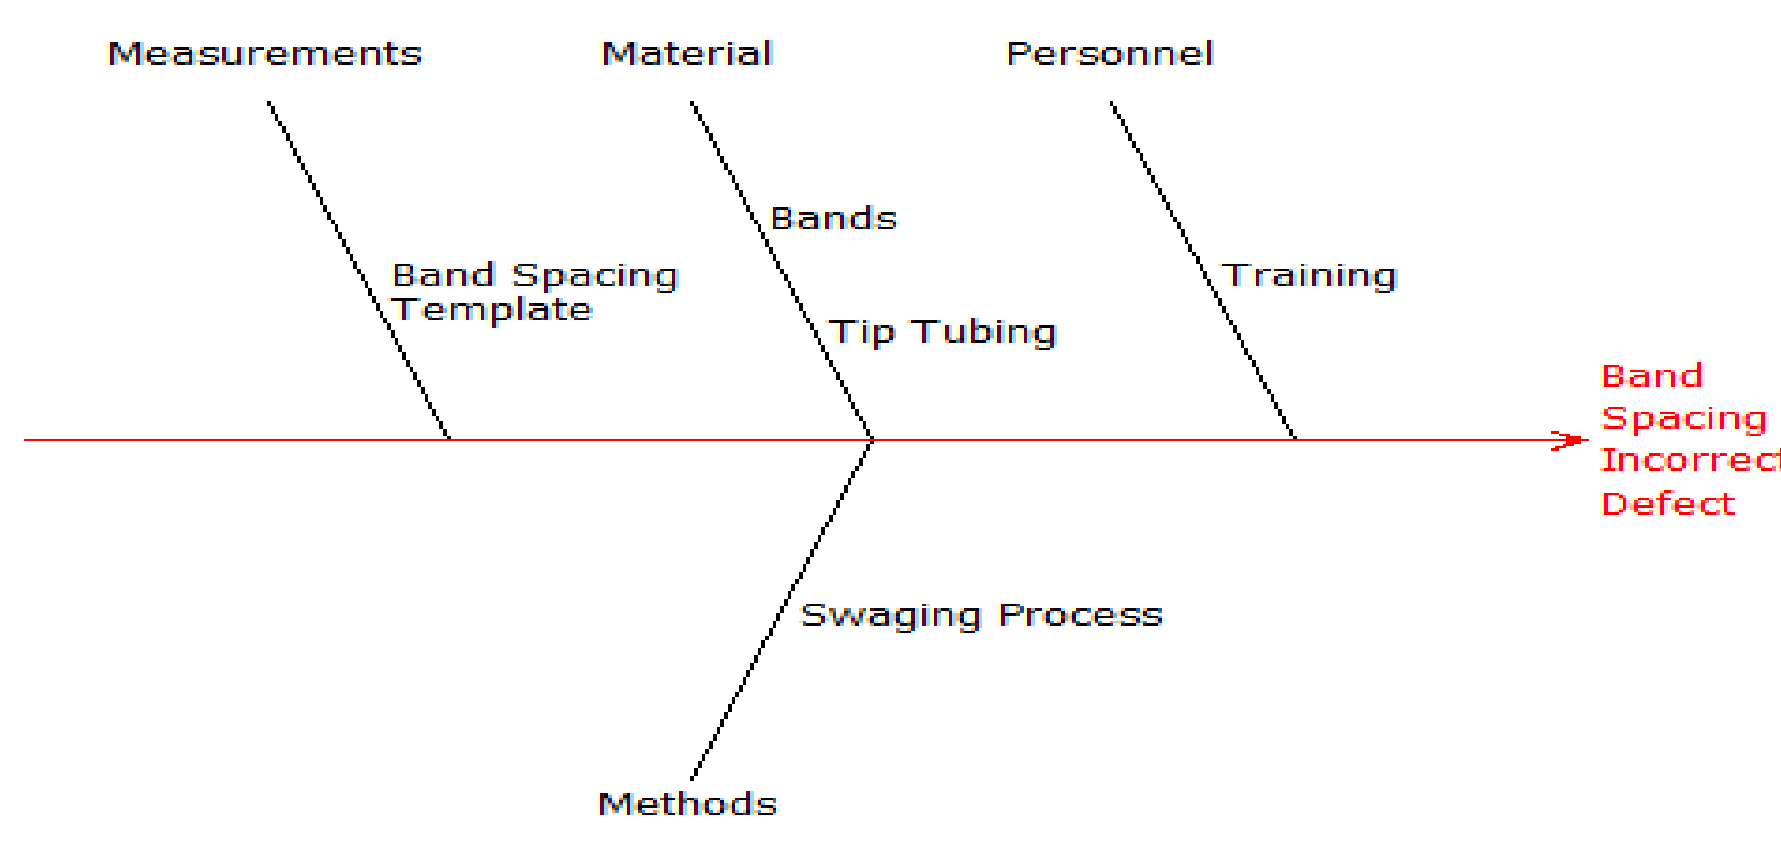
As part of the analyze phase, a fishbone diagram was performed in order to determine the possible causes triggering the defect. Band Spacing template was evaluated under the measurement category and it was determined that it could be improved since the template, as per drawing design, considers tolerances that the catheter do not has. A new prototype was designed and tested and it worked. Also, as part of the manufacturing flow, the swaging process was analyzed. In this process the catheter is passed through a swager machine with the intent of compressing the bands in the catheter. Once the bands are compressed, the band spacing template is used along with a microscope to verify if the space between bands is maintained. This same verification is also performed but with naked eye in a final device process and a discrepancy was found between the two processes; therefore, a change order was generated in order to align and standardize inspections across both processes.

Figure 6  
Defect Fish Bone Diagram

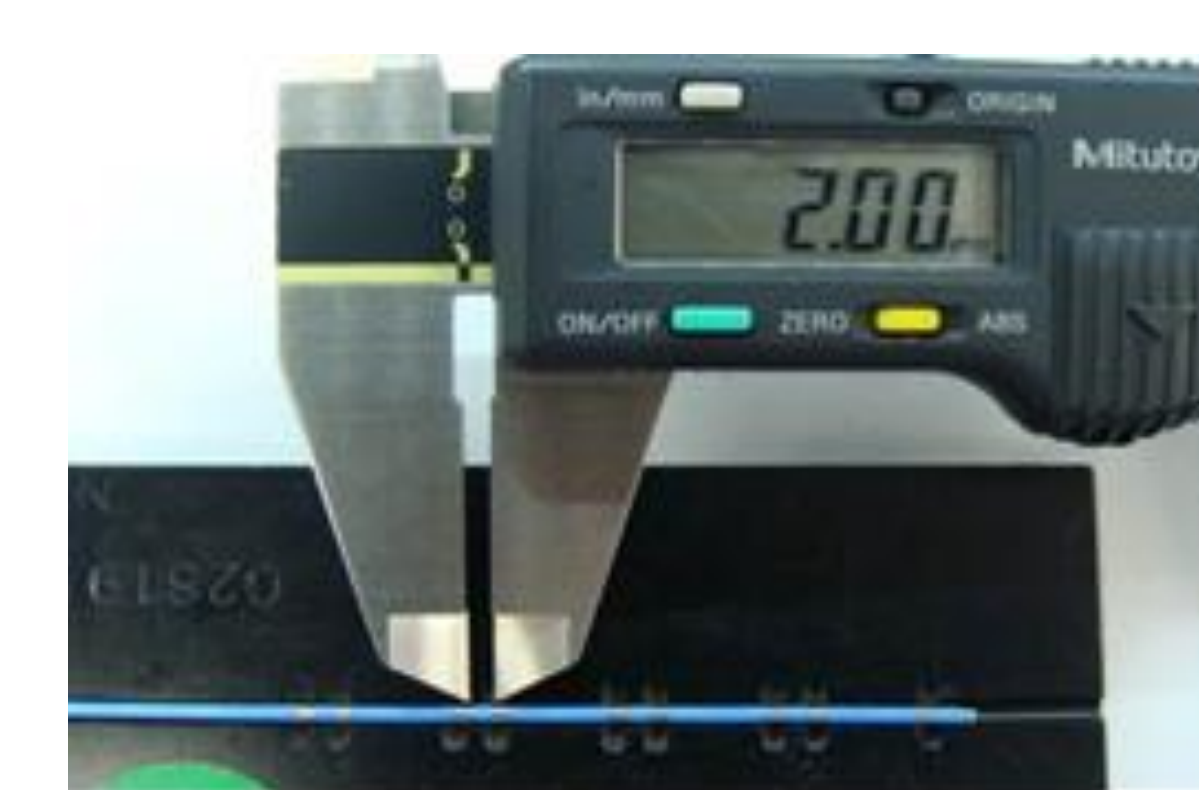
Figure 9  
Verification with Caliper

The improvements performed to the processes were divided in two phases: **Phase 1** - A change order was generated in order to standardize and align the band spacing verification in the swaging process and in the final device process to use the band spacing verification with the template with an unaided eye. Also a change in the method of measuring band space was made adding a caliper to be used along with the band spacing template with the intent of confirming band space in the case of bands are found to be as close as possible in the slots in the template.

A caliper was added, as a mitigation in Phase 1 of improvements, to work with the catheters which still presented the defect to confirm spacing. The major change was the improvement of the current band spacing template, in Phase 2, reassigning new tolerances which contributed to eliminate the band spacing defect when implemented.

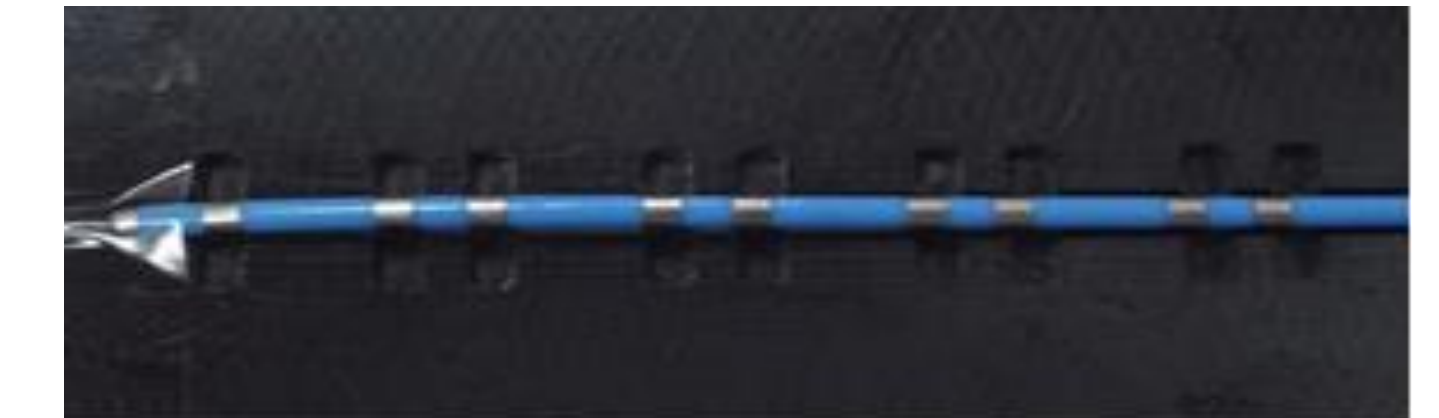
Figure 10  
Catheter with Band Spacing Incorrect Defect using current template

**Phase 2** - Current template was improved reducing the tolerance of each hole to the half of what it currently had but first the tooling number had to be removed from the product specification to introduce the new one.

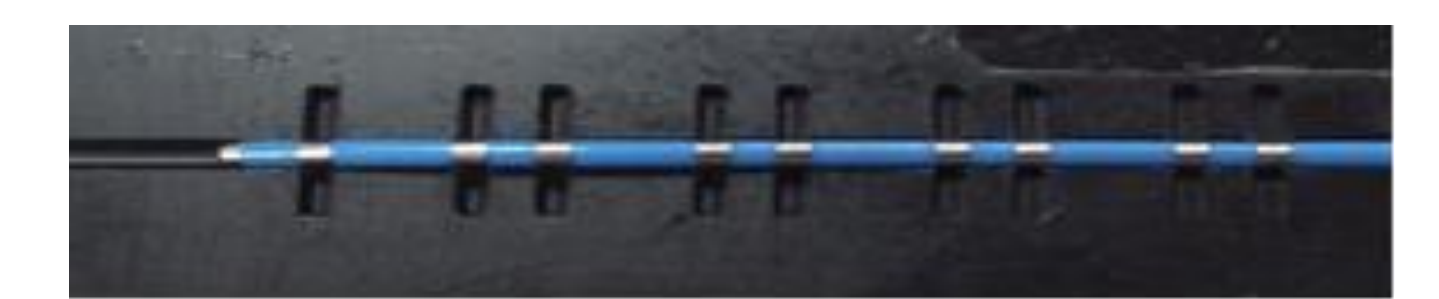
Figure 11  
Catheter using prototype template

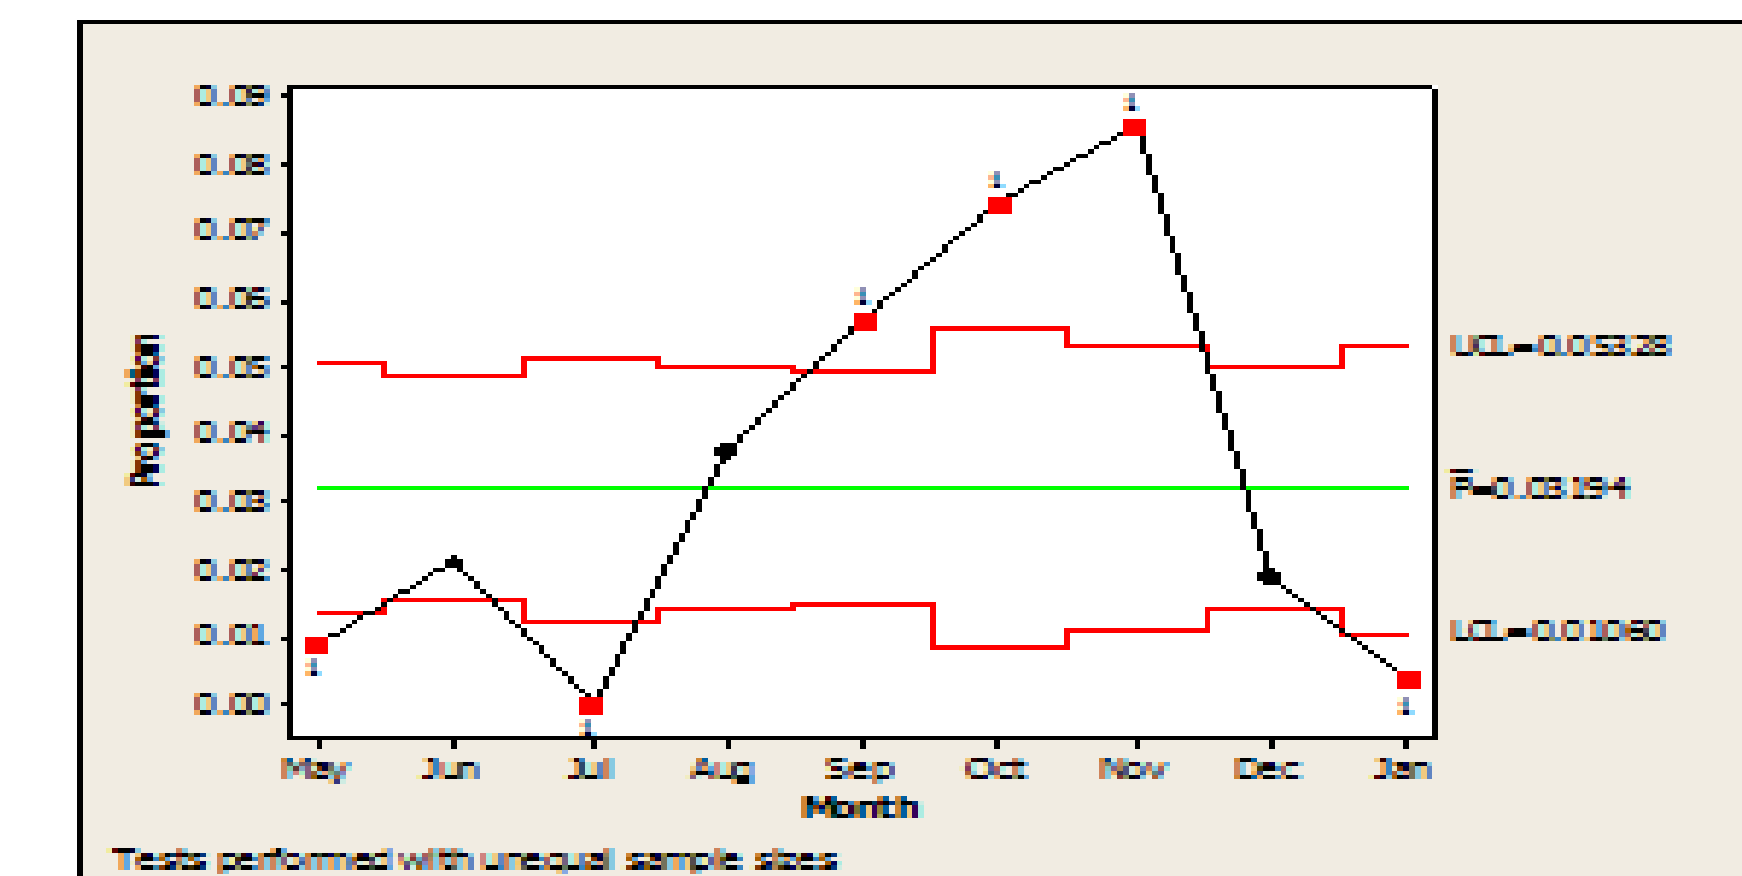
To confirm the effectiveness the defect rate trend was analyzed post improvements with a significant defect reduction seen in the months of December and January.

Figure 12  
Defect Trend
