Analysis and Recommendation of Landslide and Road Damage on State Road PR-167, Km 7.2 Naranjito, PR

Jonathan Molina Rosario, BSCE

Polytechnic University of Puerto Rico

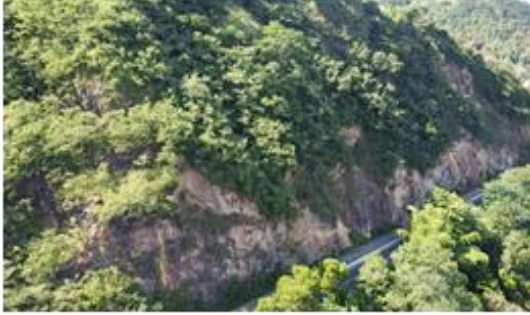
Figure 2
Aerial View of Rock Slope

Figure 2 shows the segment where the project is located. The length of the rock slope is approximately 185 meters, and the average height is 16 meters, but it reaches up to 40 meters in height. The angle of inclination of the slope concerning the horizontal is approximately 78 degrees.

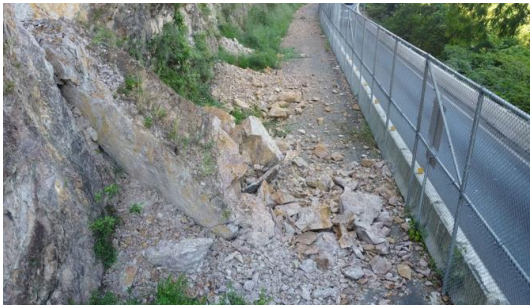
Figure 3
Buffer Zone

Currently, there is a temporary safety solution implemented in the rockfall area. The temporary solution consists of partially closing the road using temporary concrete barriers at the center of the road and a chain-link fence at the back of the concrete barriers to provide a safety buffer zone between the rock slope and the traveled way, providing a landing area for the rockfall, also to prevent the pass of the rocks to the traveled way. Figure 3 shows PRHTA buffer zone for rock fall.

The implemented temporary solution reduces the operational capacity of the PR-167 highway due to the partial closure of the road and presents vulnerabilities due to the types of materials implemented for the fence and the limited safety buffer zone provided. It is urgent to provide a permanent solution to mitigate the rock fall and guarantee the stability of the rock slope considering the geometric restrictions of the road (space limitations) and the geological conditions (height of the slope, a dip of the discontinuities, size of the fallen rocks). A cost-benefit analysis of different alternatives and recommendations is presented in this analysis.

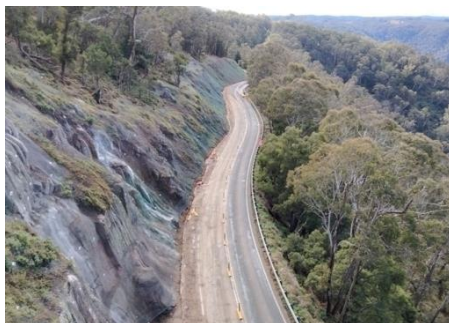
Figure 5
Wire Mesh Facing Over Rock Slope Example

Figure 5 show an example of wire mesh facing system in combination with ground anchors.

Ground anchors [3] are often used with facing systems to stabilize slopes and landslides. Different methods of facing systems may be used to transfer the ground anchor loads to the ground at the slope surface, provided the ground does not “run” or compress and is able to resist the anchor reaction forces at the excavated face. Cost, aesthetics, and long-term maintenance of the exposed face will affect the selection of the facing system.

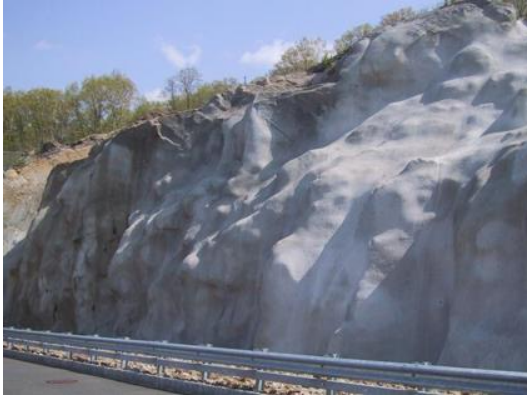
Figure 7
Shotcrete Facing Over Rock Slope Example

Figure 7 shows an example of shotcrete facing system in combination with ground anchors.

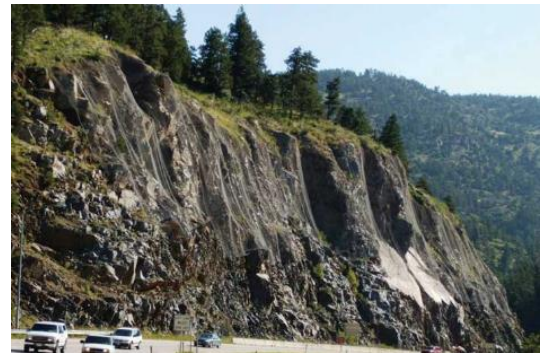
Figure 9
Drape Mesh Facing Over Rock Slope Example

For that reason, this alternative is presented with an inclination similar to the existing one in combination with a rockfall protection system [6]. Figure 9 show an example of shotcrete facing system in combination with ground anchors.
