Author: Jonathan Molina Rosario  
 Advisor: Victor M. Uribe Florez, PhD

Civil Engineering, Environmental Engineering and Land Surveying Department

## Abstract

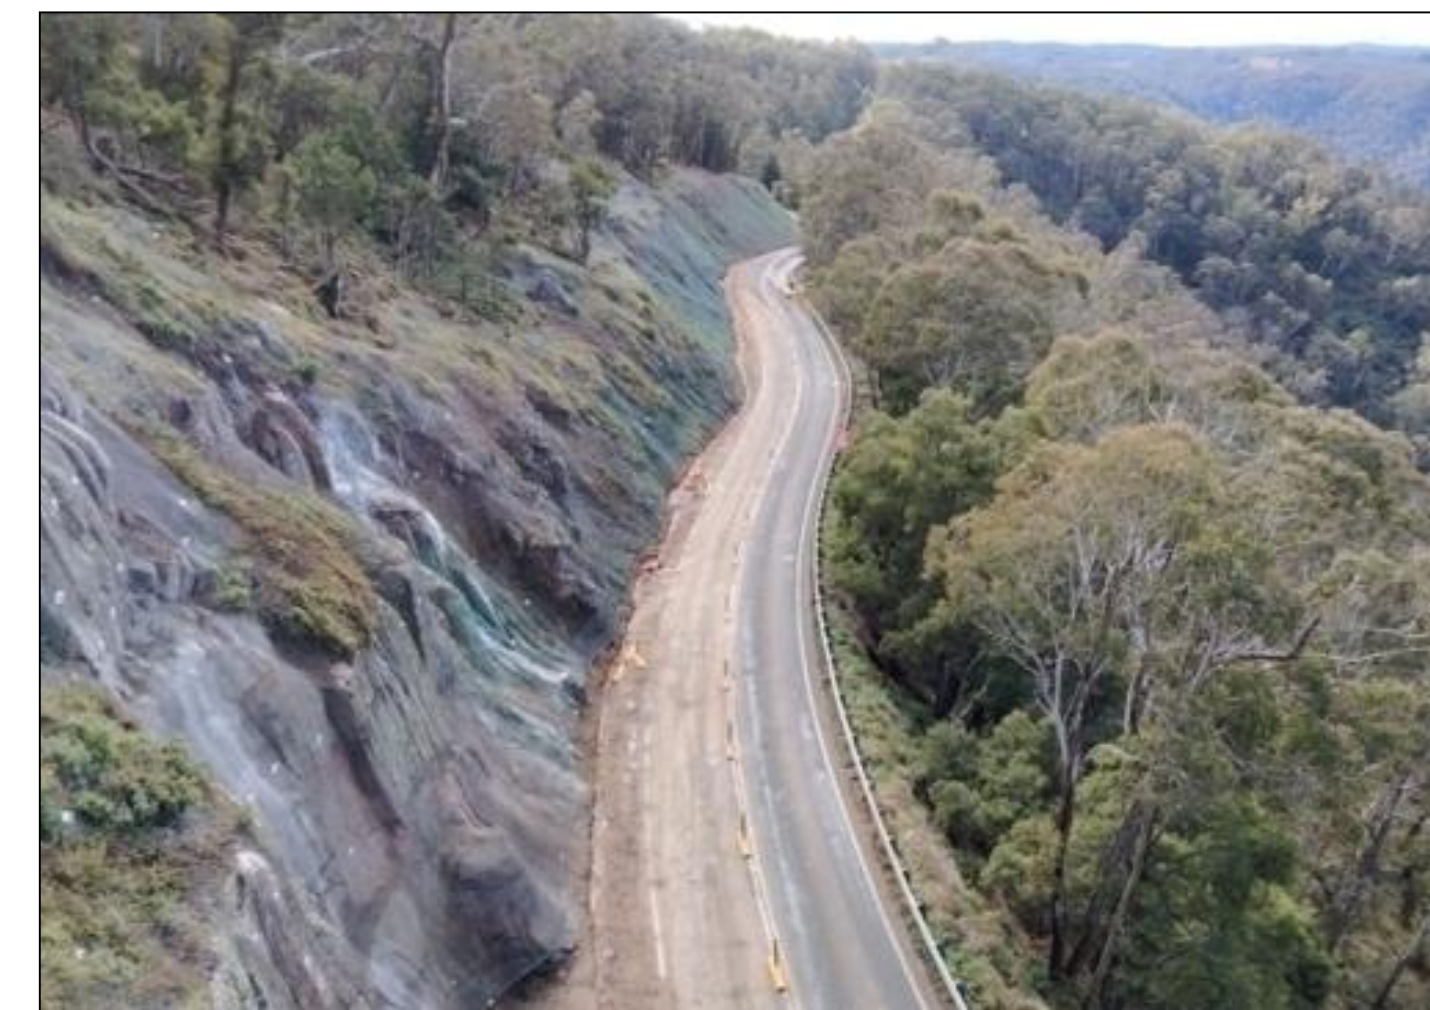
Wire Mesh Facing Over Rock Slope Example

Ground anchors are one of the most common types of internal reinforcement. Ground anchors are threaded steel bars inserted into the rock via drilled holes and bonded to the rock mass by cement grout. Because the bond strength between the cement grout and the rock is less than the steel's maximum yielding stress, it significantly impacts the rock reinforcement's design load. Dowels are used on steep slopes in the same fashion as rock bolts, while shear pins are used on flatter slopes where bedding planes and discontinuities determine the slope angle and failure plane.

Based on the results, Alternative #1 (Rockfall Protection using mesh system with ground anchors) provides the most feasible alternative.

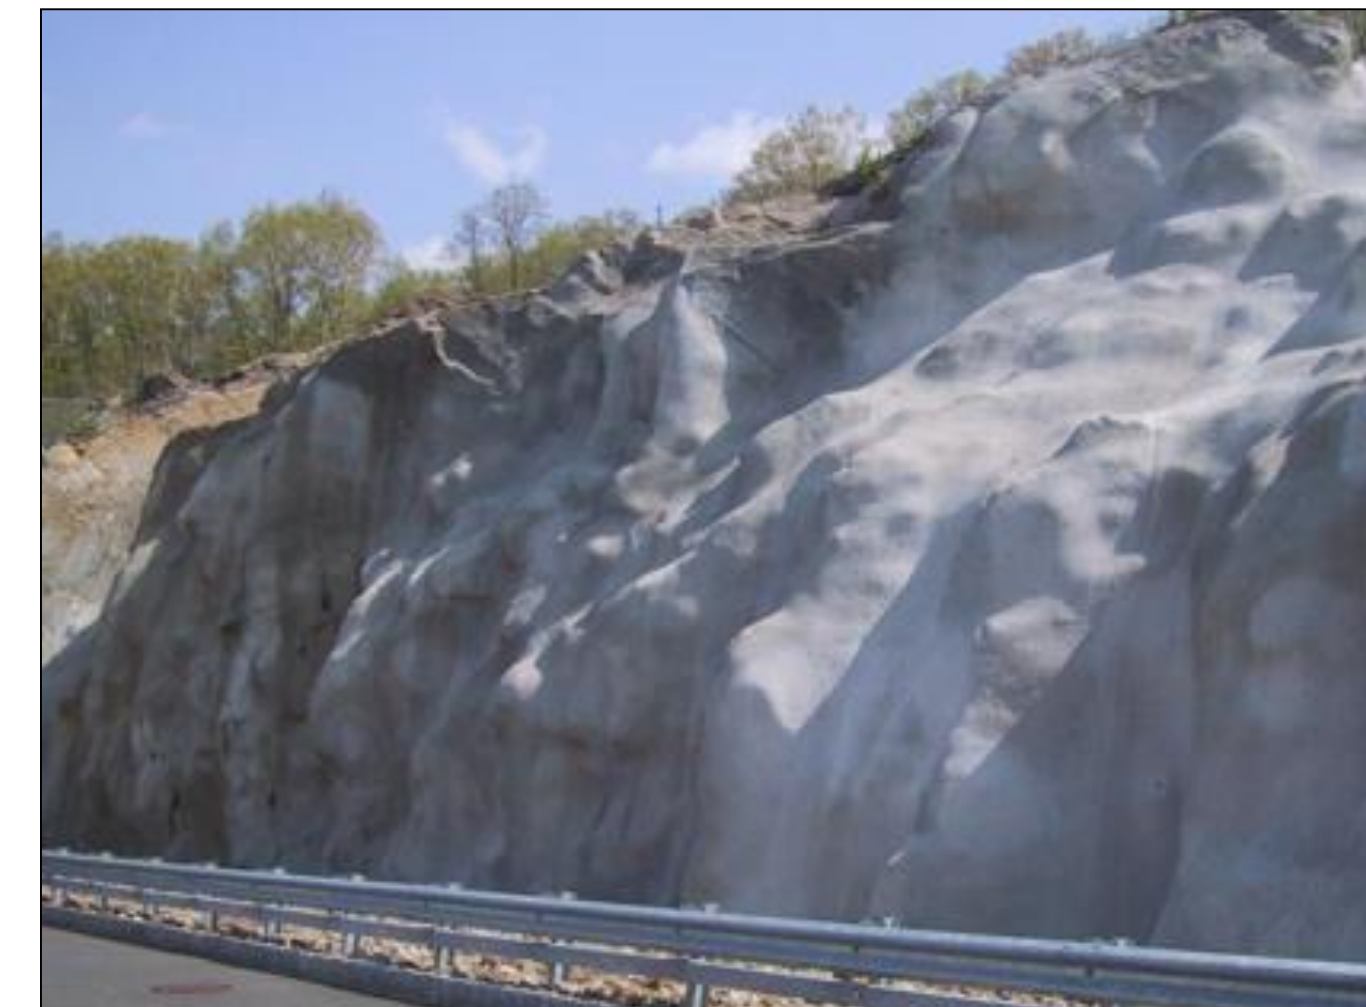
Shotcrete Facing Over Rock Slope Example

The ground anchors technique used in this alternative is the same as in Rockfall Protection, using a mesh system with ground anchors except for the facing protection. To stabilize the slope facing, a facing of shotcrete is proposed to be installed as part of this alternative. The bearing plates of the ground anchors are supported on the initial facing. The final facing is constructed over the initial facing and provides structural continuity throughout the design life. The final facing may also include an aesthetic finish.

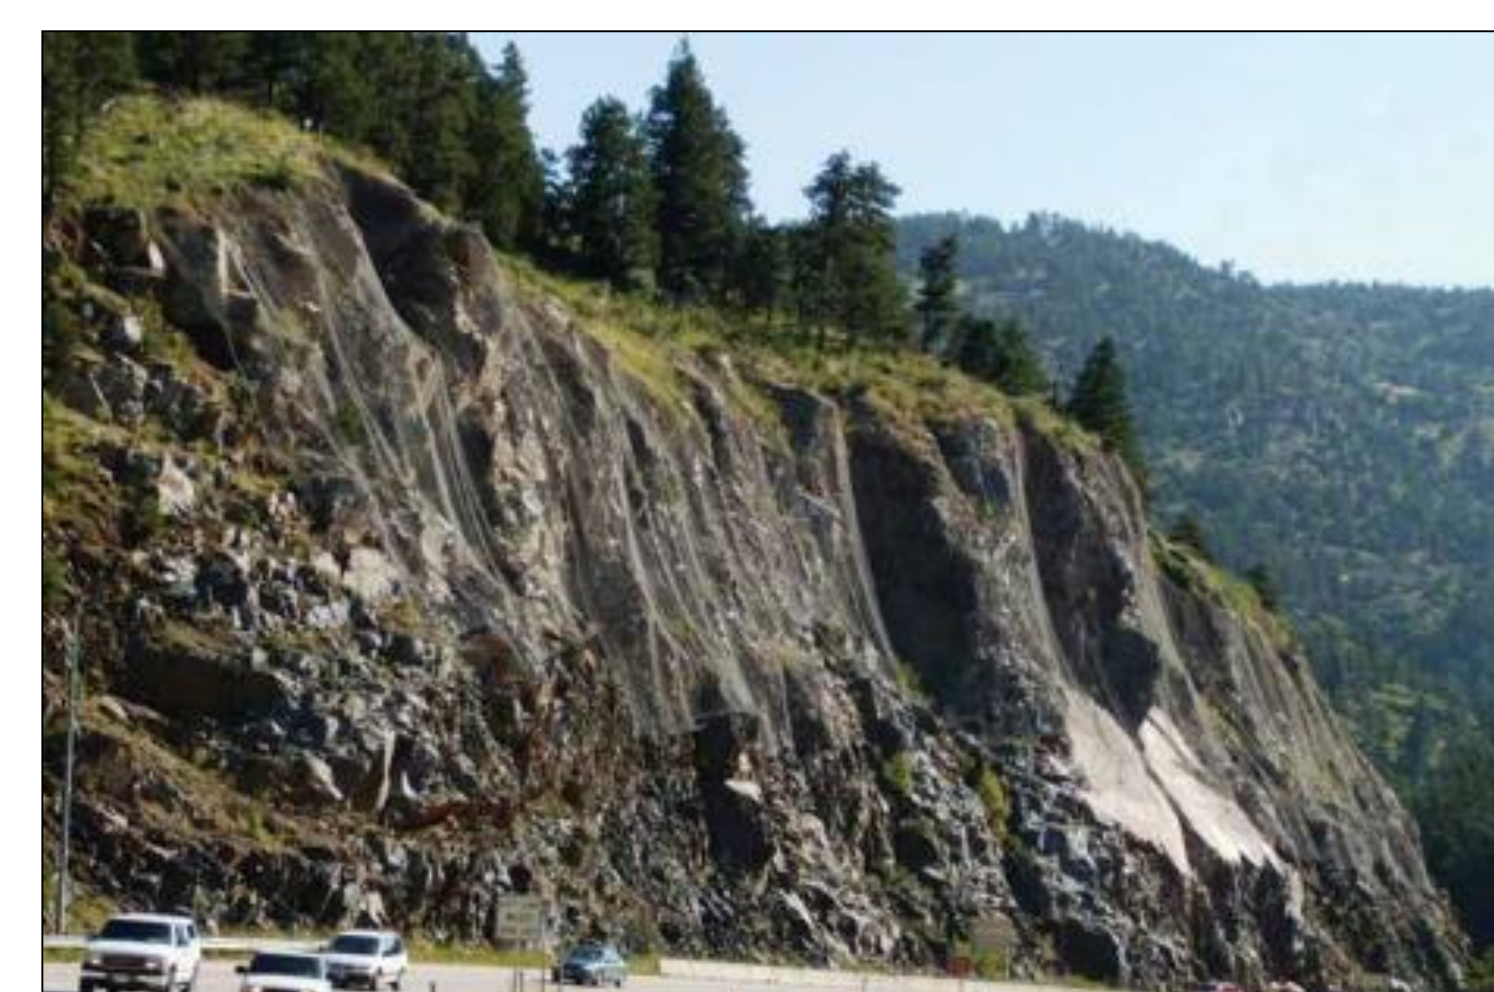
Drape Mesh Over Rock Slope Example

This alternative consists in cutting the rock slope at an offset distance of approximately 4 meters from the edge of the road to create a safety buffer zone that serves as a deposit zone in case of any rockfall. This alternative is combined with a draped mesh system to allow rockfalls to be controlled and guided into the deposition zone. The safety buffer zone is delimitating using concrete barriers and chain-link fences to prevent the pass of the rocks to the traveled way.

It is important to consider that Alternative 1 do not include the scope the consideration of a safety buffer zone to reduce the risk of rocks passing into the traveled way and increase the comfort perception of users. Alternative 3 consider a safety buffer zone between the road and the rock embankment, but this alternative was not selected because it obtained the lowest score of the three alternatives included in the evaluation. Also, for alternative 3 exists the risk of structural weakness during the implementation of the techniques for cutting the rock slope due to the high fracturing and hydrothermal alteration suffered by the rock withing the project area.
