Roxana Ramirez Iglesias
Advisor: Dr. Héctor J. Cruzado
Graduate School

Abstract

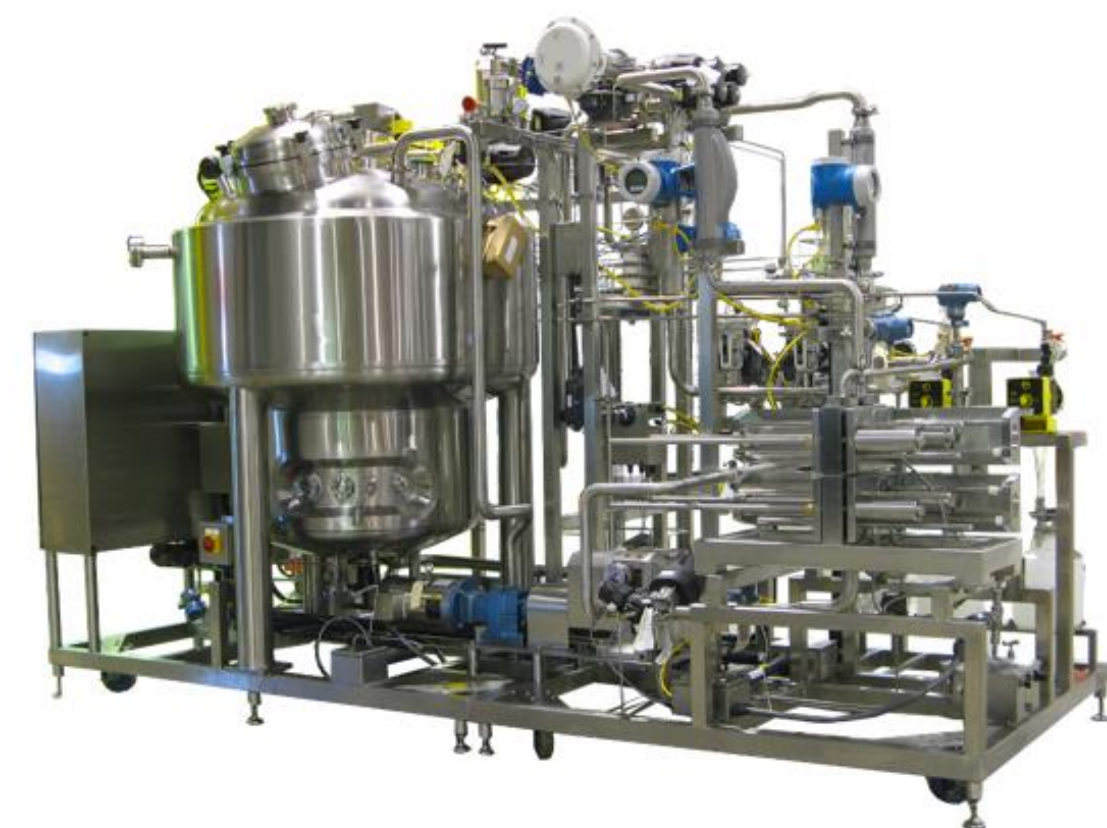
Figure 1: Purification skid [1]

As part of a vaccine manufacturing facility start-up, different processing tanks/skids were designed and installed, as shown in Figure 1. Two of the processing suites in the building are a purification room and a solvent charging room. During processing, these tanks contain hazardous chemicals like ethanol and isopropyl alcohol. In case of a safety incident, it is preferable for the safety relief devices on these skids to vent to the roof instead of venting inside the room, like in other processing suites.

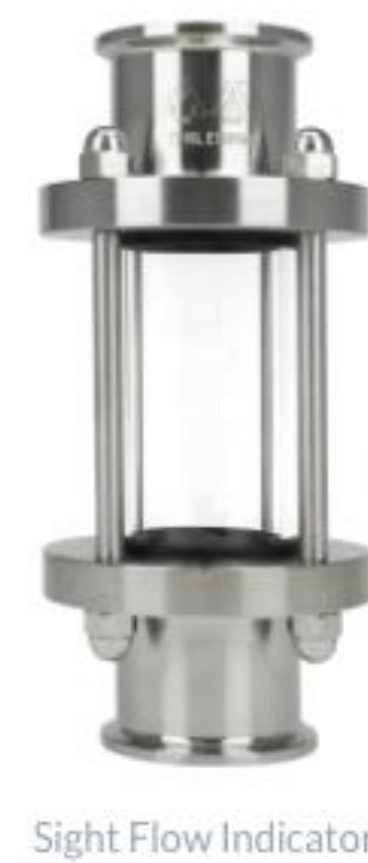
Figure 2: Sight glass [2]

Since these safety relief devices vent to the roof, the issue that operations management was facing was that rainwater was observed in the sight glass of these skids, meaning the vent lines were occluded with rainwater. Figure 2 illustrates a standard sight glass that is attached to a vent line to show the contents inside this line. Since rainwater level can vary depending on weather conditions, if the sight glass at any point was filled with rainwater and a safety incident occurred, there was a great possibility that the safety relief device for the skid would not operate as it was intended to. There was not easy way to drain the rainwater that was going into the sight glass because it was a closed end. There was also not a procedure in place to look at these sight glass regularly or to check if the sight glass was clear and free of any water, other than a preventative maintenance (PM) that the maintenance team scheduled on these skids for every three months.

To be able to manage the maintenance of these lines, the sight glasses on the vent lines where the water was observed were changed from being a closed end to an open end that closed with an endcap and a tri-clamp. This way, during processing activities, a technician is instructed by a standard operating procedure to look at the sight glass for occlusion and, if occlusion is found, to drain according to the procedure.
