## ***Incorrect Band Spacing Cost Reduction***

*Kara N. Irizarry Otero  
Engineering Program  
Dr. Hector J. Cruzado  
Graduate School  
Polytechnic University of Puerto Rico*

**Abstract** — *The purpose of this project is to identify factors and the root cause that are causing the Band Spacing Incorrect defect in Model 5F CS. Through this investigation, the DMAIC methodology was used with the intent of reducing the defect rate in a 25%, representing a cost saving of approximately \$33,000 in the third quarter of Fiscal Year 2015. The optimization and improvement of the processes and the introduction of a new improved tooling to measure band space will guarantee the reduction and control of the defect. This investigation will contribute, as a reference, to other defects to implement similar solutions among other manufacturing areas.*

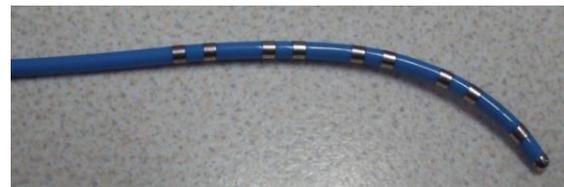
**Figure 1**  
**Model 5F CS**

Model 5F CS (shown in Figure 1) is characterized for having a different diameter and for having more electrode bands than model 6F. Model 5F CS has a 5 French diameter and has 9 bands and 1 electrode tip resulting in 10 circuits passing inside its body. Because of having so many bands, this model is more likely to present the defect. However, the defect is not presented in model 6F (shown in Figure 2) because this model has a bigger diameter of 6 French and has only three electrode bands and one electrode tip and measuring less bands is easier since this model tends to maintain its space between bands.

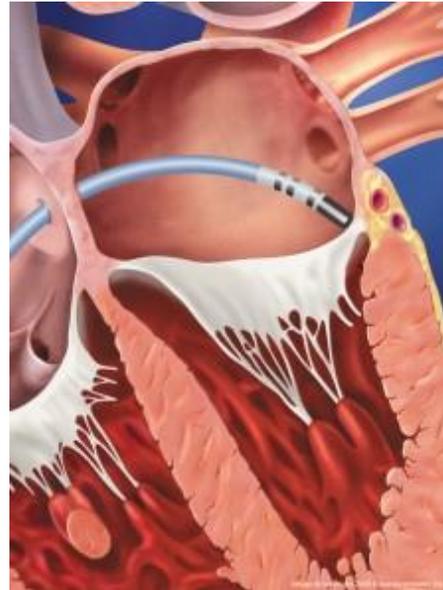
**Figure 4**  
**Ablation treatment using RF Catheter**

Cables are guided through the blood vessels in his heart. A generator sends power to your heart through catheters. Power to destroy small areas of heart tissue where abnormal heartbeat can cause an arrhythmia start. Catheter ablation is often involves radio frequency (RF) energy. This type of energy uses radio waves to produce heat that destroys the heart issue. Studies have shown that the RF energy works well and is safe”. [1] Figure 4 shows an ablation treatment using RF catheter.

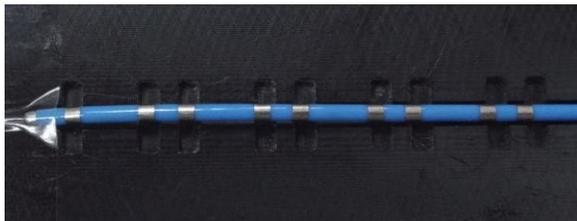
**Figure 10**  
Catheter with Band Spacing Incorrect Defect using current template

Phase 2 of process improvements consisted of improving the current band spacing template. The template with a designated tooling number was used as per specification but an opportunity was found in the tolerances it contains. Each hole in the template has the measure of the bands which is of 0.050 thousands of inch and an additional 0.010 thousands of inch at each side having a total space of .070 thousands of inch in each hole.

When the bands are compressed in the swager machine, as per material composition, it tends to expand more or less 0.02 thousands of inches so then the template has 0.018 of tolerance in excess. Figure 10 shows this excess of tolerance in the holes when a catheter is measured using the template. The bands that are out of the holes in the template look like they have moved to the left in the figure which is considered the band spacing defect.

The improvement was basically to reduce the tolerance of each hole to the half of what it currently had but first the tooling number had to be removed from the product specification to introduce the new one. Meetings with the designer

engineer were made in order to remove the current tooling number from the specification and in parallel the new prototype template was designed. In the new tooling each hole only consider the band size of 0.050 thousands of inches and only 0.05 thousands of inches to each side having a total of 0.060 thousands of inches per hole. Figure 11 shows the same catheter used in Figure 10 but using the prototype template to measure band space.
