# **Battery Assembly Re-design in a Medical Device Company**

Aisha Y. Ortiz Garcia  
Manufacturing Engineering  
Rafael Nieves, Pharm.D.  
Industrial Engineering Department  
Polytechnic University of Puerto Rico

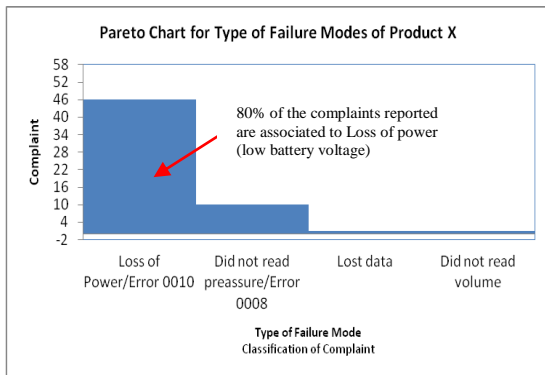
**Figure 6**  
Pareto Chart for Type of Defects

Figure 6 shows the Pareto Chart created to determine the top failure mode or complaints for Product X for YR2011. According to Pareto Chart, the main defect (complaint) is low battery (Error 0010) which represents 80% (46 out of 58 complaints reported) for Product X during YR2011.

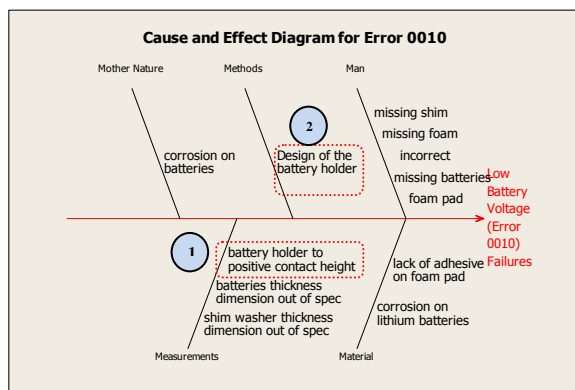
**Figure 8**

As part of the problem solving process, cause and effect diagram was used to trigger potential sources (causes) of a problem (defect). Potential sources for low battery voltage were provided by the FMECA (Failure Mode, Effect and Criticality Analysis) that was documented in the Design Phase of Product X. According to Figure 8, the sources that can contribute to low battery voltage on Product X are:

- Materials
  - Corrosion on lithium batteries
  - Lack of adhesive on the foam pad
- Method

- Design of the battery holder with the assembly of two shim washers causing a short circuit
- Man
  - Missing two or one of the shim washer
  - Missing one or both lithium batteries
  - Missing foam pad
  - Shim washer placed at the incorrect location (between batteries) creating a short circuit
  - Foam pad not placed correctly causing that batteries get loose
- Measurement
  - Shim washer thickness out of specification
  - Battery thickness out of specification
  - Battery holder height to positive contact out of specification

**Cause & Effect Diagram of Error 0010/Low Battery Voltage**

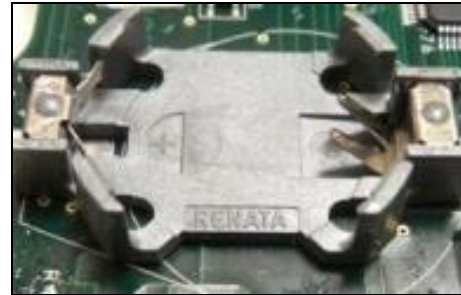
**Figure 9**

Product X, it was observed differences in the battery holder component of the PCB board. Defective units with low battery voltage did not have a “Swiss Made” engraving on the battery holder that the good units have. See Figure 9 for Non Swiss Made Engraving (China Battery Holder) and Figure 10 for Swiss Battery Holder.

**Non-Swiss Battery Holders (Bad)**

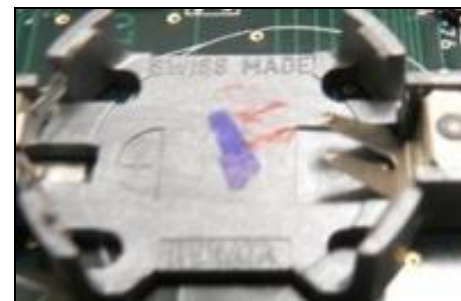
**Figure 10**

**Swiss Batter Holder (Good)**

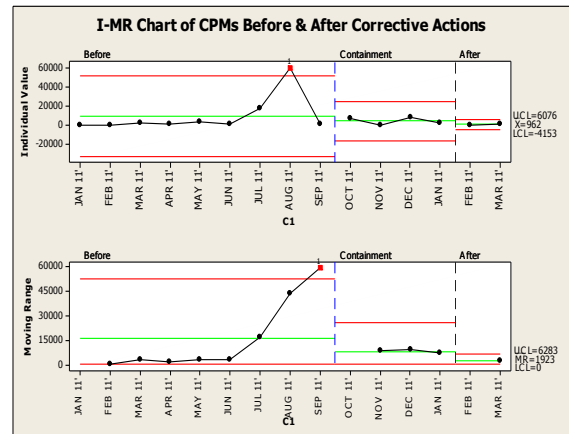
**Figure 14**  
**CPMs Trend Before and After**

After the implementation of the top washer battery redesign, it can be observe on Figure 14 that the CPMs improvement represents 81% of reduction from the baseline 5000 CPMs during YR2011 vs. 962 CPMs after corrective action. Complaints are reported in a weekly basis and discussed with the staff in order to monitor the goal of this design project.
