Abstract

Due to the rain caused by Hurricane Maria there were various slope failures around Puerto Rico (PR). This project evaluates a failure in Lares, PR, road PR-124. The evaluation consists in mitigate that failure with two designs for retaining walls (Cantilever and Gabions).

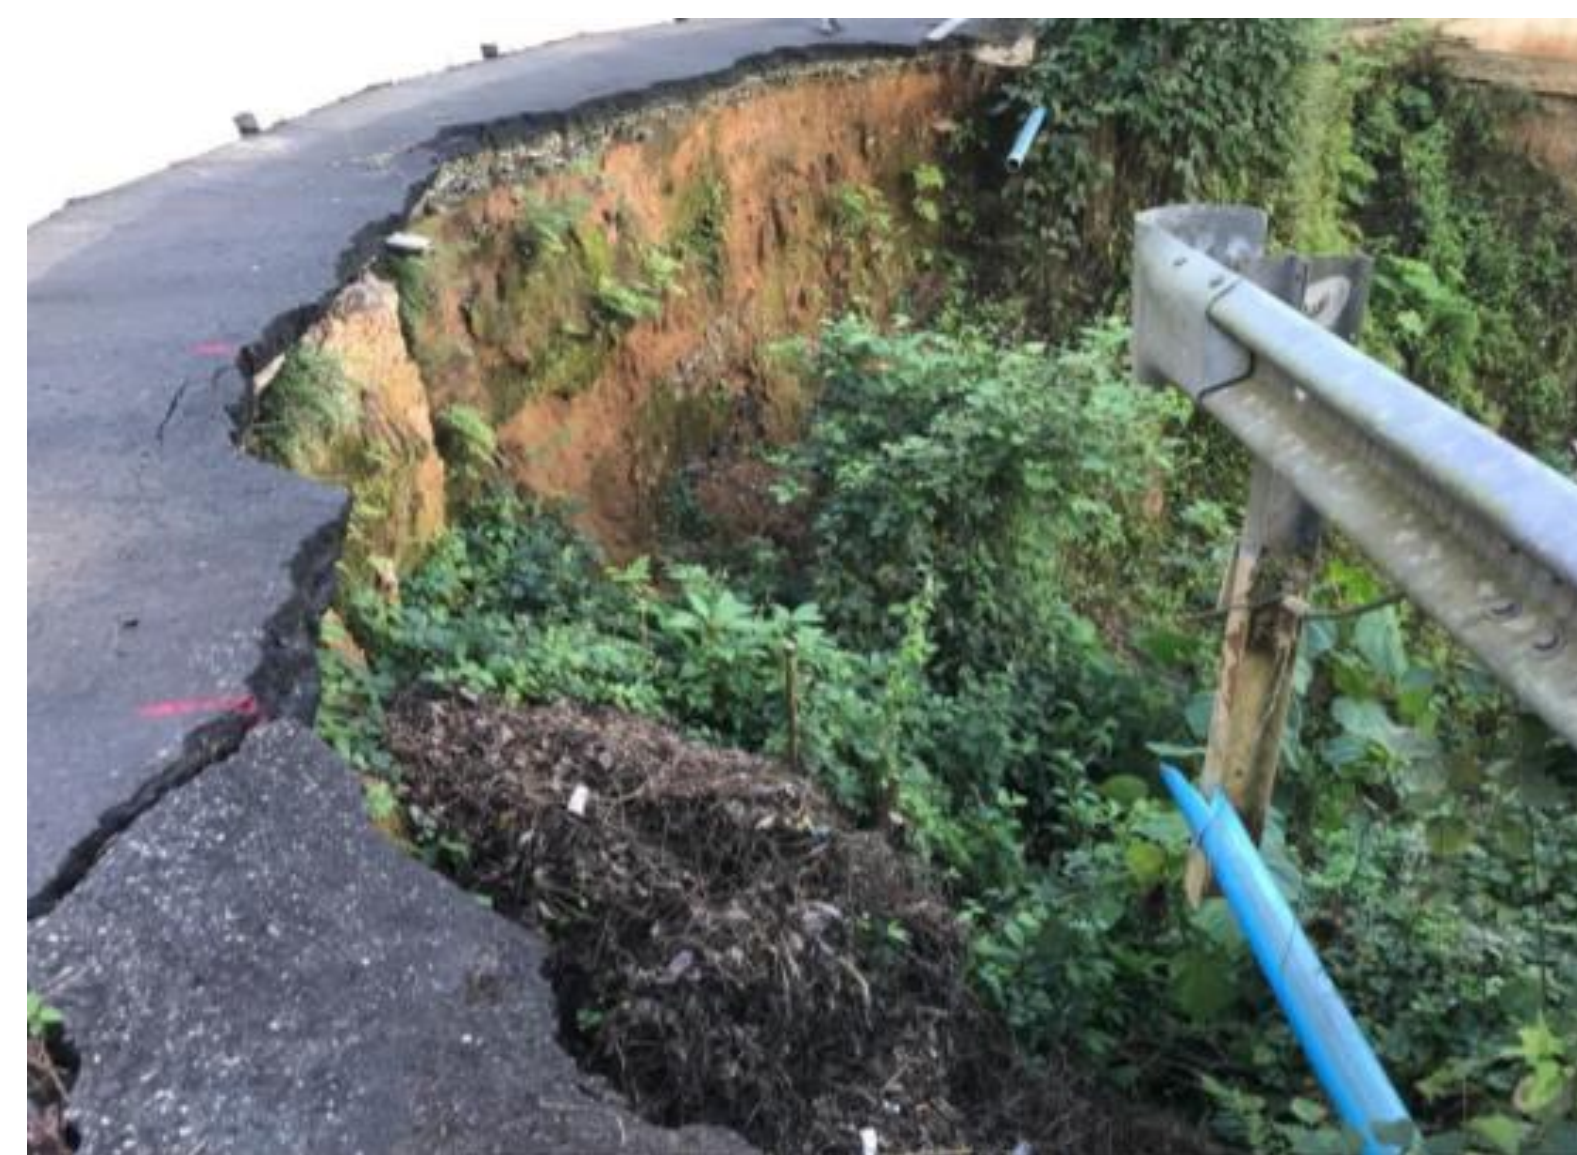
Figure 2.
Shows the Slope Failure on PR-124

Hurricane Maria caused various slope failures around the island, which means that those areas were affected and need a design to prevent slope failure.

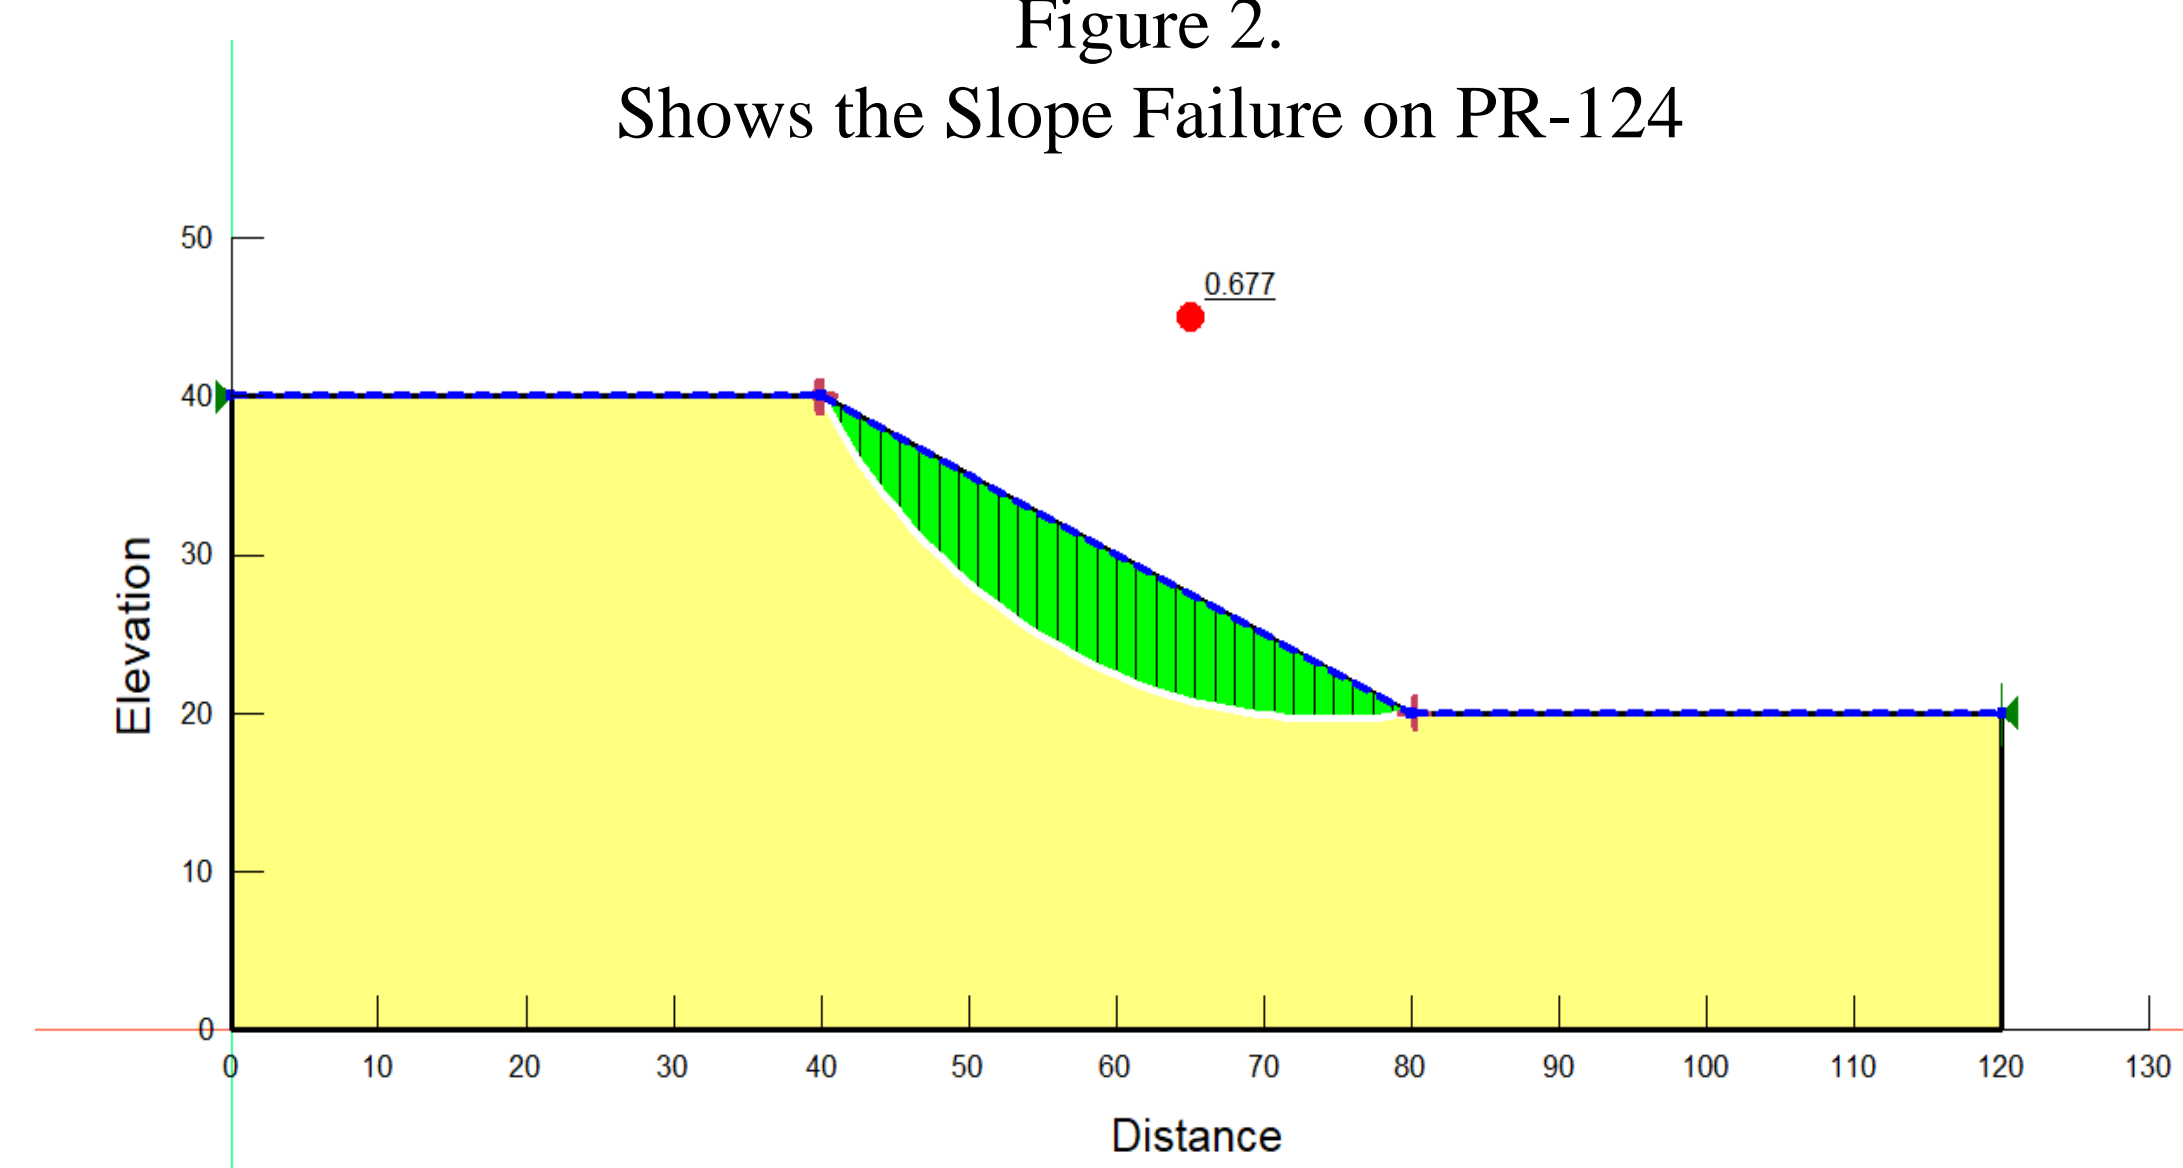
Figure 3.
Illustrates GeoSlope using the Piezometric Line

Although Hurricane Maria caused devastation on the island, it gave people an impulse to innovate new ideas. While simulating the slope in GeoSlope with both conditions, saturated and dry, as expected, the most critical safety factor was the saturated, 0.677. The designs presented in this project came to be because of that devastation. Although this project takes place in Lares, PR, both designs can be used around the island.
