Christian Berríos Soto
 Master of Engineering in Civil Engineering
 Christian Villalta Calderón, PhD
 Department of Civil and Environmental Engineering and Surveying
 Polytechnic University of Puerto Rico

Abstract

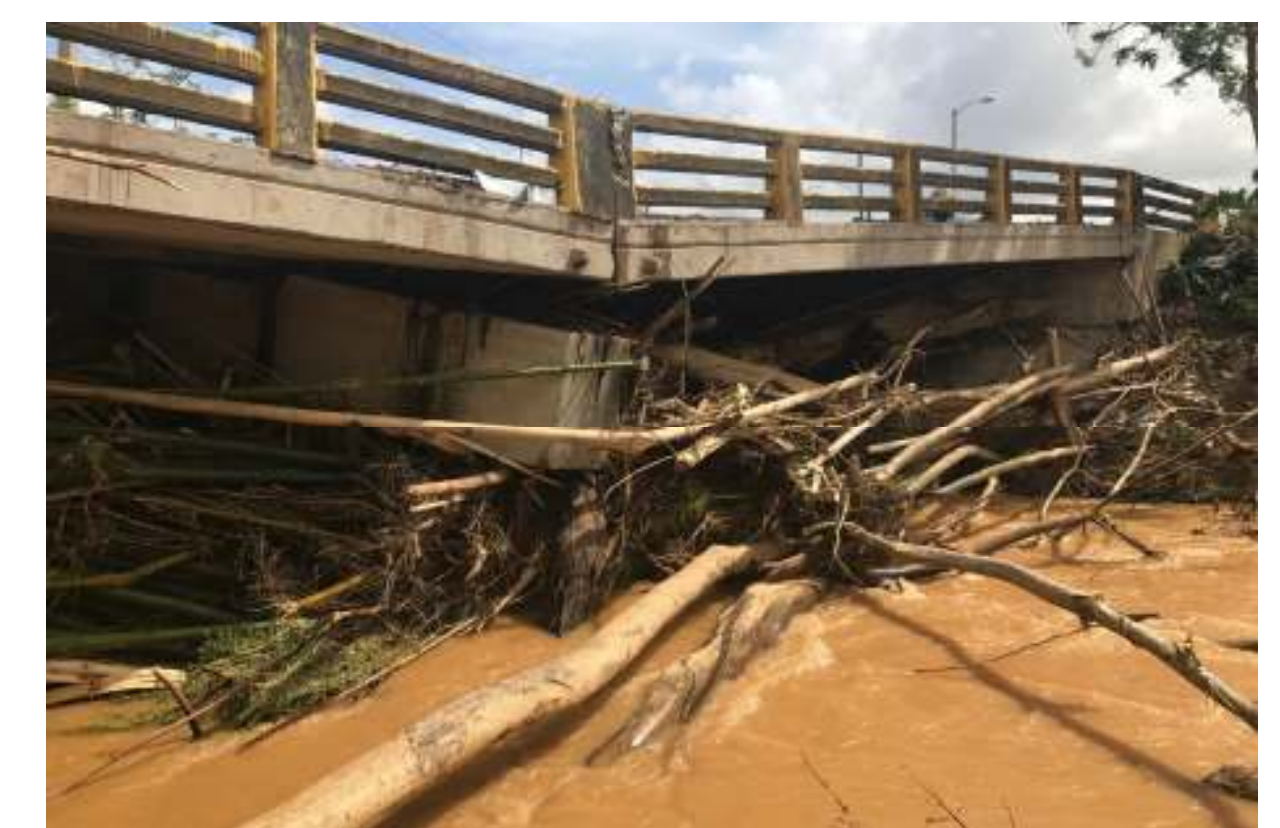
Hurricane Maria resulted in 26 bridge collapses and over 400 damaged. However, most of said collapses may have been an effect of transported debris accumulating around the bridge and blocking the opening. Large amounts of debris can cause heavy lateral and vertical forces capable of pushing and carrying the structure away.
