# ***Design and Construction of a Telecommunications Tower Foundation Using Micropiles***

Master of Engineering in Civil Engineering

Polytechnic University of Puerto Rico

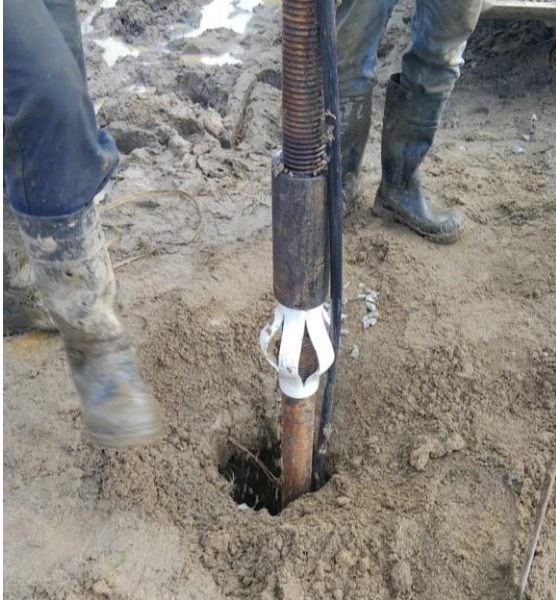
**Figure 9**  
**Micropile Reinforcing Bar Installation**

Once the hole was drilled with the DTH, the reinforcing bar could be inserted into the hole. See Figure 9.

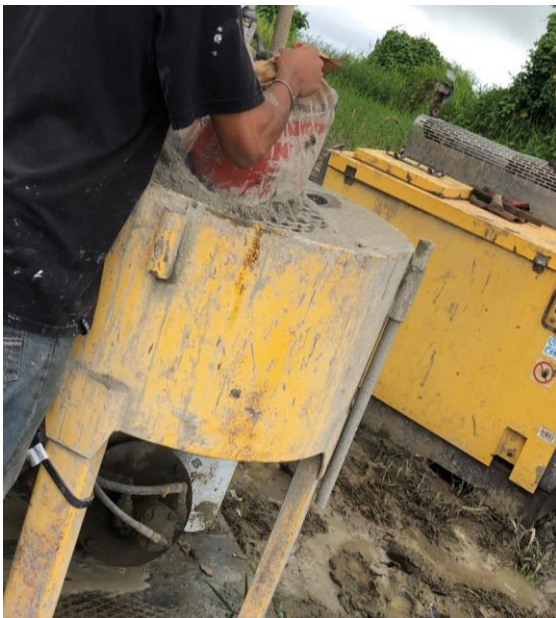
**Figure 10**  
**5,000 psi Neat Cement Grout Mixing and Pumping**

After inserting the reinforcing bar, grout is mixed to design properties such as water to cement ratio (w/c) and fluidity. See Figure 10.

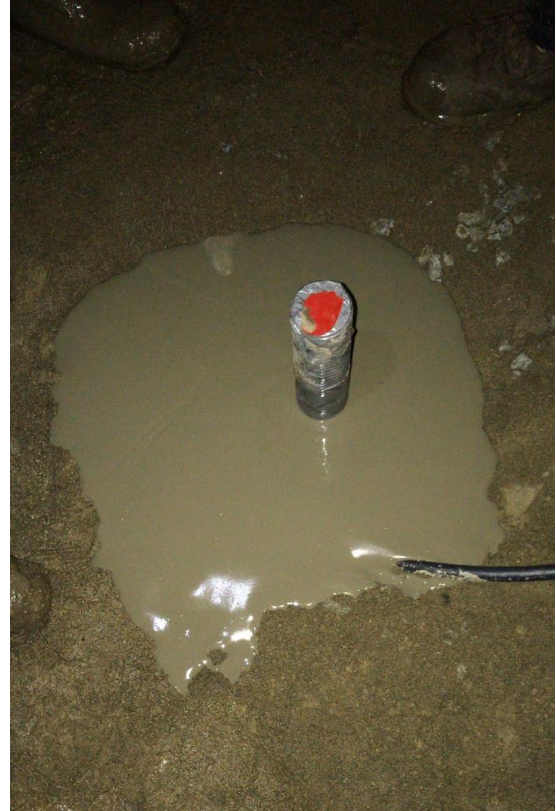
**Figure 11**  
**Finished Micropile**

Figure 11 below shows the cement grout after pump through tremie pipe from bottom elevation of pile until overflow. This practice ensures a proper placement of grout to avoid voids in the micropile.

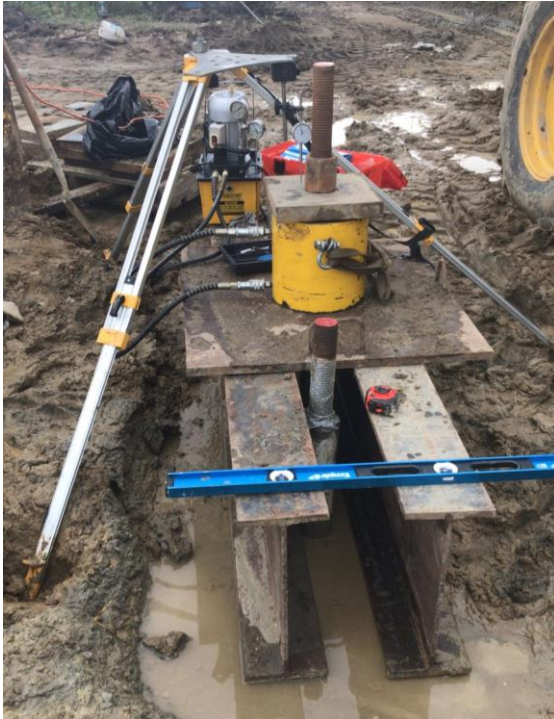
**Figure 12**  
**Load Test Set-Up**

A free length (Unbonded Length) of about ten (10) feet allowed to place reaction beams right beside the pile tested. The free length prevents load transfer to the surrounding soils which otherwise would negatively affect the results of the test. A concrete slab was constructed to support the reaction beams. The slab transfer the loads more evenly and to a larger area while reducing the bearing pressure. Figure 12 shows the set up for the load test performed.

One proof test on a non-sacrificial micropile was tested to 100% of the design ultimate load of 300 kips. The test was performed following Procedure A1 of ASTM D3689 [5].

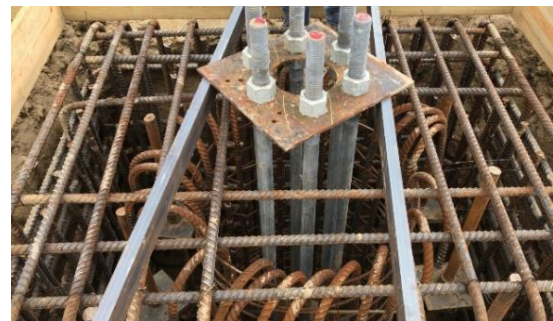
**Figure 14**  
**Picture Showing Steel Reinforcement Partially Completed**

Once all micropiles construction have been completed and load test was performed, the construction of the pile caps was initiated. The pile will serve to transfer the load from the tower to micropiles. The steel reinforcement was partially pre-assembled to reduce construction time. See Figure 14 that shows the steel reinforcement partially completed.

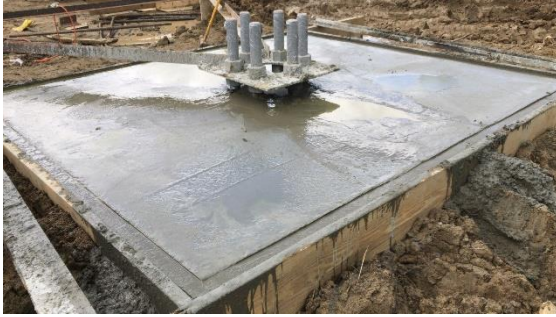
**Figure 15**  
**Picture Showing Completed Pile Cap**

The concrete mixing was done on site with the aid of a mobile concrete volumetric mixer (Mini-Master). This was calibrated on site before pouring. Concrete casting could be completed in two days. Please see Figure 15 for a depiction of the finished pile cap.
