Design and Construction of a Telecommunications Tower Foundation Using Micropiles

Juan F. Mejías López
 Master's in Civil Engineering
 Advisor: Dr. Alberto Guzmán, PE

The proposed project consists in the design and construction of a foundation system to support a telecommunication self-supported tower, with a height of about 200-feet as measured from ground surface.

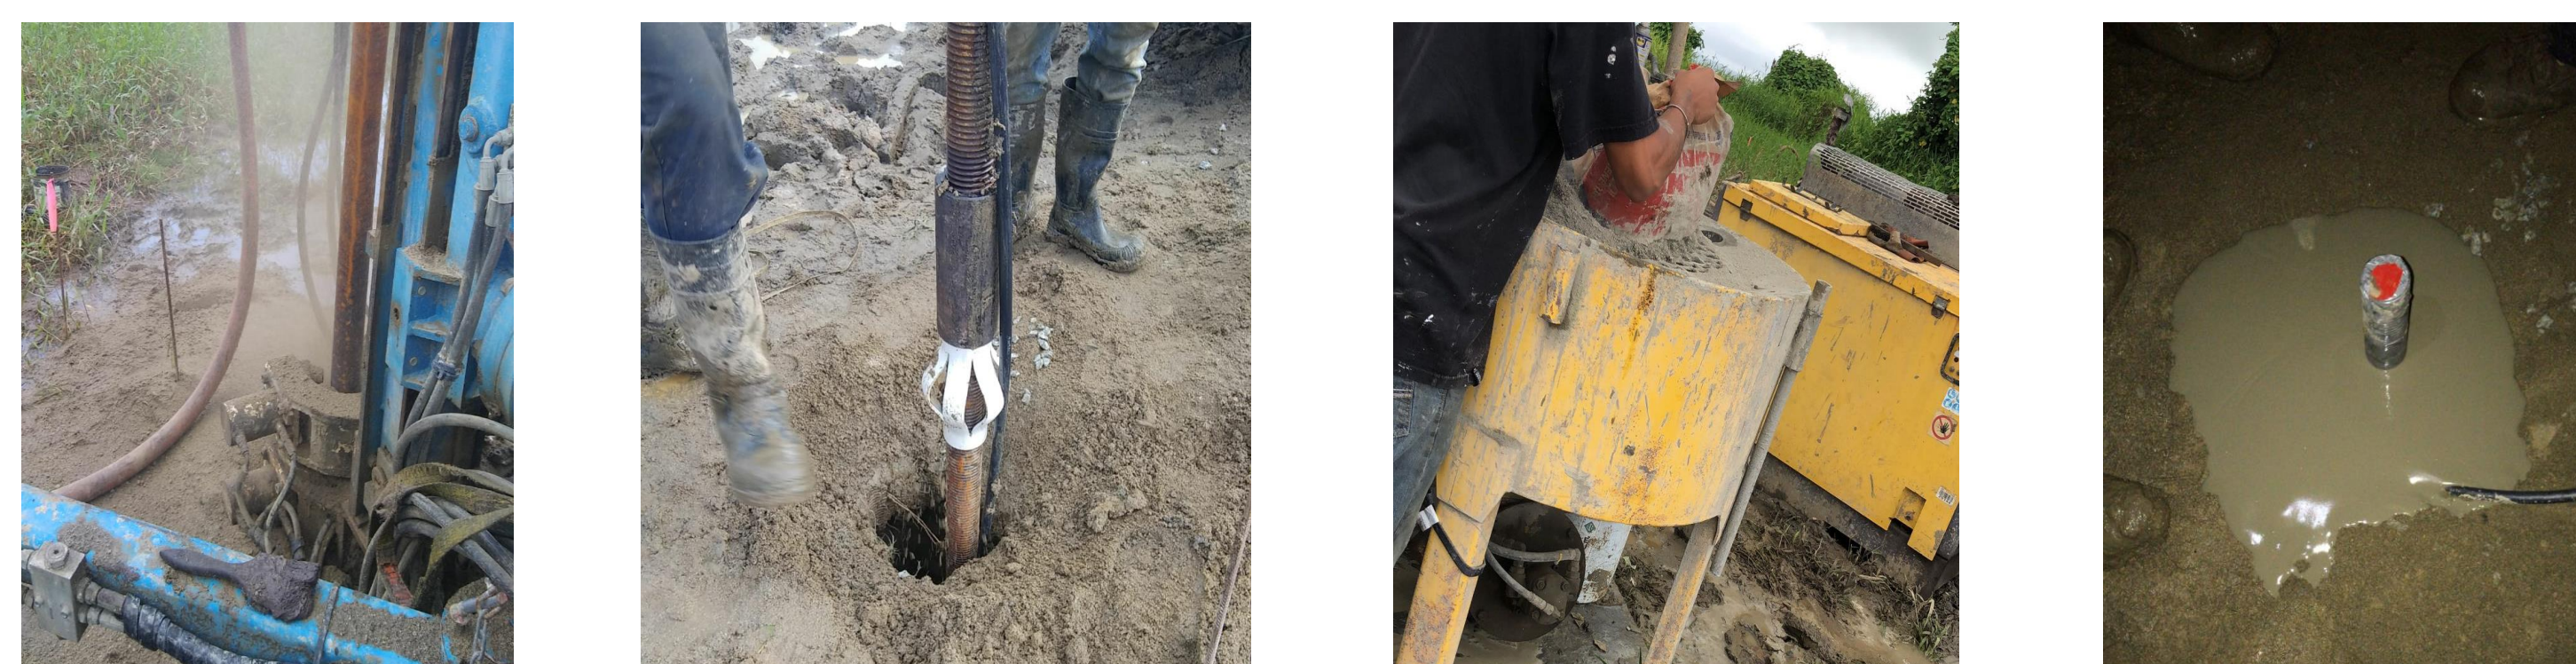
The construction of a micropiles in this project was a relatively simple process. The subsoil conditions allow for open hole drilling without the need of hole stabilization. No casing or slurries were required to maintain the hole open.

Percussion rotary drilling was used to drill through the Granodiorite Rock. The rotary-percussion drill is a type of rock drill that uses both rotary and percussive action in order to chip away rock and produce a hole.

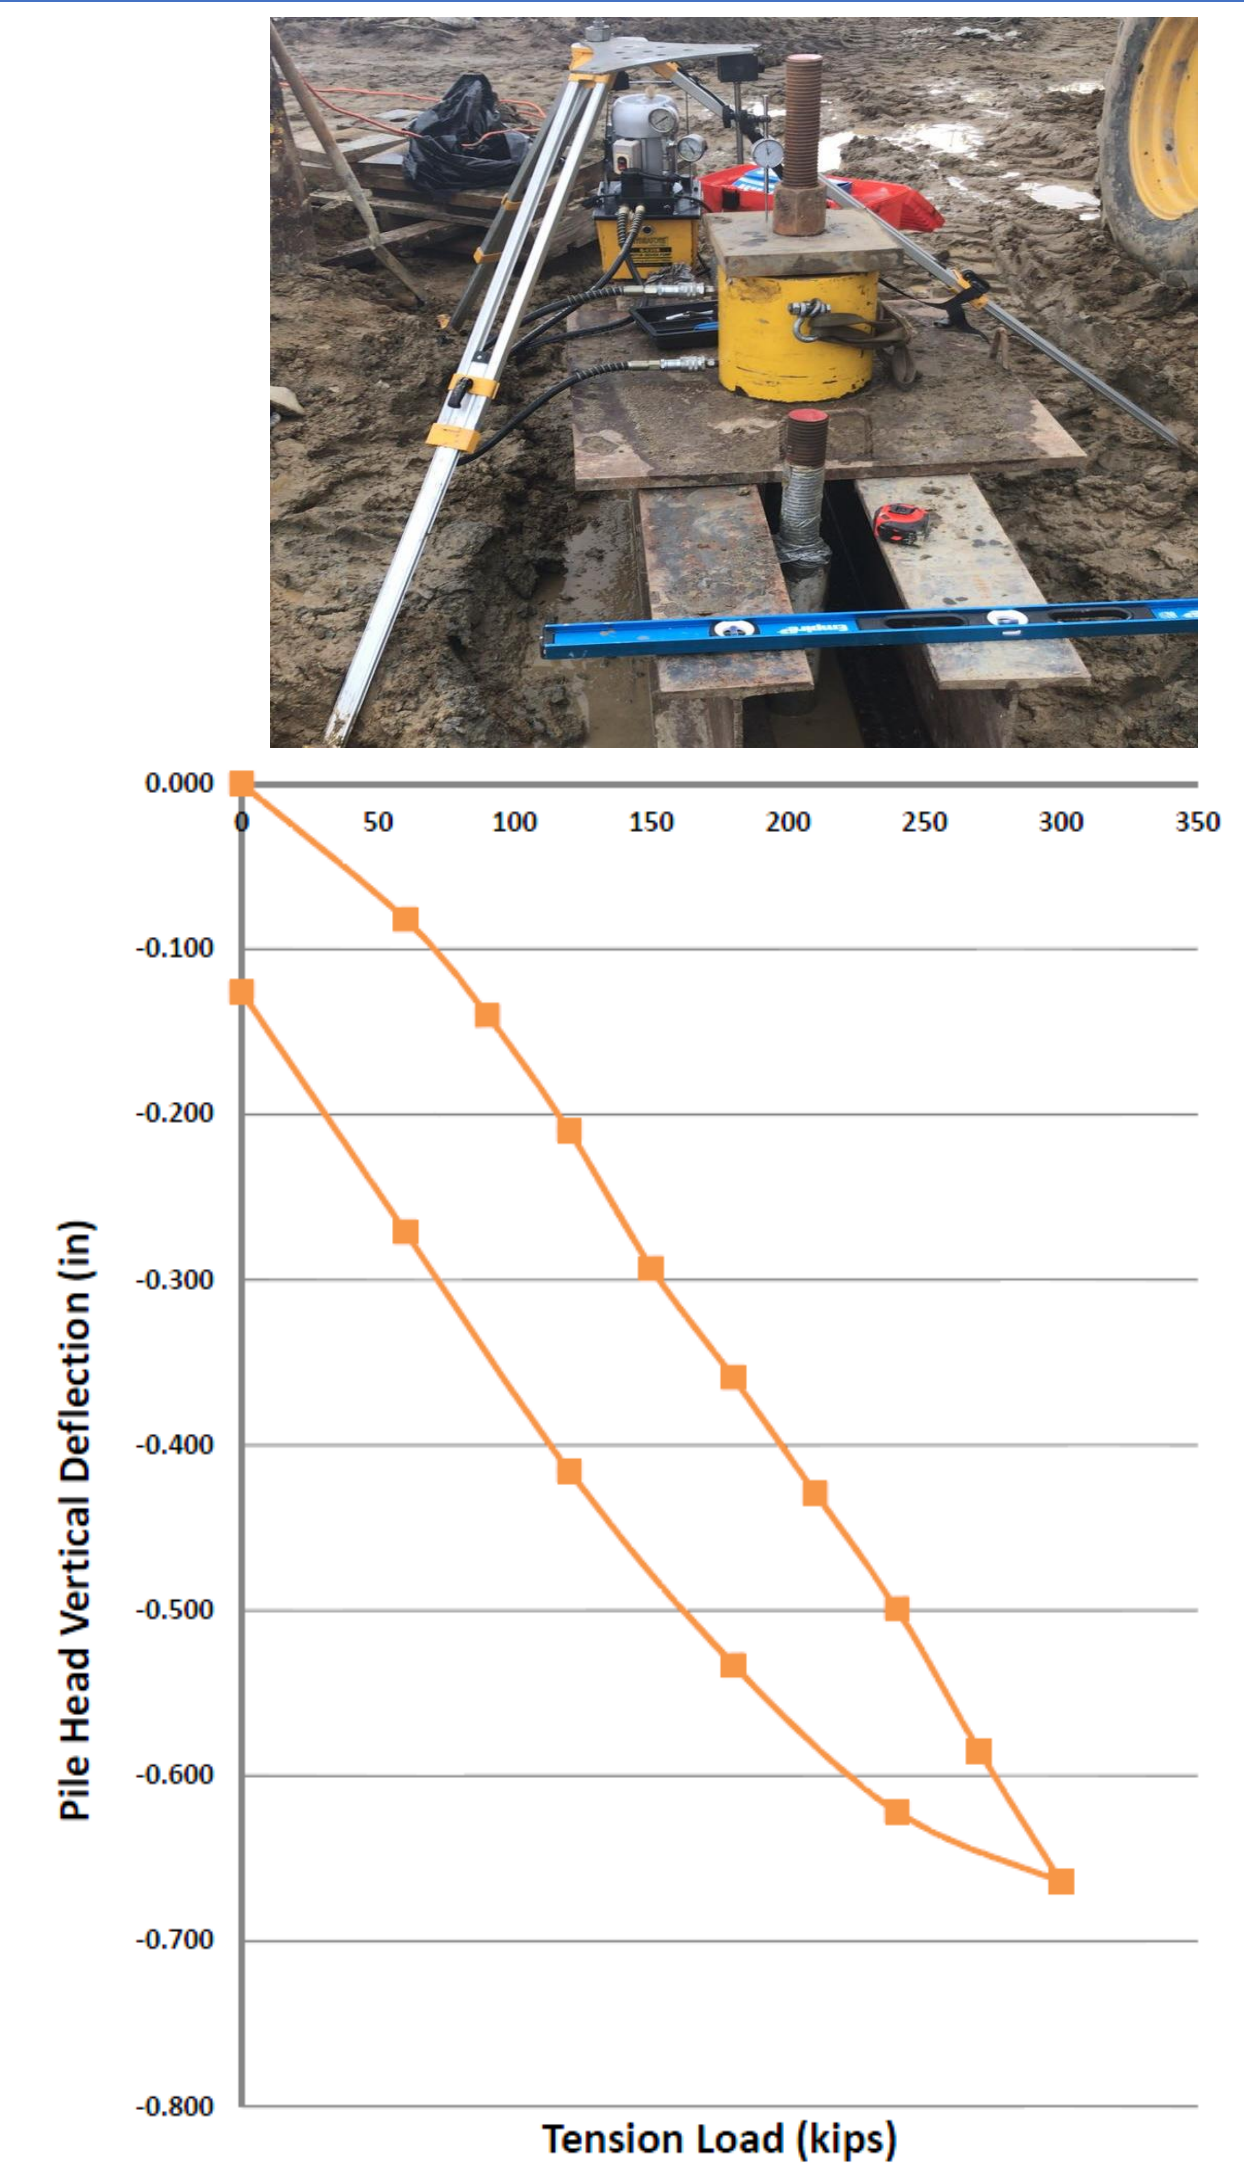
One proof test on a non-sacrificial micropile was tested to 100% of the design ultimate load of 300 kips. In general, the results of the load test showed an almost linear behavior. Failure of piles under tension test would be characterized with excessive deflections and a non-linear relationship of load to deflection, such was not the behavior observed for this test. Hence, no grout to ground bond failure is observed, nor structural failure of the reinforcing bar was observed.

The results of load test, performed on a non-sacrificial production micropile, showed that the micropiles can safely support the high magnitude 300 kips design ultimate load for each micropile. In addition, the load test showed that the weathered Granodiorite Rock, present at the project site and in a vast area in eastern part of Puerto Rico, is capable of developing relatively high values of grout to ground bond capacity. This last is of utmost importance, provided that general tendency of designers is to use lower values knowing a safe design will result. This "tendency" results in cost increases that are transferred to owner.

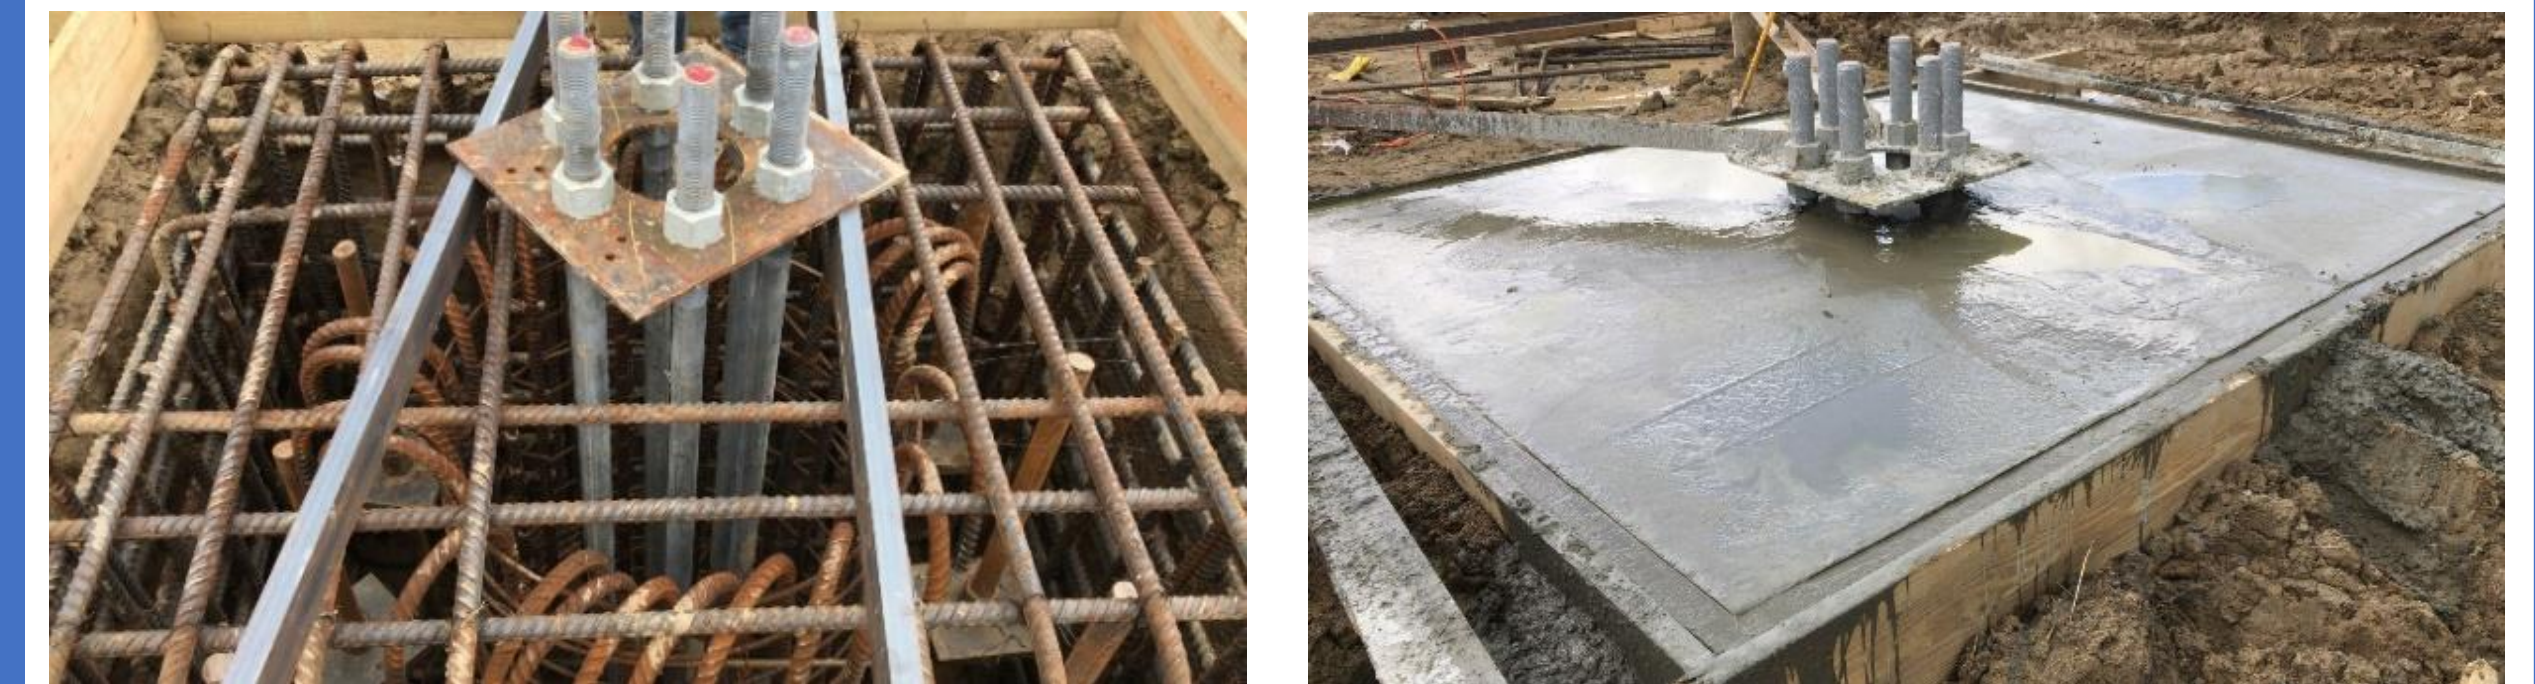
Once all micropiles construction have been completed and load test was performed, the construction of the pile caps was initiated.
