Joe Michael Rivera Rosario
 Advisor: Prof. Héctor J. Cruzado, PhD
 Master of Engineering Management Program

Abstract

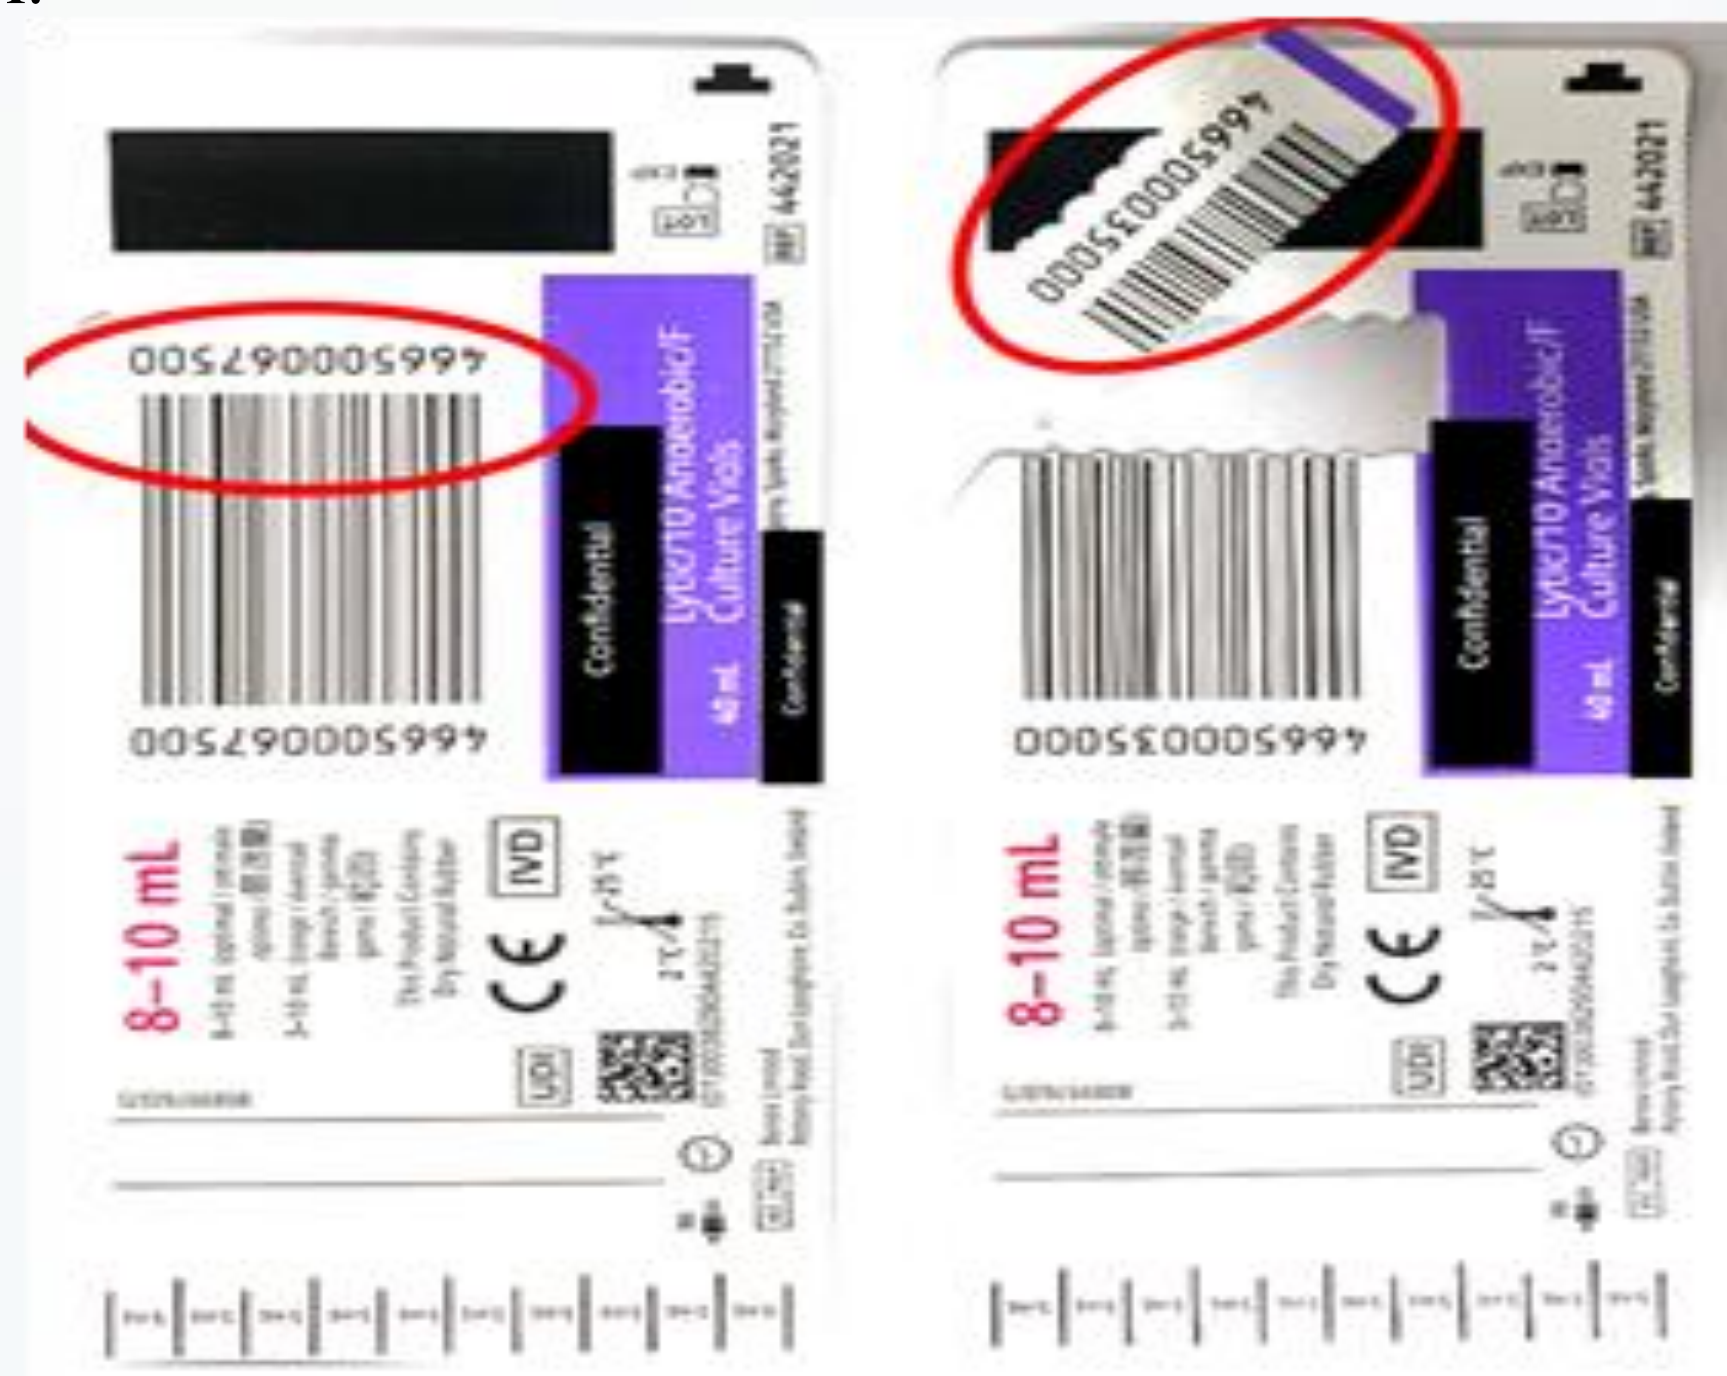
Figure 1
Label Pull Tab

A non-conforming label has reached losses of \$150,000 from January to February 2023. A non-conforming label is considered one that does not meet the client's quality standards or specifications. The label produced for this client is used on medical containers/serums. What makes it special is that it contains a pull tab, a portion of the label that comes off which contains critical information. Figure 1 shows the construction of label.

The label's pull tab is detaching constantly in the facility and reaching the client when not detected in the inspection process. The objective of this project is to minimize or eliminate this occurrence which will lead to cost prevention and maximize maintenance works to minimize downtime and improve output of good labels.

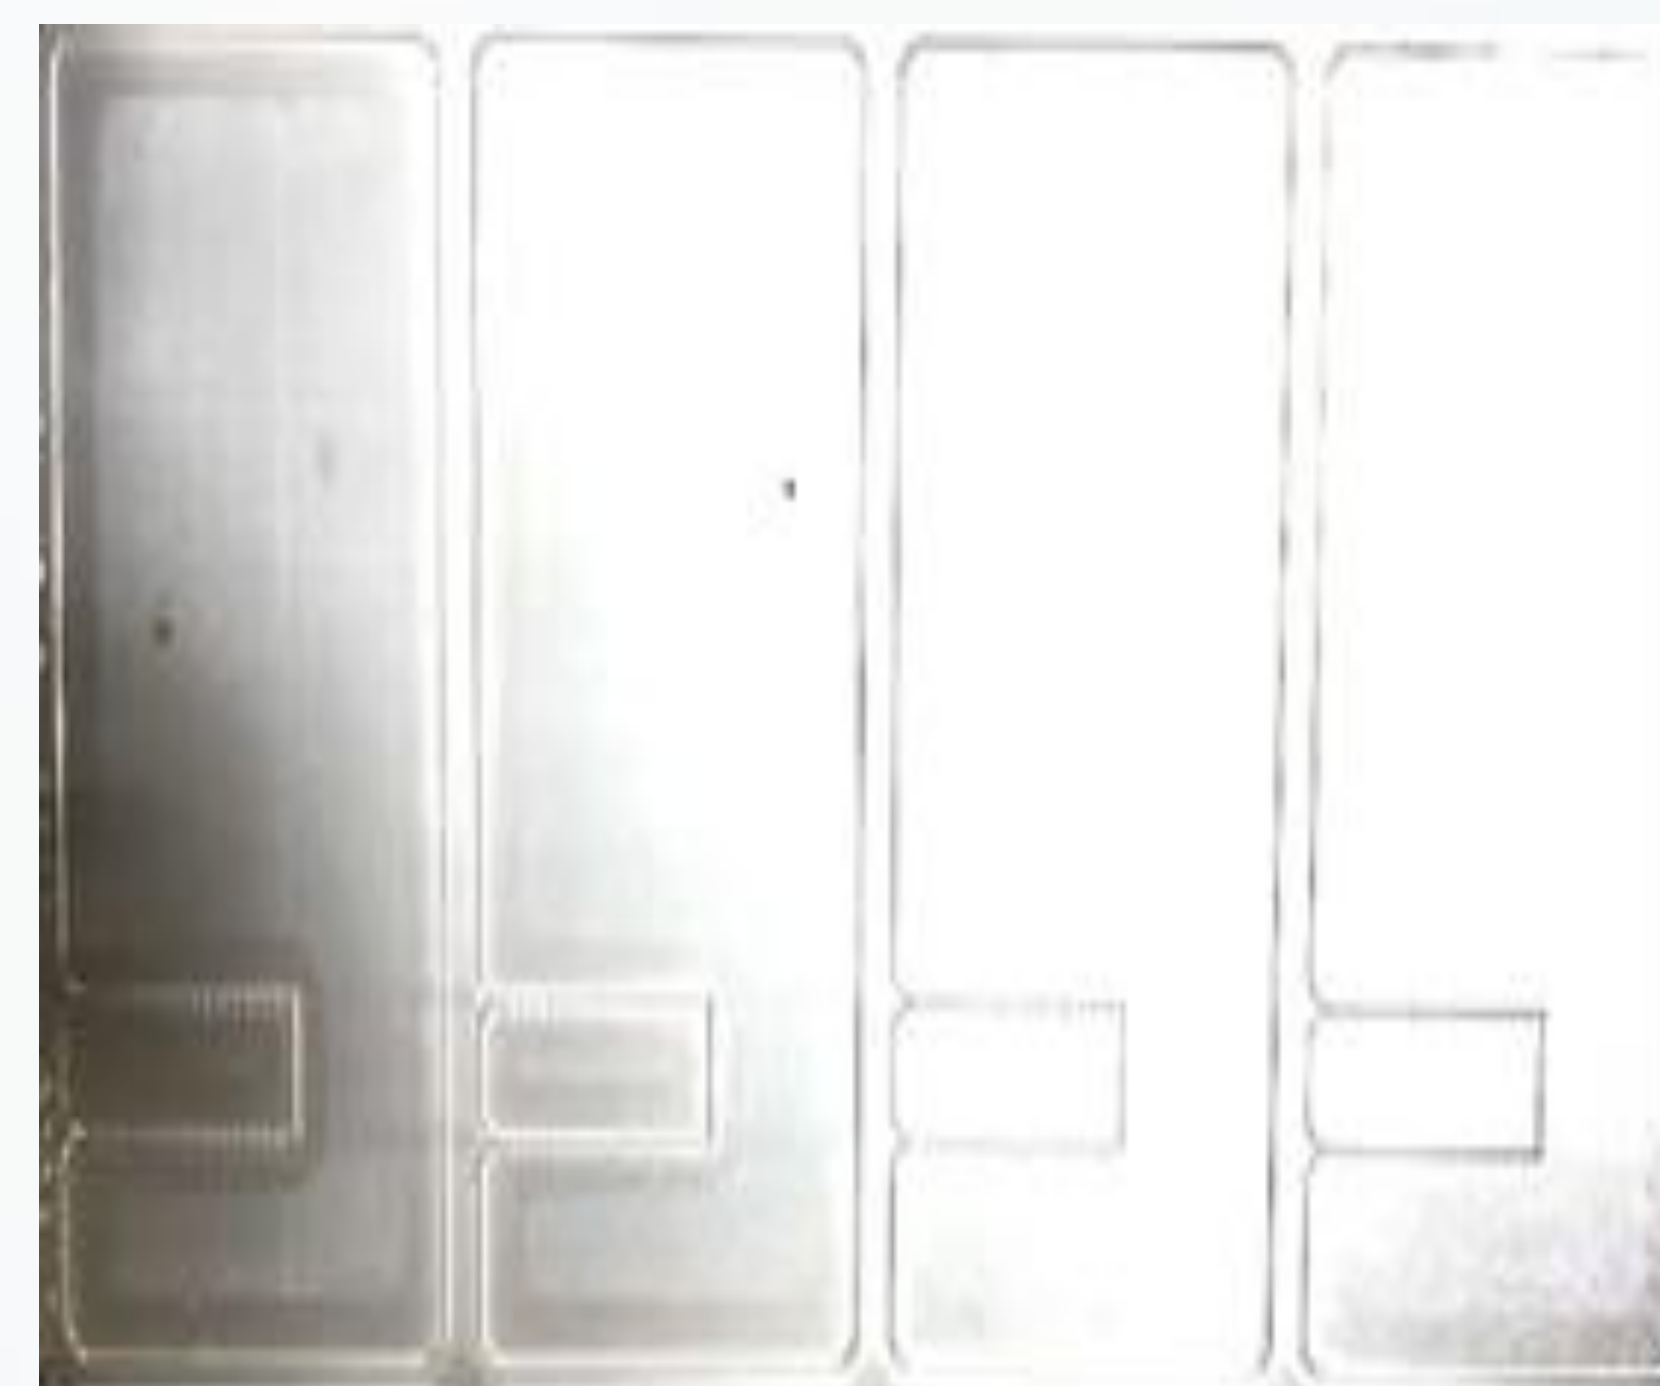
Figure 2
Flexible Die

- Losses came to a total of \$150,000 with a production output range of 7-10 million units (labels) per month.
- First area visited was the flexible die station on the press.
- The flexible die is the component that performs the perforation/cut of the label. [1]
- Please refer to Figures 2 and 3 to observe a flexible die sheet and station.

- These were changed by operator's judgement and SOP mentioned it must be changed every 4 months.
- This period was assigned aleatory with no data gathering study.
- A logbook was located near the press where operators recorded each time they changed the flexible die.
- The logbook was utilized to calculate the data discussed in the analyze phase.

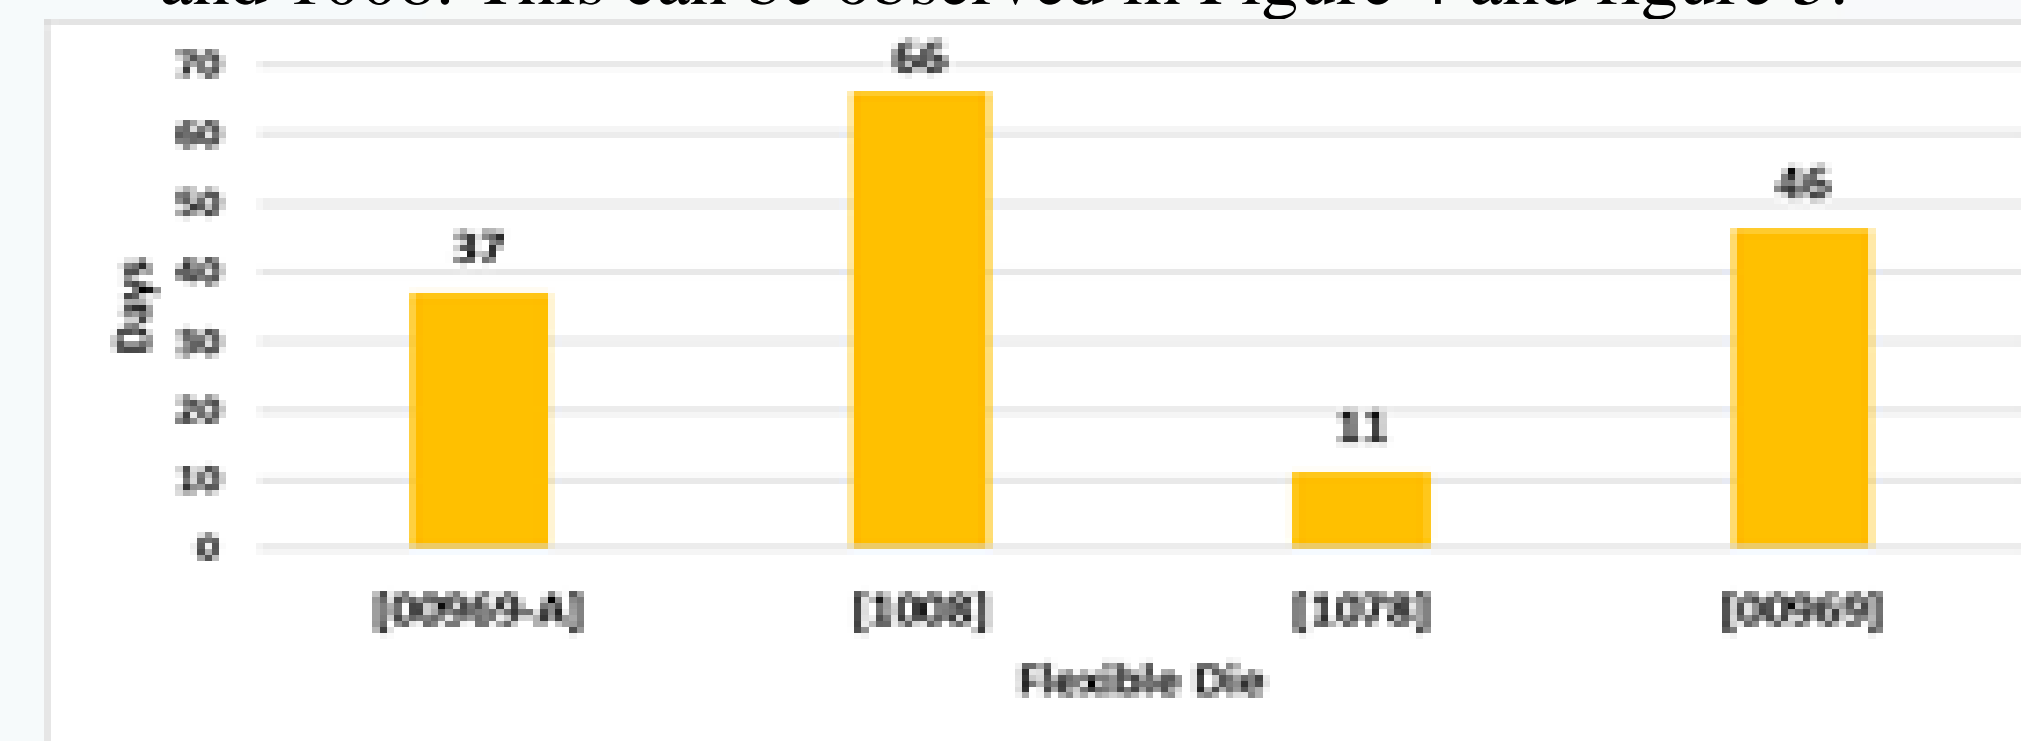
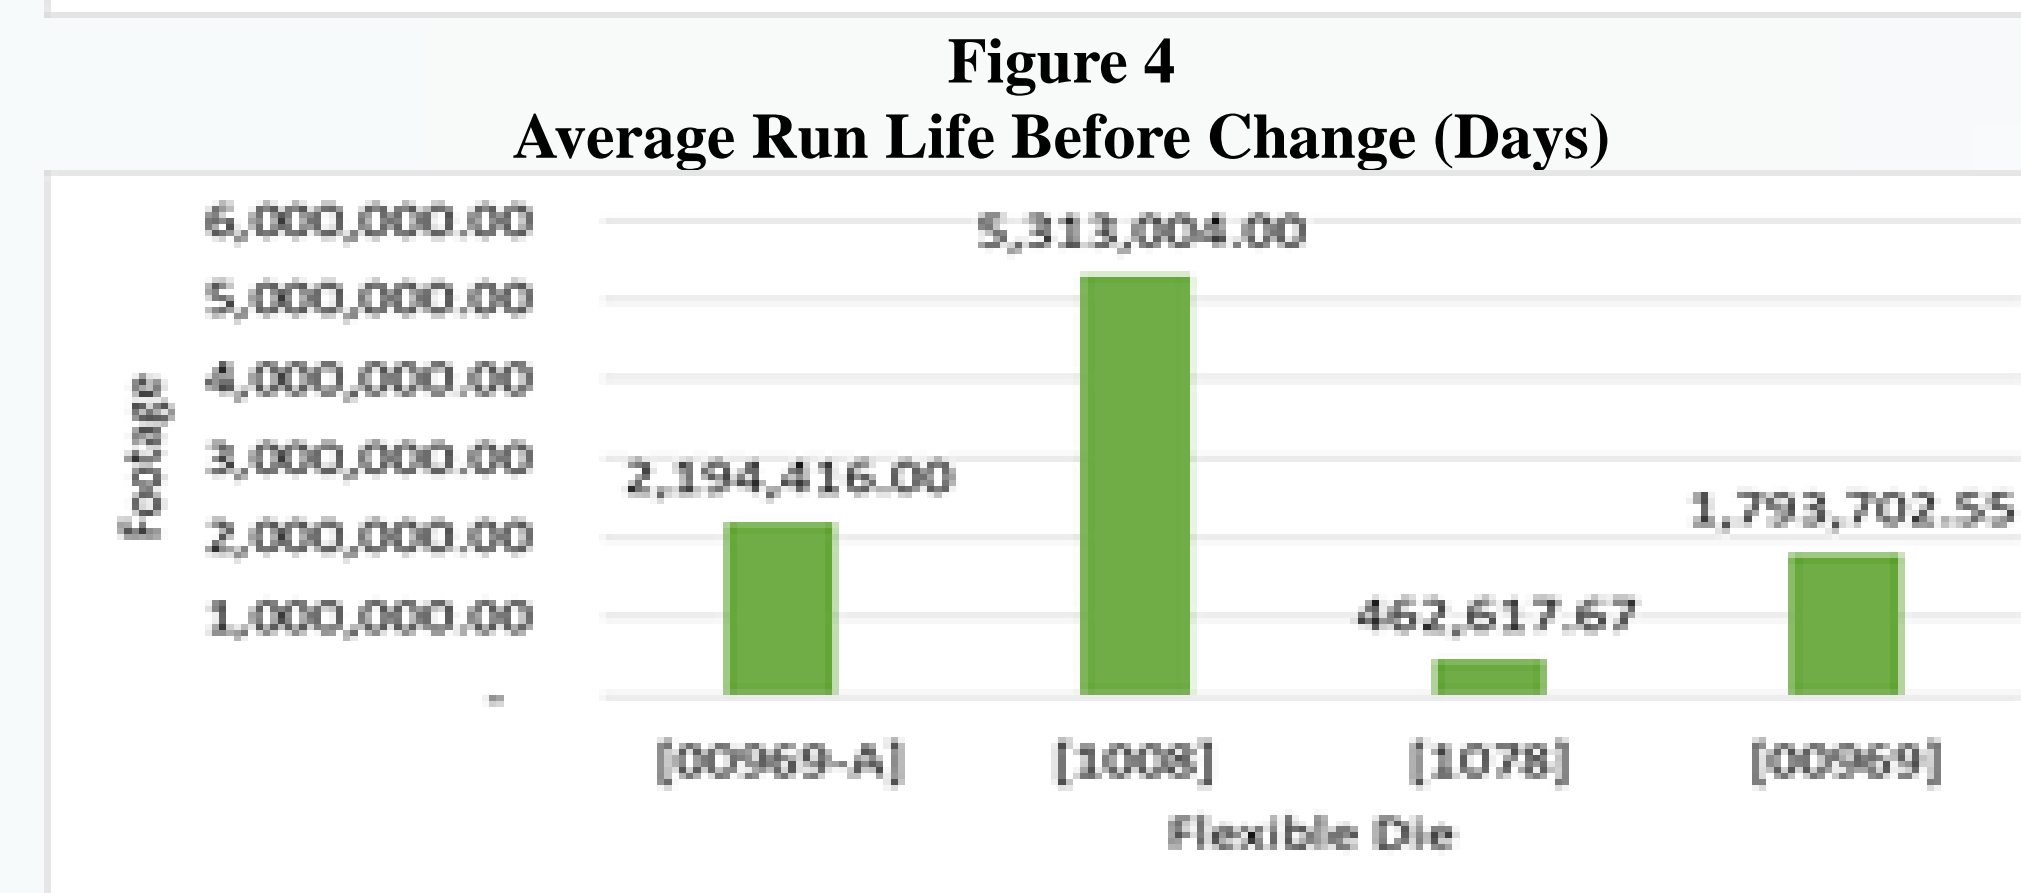
- The analyze phase was alimeted from the measure phase.
- The first step was calculating the run life for the different types of dies used for the current product using the logbook of the operators.
- The reference numbers for the current flexible dies are 00969 and 1008. This can be observed in Figure 4 and figure 5.
