ABSTRACT

A medical device company in Puerto Rico aims to improve an Ultrasonic Welding Process of a high-volume bone shredding medical device. The current process yield is 93% and must be at least 95% to meet the manufacturing site Key Performance Indicators. Six Sigma methodology was used as the improvement project framework. Tools such as Process Failure Mode and Effect Analysis, Cause and Effect Analysis and Tool Life Studies were used to evaluate the root cause of the underperforming yield. The root cause for the incomplete and over-welding defects was confirmed to be wear in the ultrasonic welding holding fixture which allowed parts to vibrate during welding. Improvements to reduce wear to the fixture were implemented. Process yield monitoring after the implementation of changes consistently show an increase in yield of over 95% and a cost avoidance of over \$12,000 dollars a month.

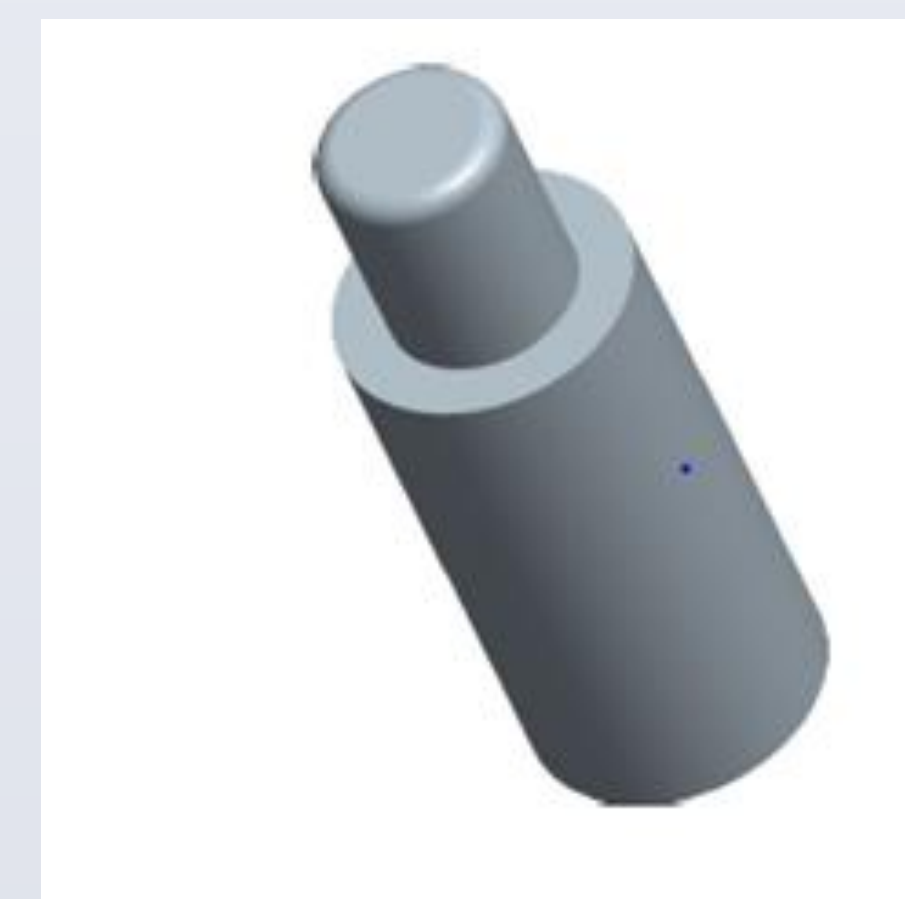
Figure 2: Centering Fixture Support Pin

Based on the investigation and findings obtained during the Analysis Phase, two solutions were proposed. Solution #1 consisted of re-designing the pin centering fixture which holds the parts together during the welding operation. Re-design was proposed to change the material from the acetal homopolymer Delrin to a high wear resistant metal like tungsten carbide to withstand the metal-to-metal friction of the stainless-steel disk. Since the fixture was already designed and only consisted of a material change, the engineering hours invested into fixture design were negligible. An external machine shop quoted \$1,000 to manufacture the fixture with a lead time of two weeks. Implementation of the new fixture can be performed in one day through an unscheduled preventive maintenance event if necessary.

Therefore, Solution #1 was pursued and implemented. Fixture design as shown in Figure 2, Figure 3 and Figure 4 was sent to a machine shop approved supplier for machining.

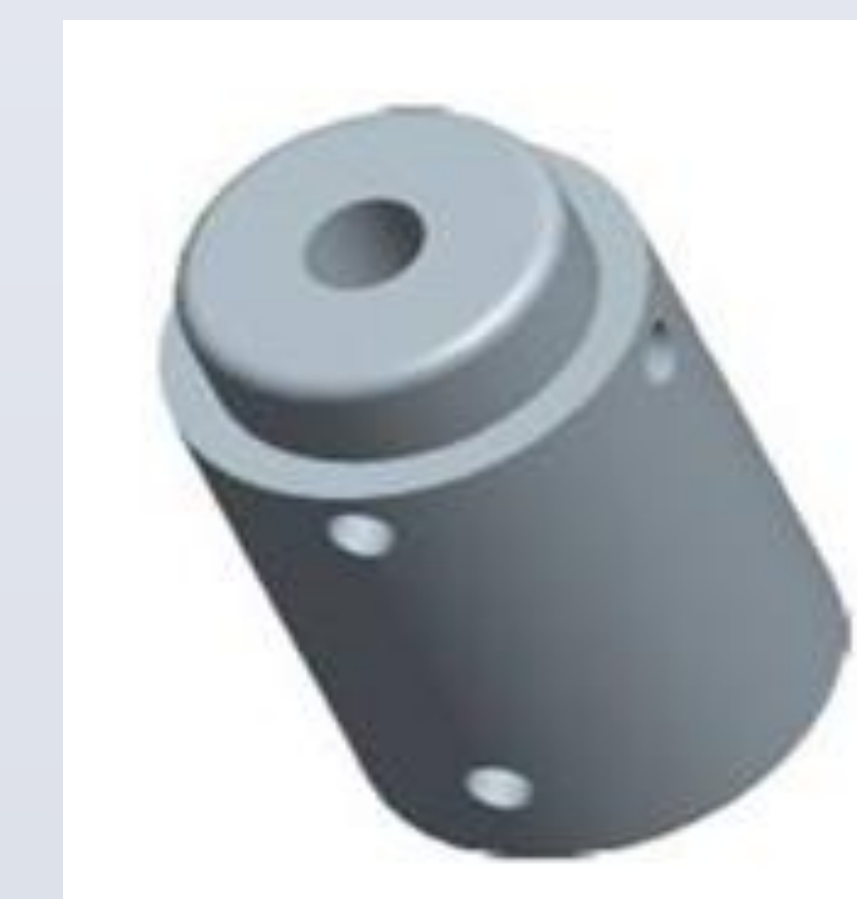
Figure 3: Centering Fixture Support Base

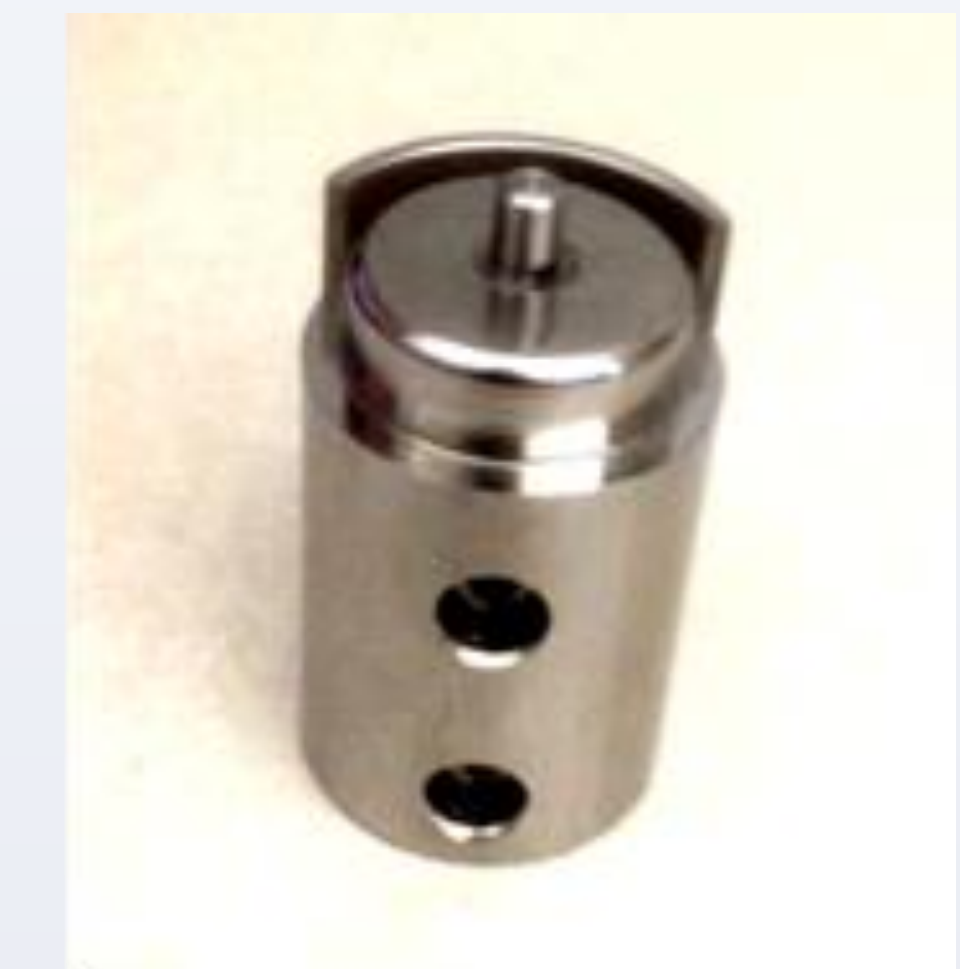
Figure 5: Tungsten-Carbide Centering Fixture

The new centering fixture, as shown in Figure 5, was received and implemented in the ultrasonic welding process as a preventive maintenance event during a planned plant shut down in December 2020. After the change implementation the monitoring phase began. The ultrasonic process yield is being monitored for a period of three (3) months on a weekly basis.

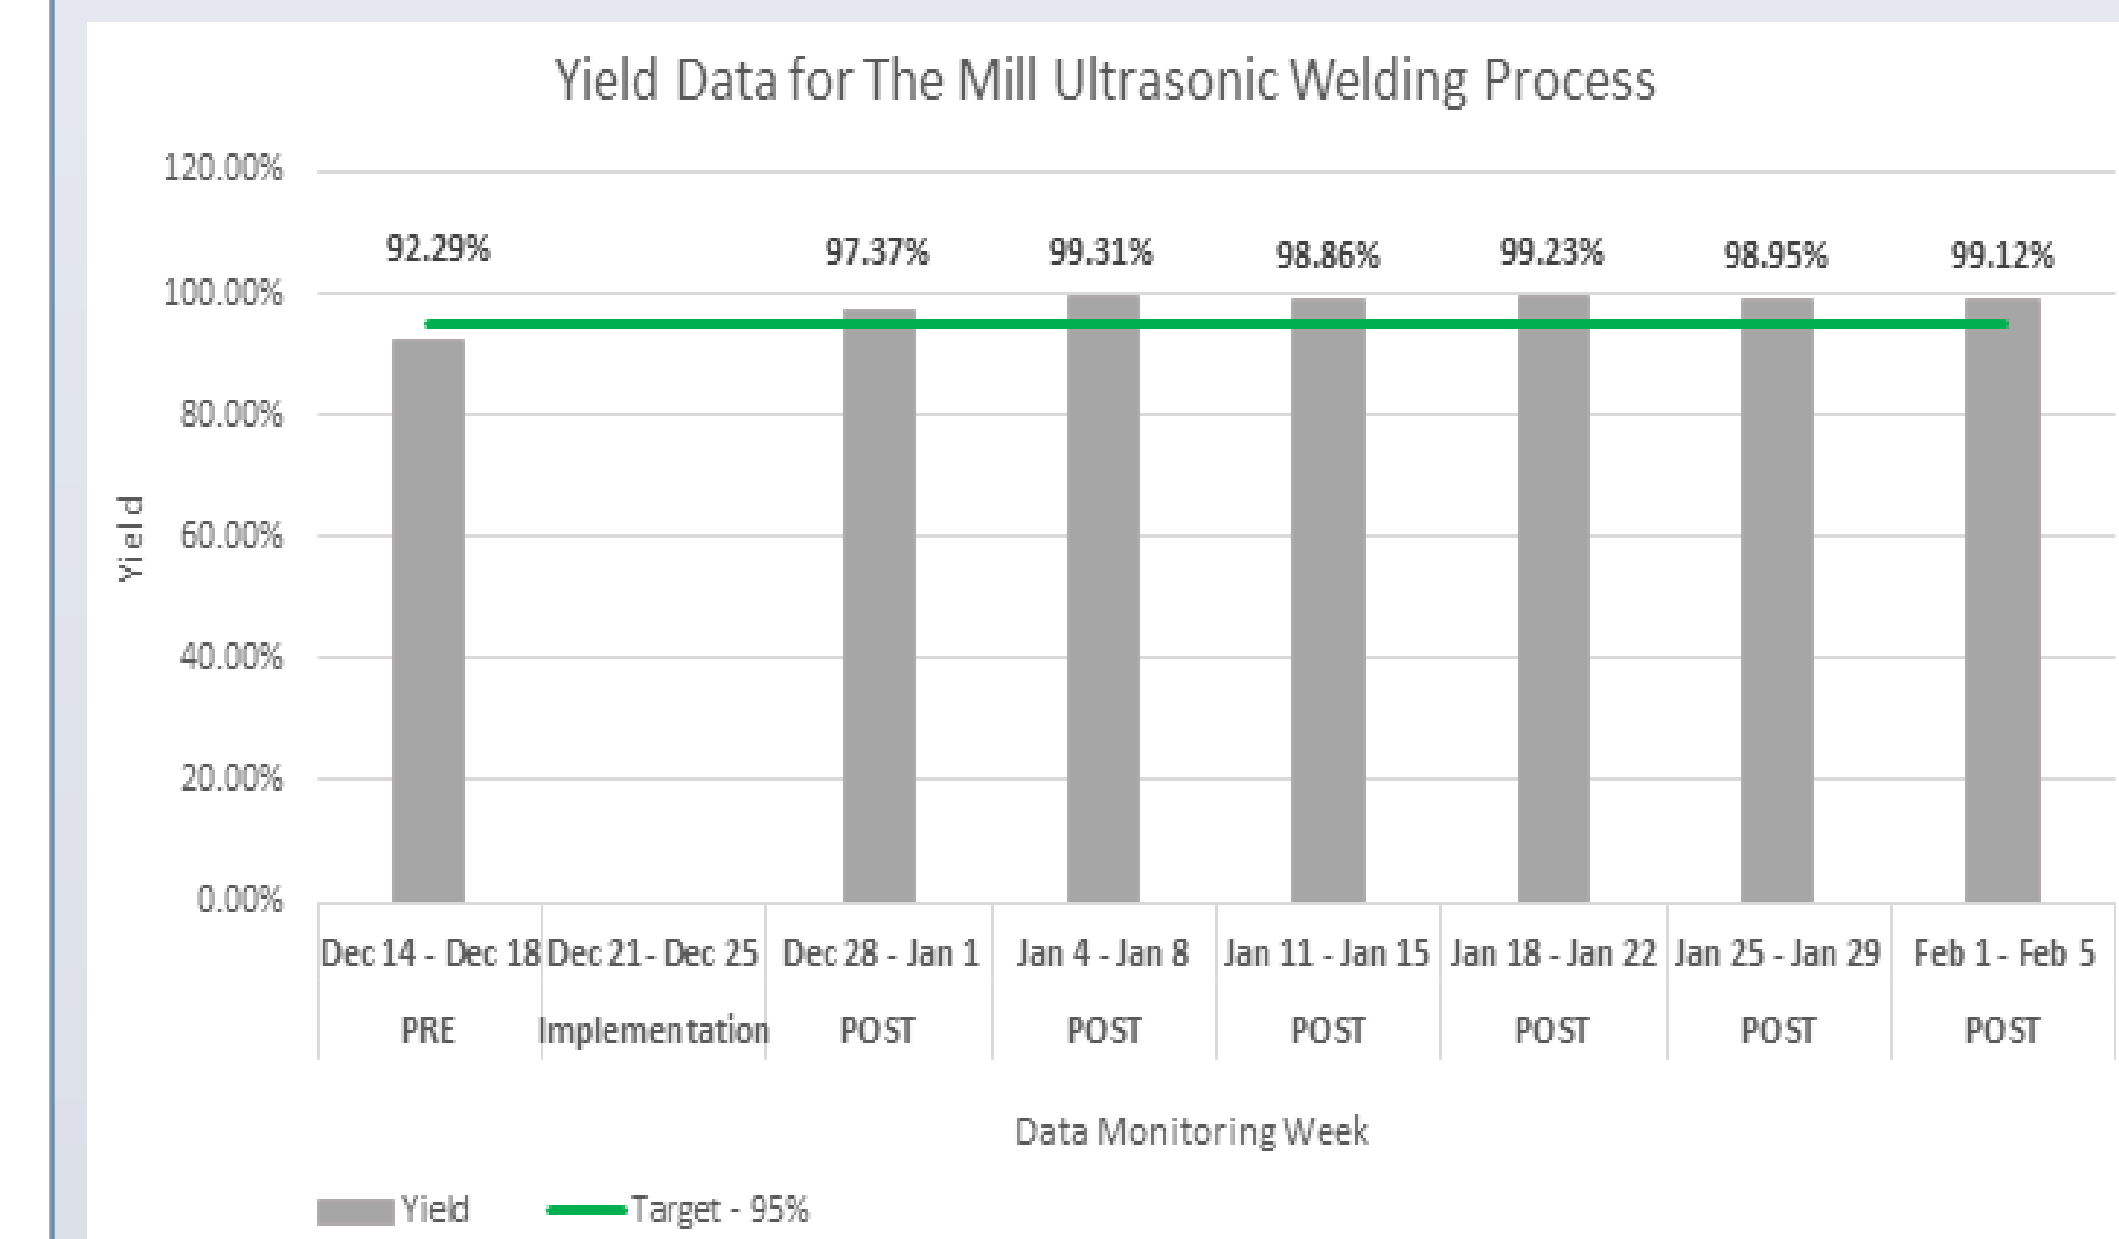
As can be observed in Figure 6, yield has been consistently reported to be higher than 95% since the change was implemented. If this trend continues it can be concluded that the wear on the centering fixture was the main contributing factor and root cause of the underperforming yield. Moreover, the improvement project can be considered successful and effective at meeting the objectives to reach the KPI goal of at least 95% and providing a cost avoidance of over \$12,000 monthly.

Figure 6: Yield Data Pre and Post Change Implementation
