INTRODUCTION

SCOPE

The project consists of the detailed visual and structural evaluation of each member of bridge #1103 located in Juncos, Puerto Rico by using the current design codes and manuals to find its condition and propose an appropriate retrofit solutions along with a new permanent detour which will serve for traffic control during the repairs to the bridge. Also an alternative road and a rest area building was proposed for drivers to stop during their trip.

The bridge #1103 and project # AC-003008 is in the state road PR-30 located in Juncos Puerto Rico. The bypass contains two identical bridges with a median that separates them. The one chosen was the right bridge, the Gurabo to Juncos direction. The bridge is 173 feet long and 40 feet wide. It contains 2 lanes of 12 feet each and an exclusive lane for emergencies of 12 feet wide and lesser left side small 4 feet margin which includes concrete barriers. The bridge has a vertical clearance of 14 feet and 6 inches and its superstructure contains the following components: a concrete slab 6 inches thick, 5 T-Girders beams of variable section, 10 steel bearings that support the girders and bent beams, 20 diaphragms and 2 b

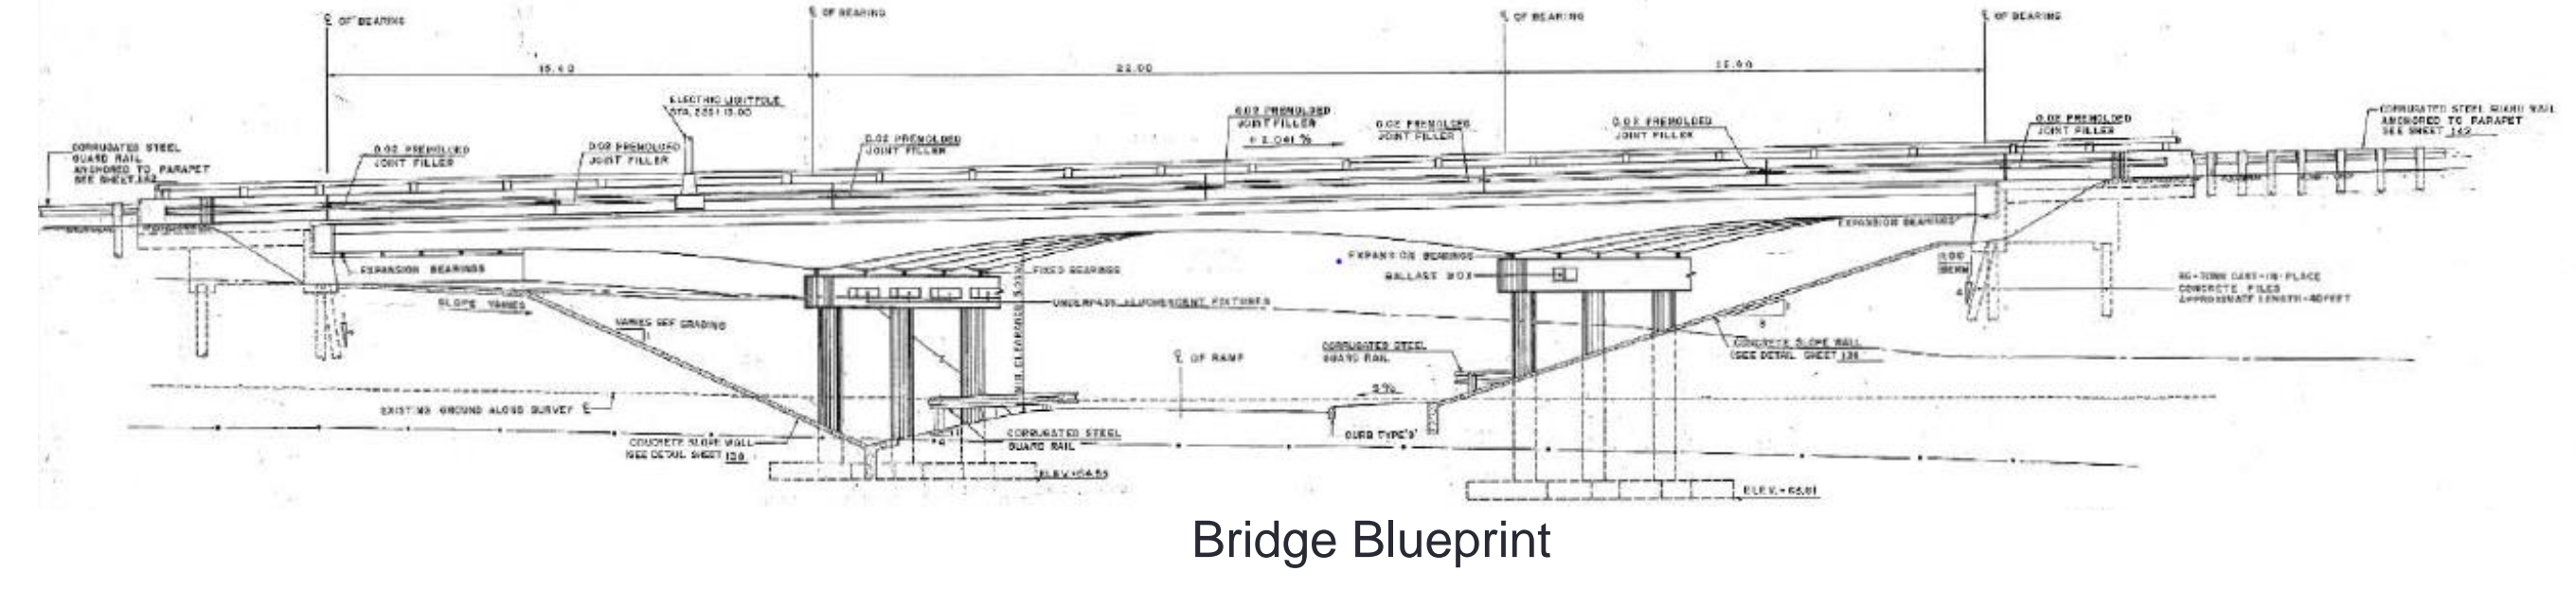
BRIDGE EVALUATION

The bridge condition was found to be poor as many aspects of the original 1960's design don't meet the actual codes and manuals requirements for current construction. Specifically, the slab was found to be faulty and a retrofit design was establish to correct it. As far the bearings go they are in immediate need of repair due to extreme corrosion. Finally, a complete design of a bridge deck drainage system was required as water damage was one of the main reasons that other structural elements of the bridge were not up to standard.
