Analysis of a Slope Failure in Los Canales Road in Carolina Puerto Rico after the Tropical Storm Irene

Melissa Castro Del Valle
Civil Engineering
Omaira Collazos, Ph.D.
Civil and Environmental Engineering Department
Polytechnic University of Puerto Rico

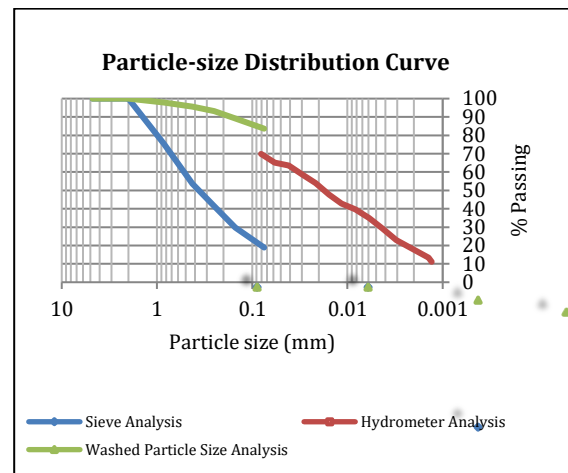
Figure 5
Laboratory Test Results

To find the soil properties a soil sample was used and several laboratory tests were performed. A grain size distribution test [2] was performed to determine the size range of particles in the soil; the results are shown in Figure 5. A soil-washing laboratory was performed to identify the amount of fines. The amount of soil passing the sieve #200 was 84 percent, which means the material is cohesive with a small amount of coarse particles. The grain size distribution for the soil-washing results is shown in Figure 5.

A hydrometer test was performed to identify, through sedimentation of soil particles, the amount of particles size smaller than 0.075mm. Results are shown in Figure 5. Clay particles are generally

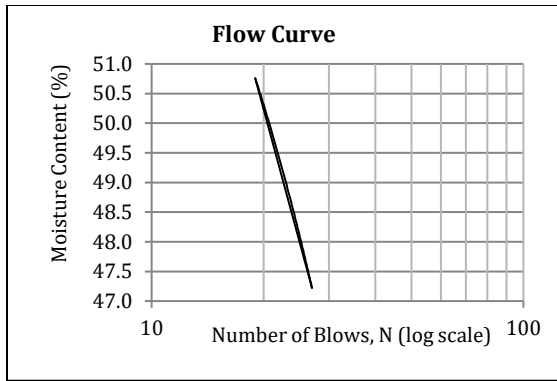
Figure 6
Liquid Limit Test Results

The consistency limits were determined performing the liquid limit, plastic limit and plasticity index tests [4]. The results for the liquid limit test are shown in Figure 6. For a 25-blow count the liquid limit value obtained was 48%.

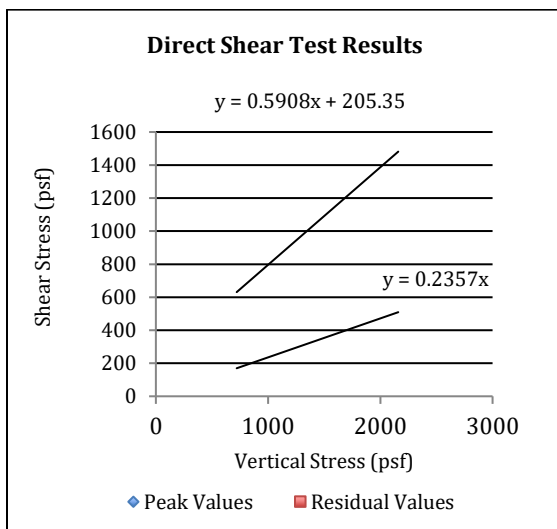
Figure 7
Plot of Direct Shear Test Results

To perform a slope stability analysis the angle of friction and cohesion parameters are indispensable. These shear strength parameters were obtained performing a direct shear test [7] on the soil sample. The results are shown in Figure 7. The test was performed applying vertical stresses of 5, 10, 15 psi to three remolded soil samples. The angle of friction is the tangent of the slope for each curve. The peak angle of friction (ϕ_p) was 30 degrees and the residual angle of friction (ϕ_r) was 13.3 degrees. Since the material was a cohesive one a cohesion of 205.35 psf was obtained for the peak analysis.
