Structural Evaluation and Rehabilitation Design of Puente Blanco in Quebradillas

Lismarie Vargas Andino

Master in Civil Engineering

Polytechnic University of Puerto Rico

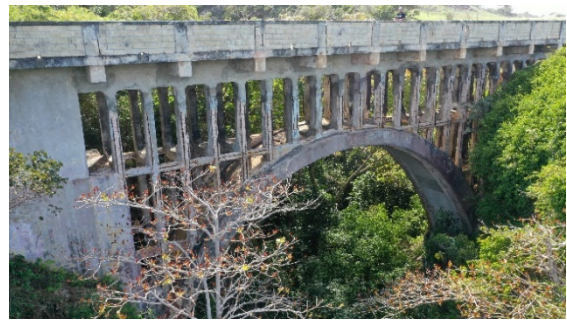
Figure 4
Bridge in its present condition

In 1984, Puente Blanco was listed in the National Register of Historic Places. In 1985, the bridge was renovated to widen the roadway to 23 feet for vehicular use by placing an 11-inch slab on top of ten beams (figure 4). In 2008, the Department of Transportation and Public Works (DTOP) closed the bridge to vehicular traffic [4].

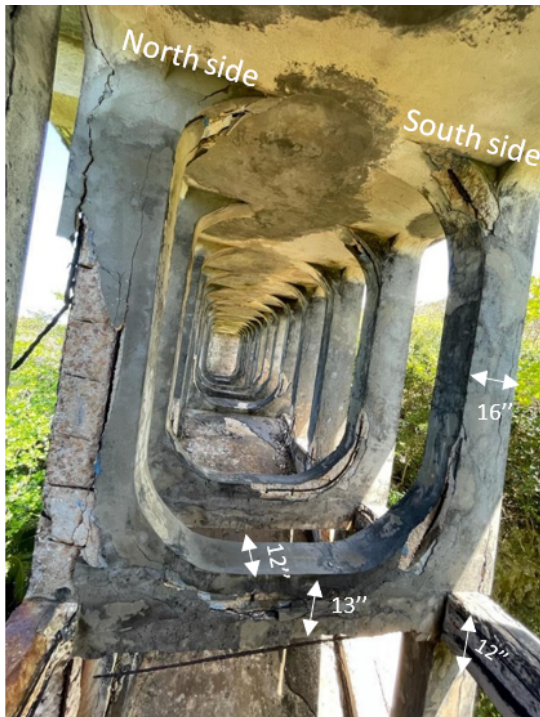
Figure 5
Interior of bridge

Measurements were taken of some elements of the bridge structure to subsequently make as-built drawings of the structure. The dimensions shown in Figure 5 were not found in the plans, they were measured on site.
