Effects of In-stream Sand and Gravel Mining in Scour at Bridges in Puerto Rico

Ana L. Torres Santana

Master of Engineering in Civil Engineering

Polytechnic University of Puerto Rico

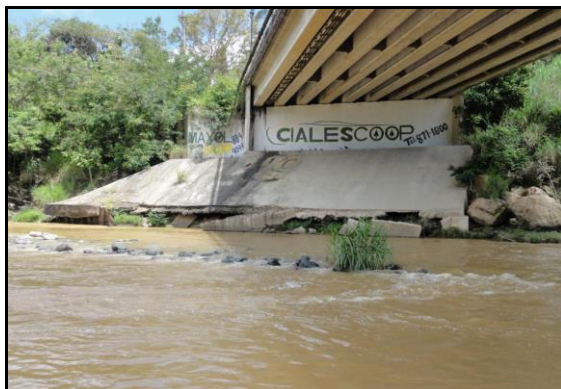
Figure 4
BR-1374 PR-149, Ciales

Bridge BR-1374, shown in Figure 4, is located in road PR-149 over the Rio Grande de Manatí in the Municipality of Ciales near another site identified as a gravel pit, but no additional information was a found about the permit for this project. The right abutment of the bridge shows visible scouring and it has been assessed by PRHTA as part of the Scouring Evaluation Program.

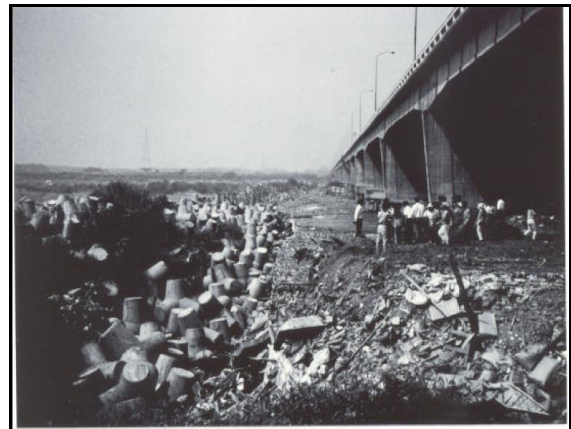
Figure 9
Channel Response to In-stream Gravel Removal [4]

On 1995, the Kaoping Bridge over the Kaoping River in Taiwan, was suffering the undermining of its piers due to the effect of headcutting of over 7 m from in-stream gravel mine located downstream the bridge. As a countermeasure, the downstream margin was protected with gabions and concrete jacks to control the incision as shown on Figure 9 and the gravel mining was prohibited 1 mile from the bridge [6].

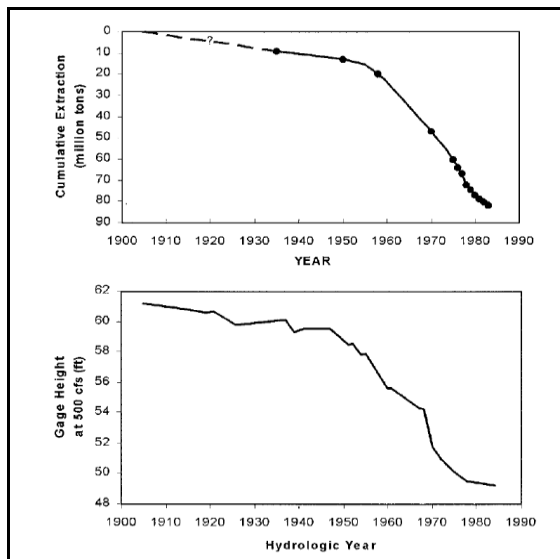
Figure 11
Specific Gage Data for Cache Creek, California

The Cache Creek in California, USA have records of gravel mining since 1940. A plot from a specific gage data for 500 cfs (Figure 11) from 1910 to 1980, shows that the river bed has degraded more than 10 ft (3 m) in this period.

An incision of 4m was made 1400 m downstream the Capay Bridge where the extraction was being held. After a flood in 1992, a nickpoint over 3 m deep extended 700 m upstream. Another heavy flow in 1993, caused the nickpoint to migrate another 260 m excavation and in a 50- yr flood in 1995, the nickpoint migrated under the Capay Bridge, contributing to the near- failure of the structure.
